I'll Be Done in a Flash!

An Arc-blast Incident

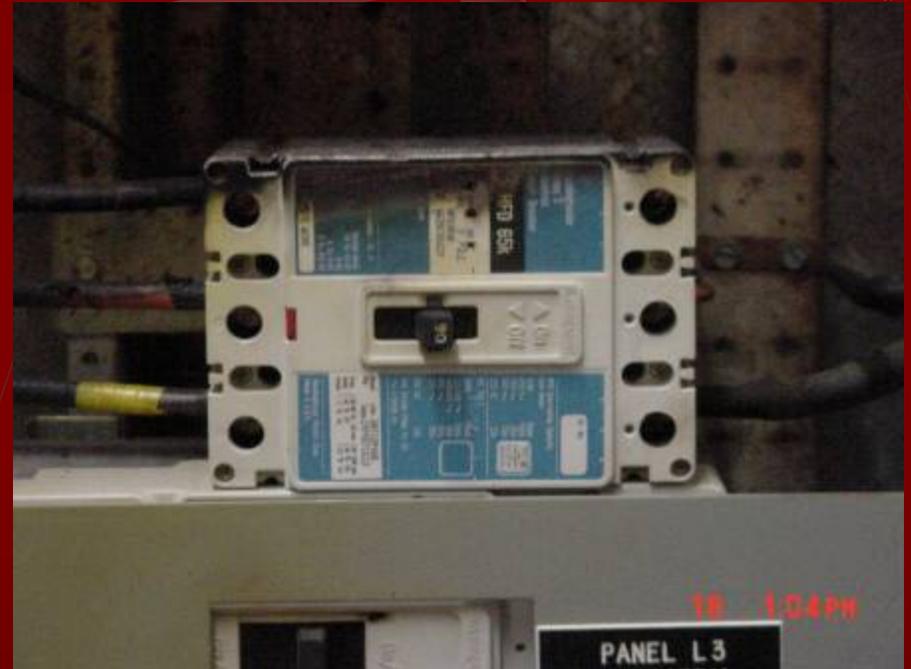
- Removal of malfunctioning existing 3 phase 480 volt circuit breaker and hardware (fingers, contacts) from a Westinghouse 1,000 amp 3 phase 480 volt Main Distribution Panel (MDP).

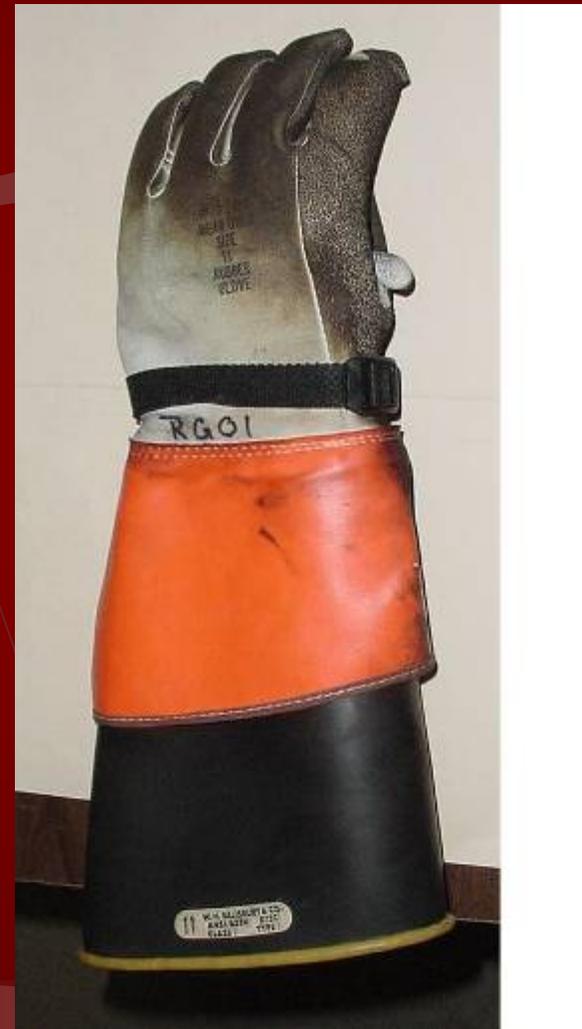
- With just the use of a pair of Salisbury Class 1 Type 1 electrical gloves and a pair of Kunz insulated glove protectors, as the only Personal Protective Equipment being used.

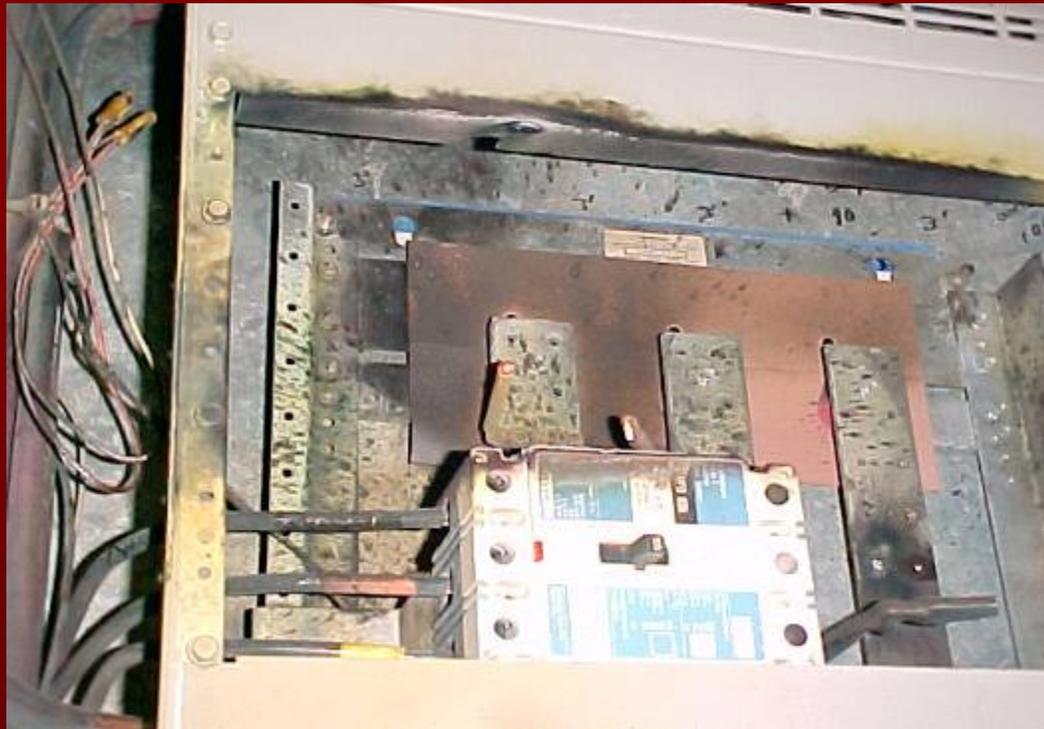
- The Journeyman began to loosen one of the “fingers” when it began to shift in the direction of a second “finger”.

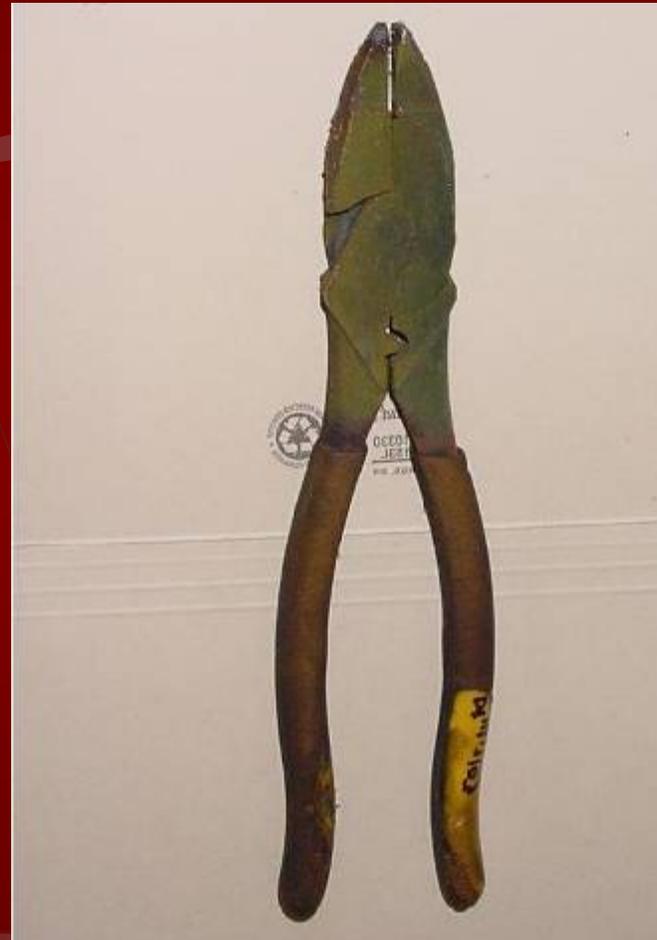
- The Master Electrician grabbed a pair of pliers and the left glove to secure (keep from moving) the “live finger” while the screw was being removed.

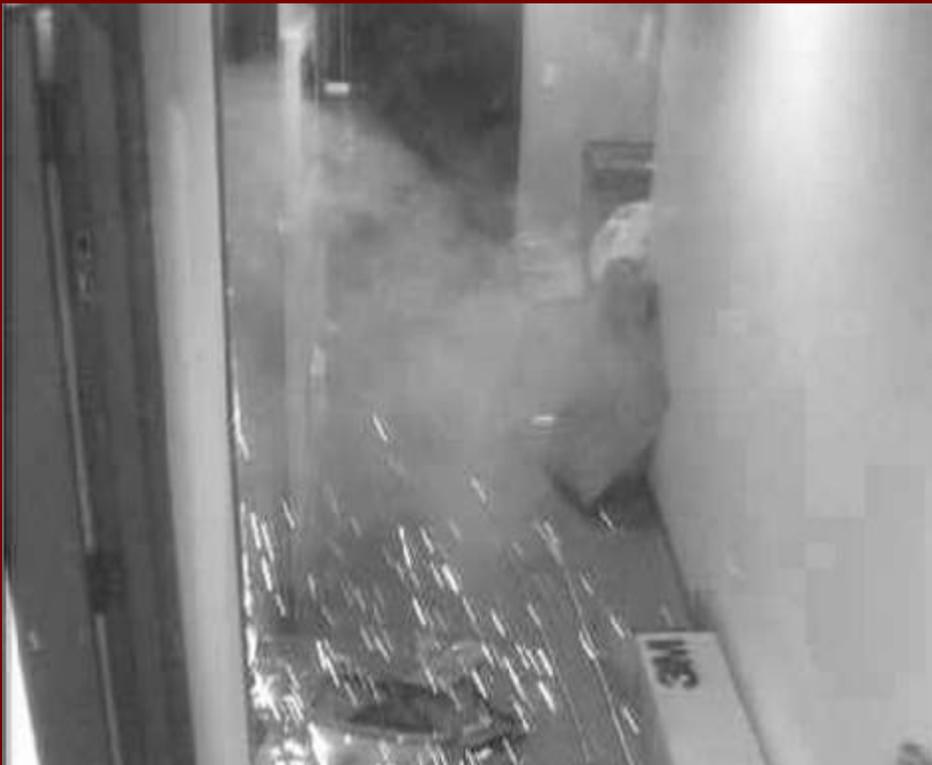
- As the Journeyman was bent over looking for the screwdriver, the Master Electrician's grip failed causing the "finger" to buck the other two phases as well as the grounded cabinet.

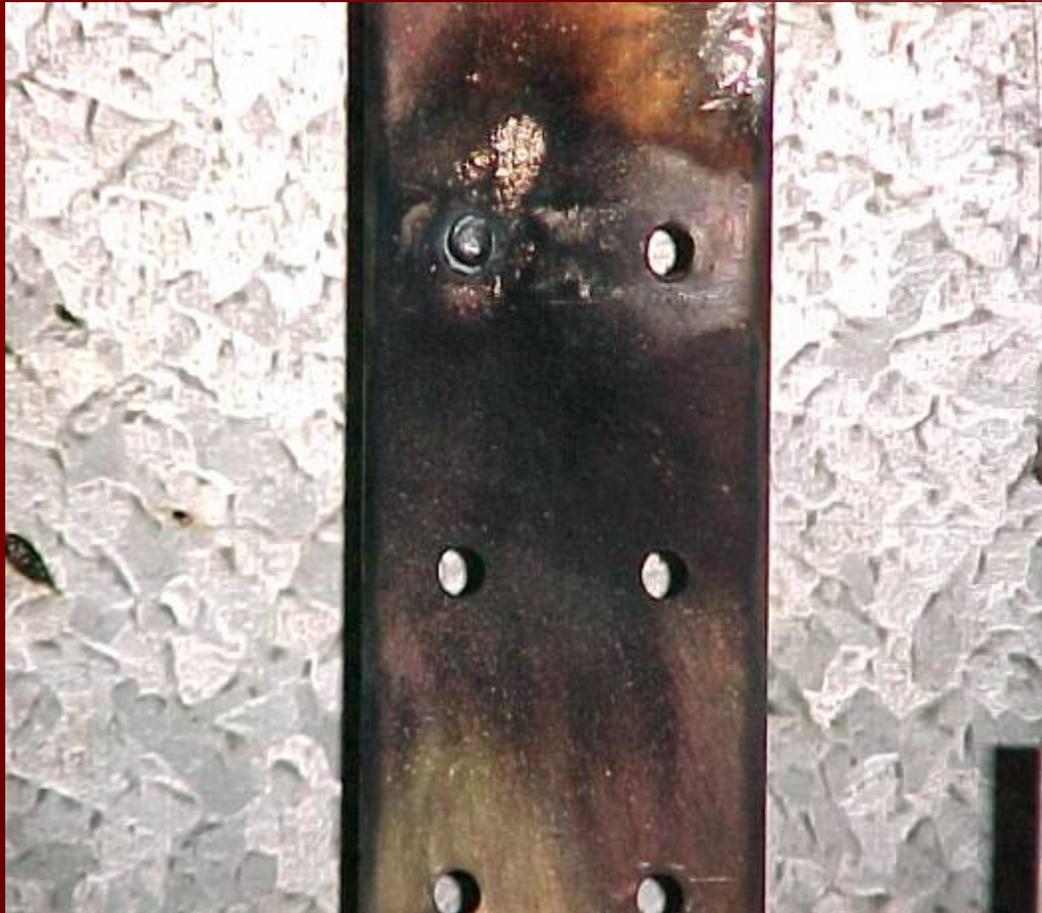
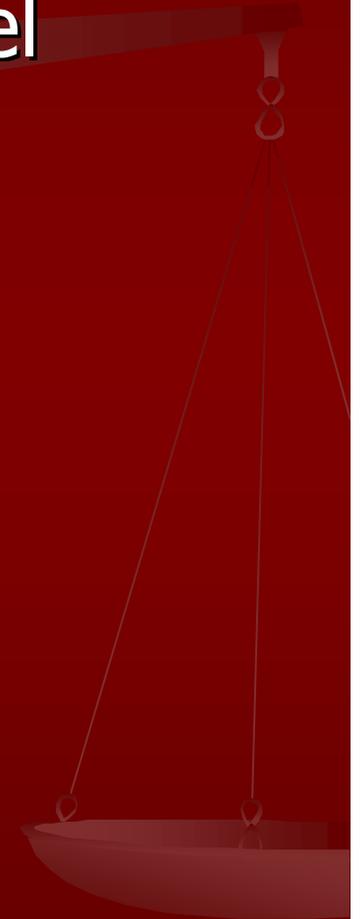
- Both men were seriously burned and were transported by Helicopter and Ambulance to the Burn Center.
