# RECENT UNITED STATES COAL MINE FIRES: LESSONS LEARNED

**John E. Urosek, Dennis A. Beiter, Richard T. Stoltz and William J. Francart**  
**Mine Safety and Health Administration**  
**United States Of America**

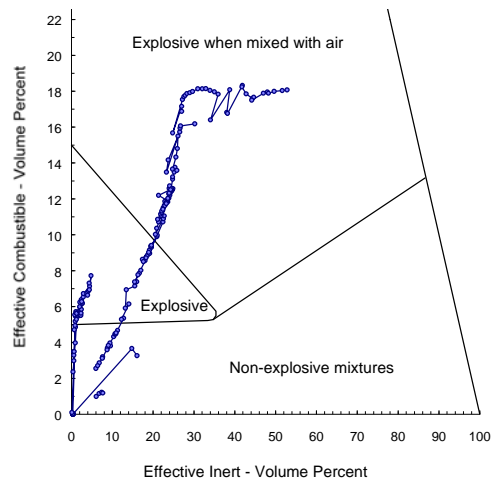
Figure 1. Explosibility Determination of Atmosphere

A 72-hour waiting period has usually been sufficient for the mine atmosphere to become settled following sealing of mine fires. Approach to mine openings is not permitted within the 72 hours or later if the environment is considered unstable. Generally, explosions after the 72 hour waiting period are not common. Explosibility determinations as shown in Figure 1 did not permit approach to the shaft area.

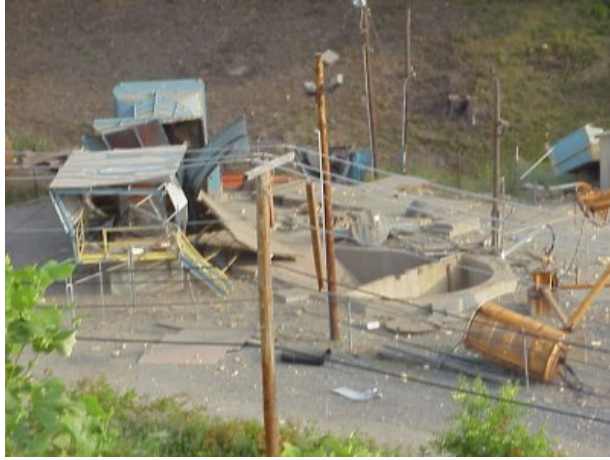
On June 26th, at 3:20 a.m., approximately 77 hours after the mine was sealed, an explosion occurred underground which damaged the temporary seal and fan installation at one of the ventilation shafts. The damaged shaft, shown in Figure 2, was more than 1.6 kilometers from the original fire area. The explosion caused little disturbance at a ventilation shaft much closer to the original fire area and was initially undetected at the other surface openings.

Figure 2. Damaged Surface Facilities

The damaged shaft was resealed later that day. Air samples from the old borehole located in by the original fire area revealed the gas concentrations in that portion of the mine to be oxygen - 12.39 percent, methane - 18.18 percent, carbon dioxide - 3.52 percent, carbon

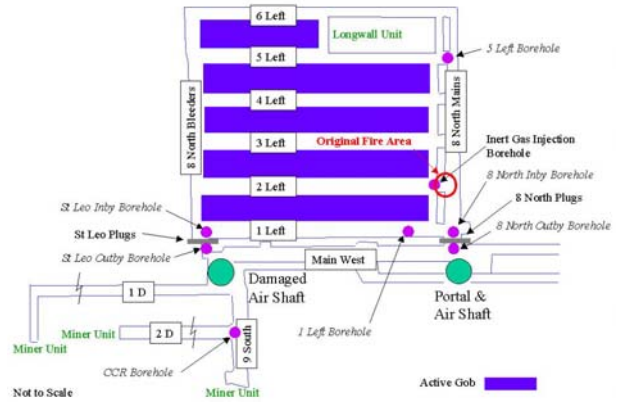
Figure 3. Remote Plugging Plan Detail

Exploration during recovery near the fire area confirmed the results indicated by the gas trends: the plugs were not effective. Also, exploration revealed the explosion had not originated in the fire area. The explosion source was located on one of the development section and was not related to the fire. Thus, the degree and extent of damage on the surface caused by the explosion was understandable. Completion of the mine recovery continues at the time this was written.

Mine management developed a plan to use remote plugs, injected through boreholes, to try to separate the fire area from the rest of the mine as shown in Figure 3. The ventilation plugs were completed on July 13, 1999. The total amount of material injected was approximately 900 metric tons. Continued sampling analysis revealed similar changes in gas trends on both sides of the plugs. These similarities indicated the effectiveness of the plugs was questionable. The ability of the plugs to isolate the fire area from the remainder of the mine was doubted. Successful installation of the plugs might have enabled the remainder of the mine to be re-ventilating more quickly. Recover operations settled in for a longer waiting period.

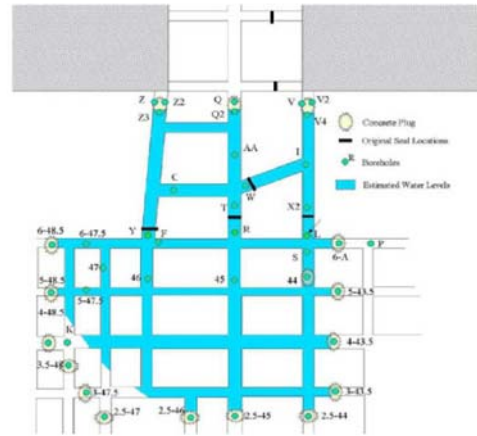
Figure 5. Final Plug Locations and Extent of Water

By May 8, drilling was completed and water had roofed much of the fire area as shown in Figure 5. Fire gasses had fallen to the lowest levels measured since the event started and continuous monitoring was stopped. A total of 43 boreholes were drilled during the recovery operation along with the installation of 17 remote plugs.
