# RECENT UNITED STATES COAL MINE FIRES: LESSONS LEARNED

**John E. Urosek, Dennis A. Beiter, Richard T. Stoltz and William J. Francart**  
**Mine Safety and Health Administration**  
**United States Of America**

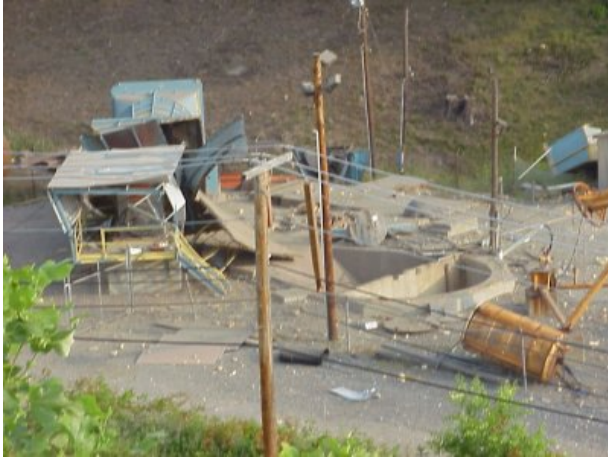
On June 26th, at 3:20 a.m., approximately 77 hours after the mine was sealed, an explosion occurred underground which damaged the temporary seal and fan installation at one of the ventilation shafts. The damaged shaft, shown in Figure 2, was more than 1.6 kilometers from the original fire area. The explosion caused little disturbance at a ventilation shaft much closer to the original fire area and was initially undetected at the other surface openings.

Figure 2. Damaged Surface Facilities

The damaged shaft was resealed later that day. Air samples from the old borehole located inby the original fire area revealed the gas concentrations in that portion of the mine to be oxygen - 12.39 percent, methane - 18.18 percent, carbon dioxide - 3.52 percent, carbon

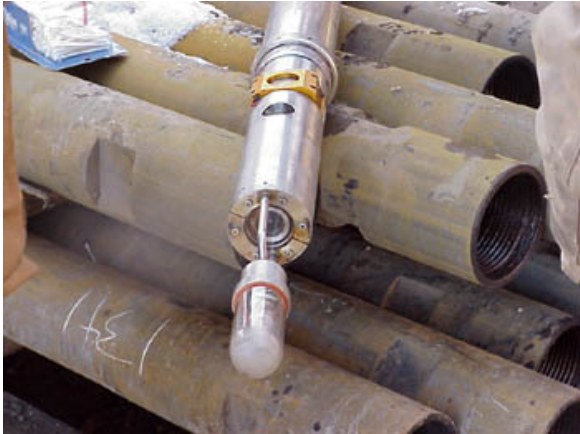
Figure 4. Remote Monitoring Borehole Camera

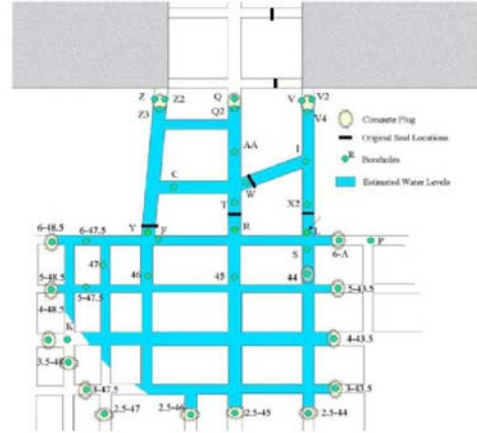
By May 8, drilling was completed and water had roofed much of the fire area as shown in Figure 5. Fire gasses had fallen to the lowest levels measured since the event started and continuous monitoring was stopped. A total of 43 boreholes were drilled during the recovery operation along with the installation of 17 remote plugs.

Figure 5. Final Plug Locations and Extent of Water
