I'll Be Done in a Flash!

An Arc-blast Incident

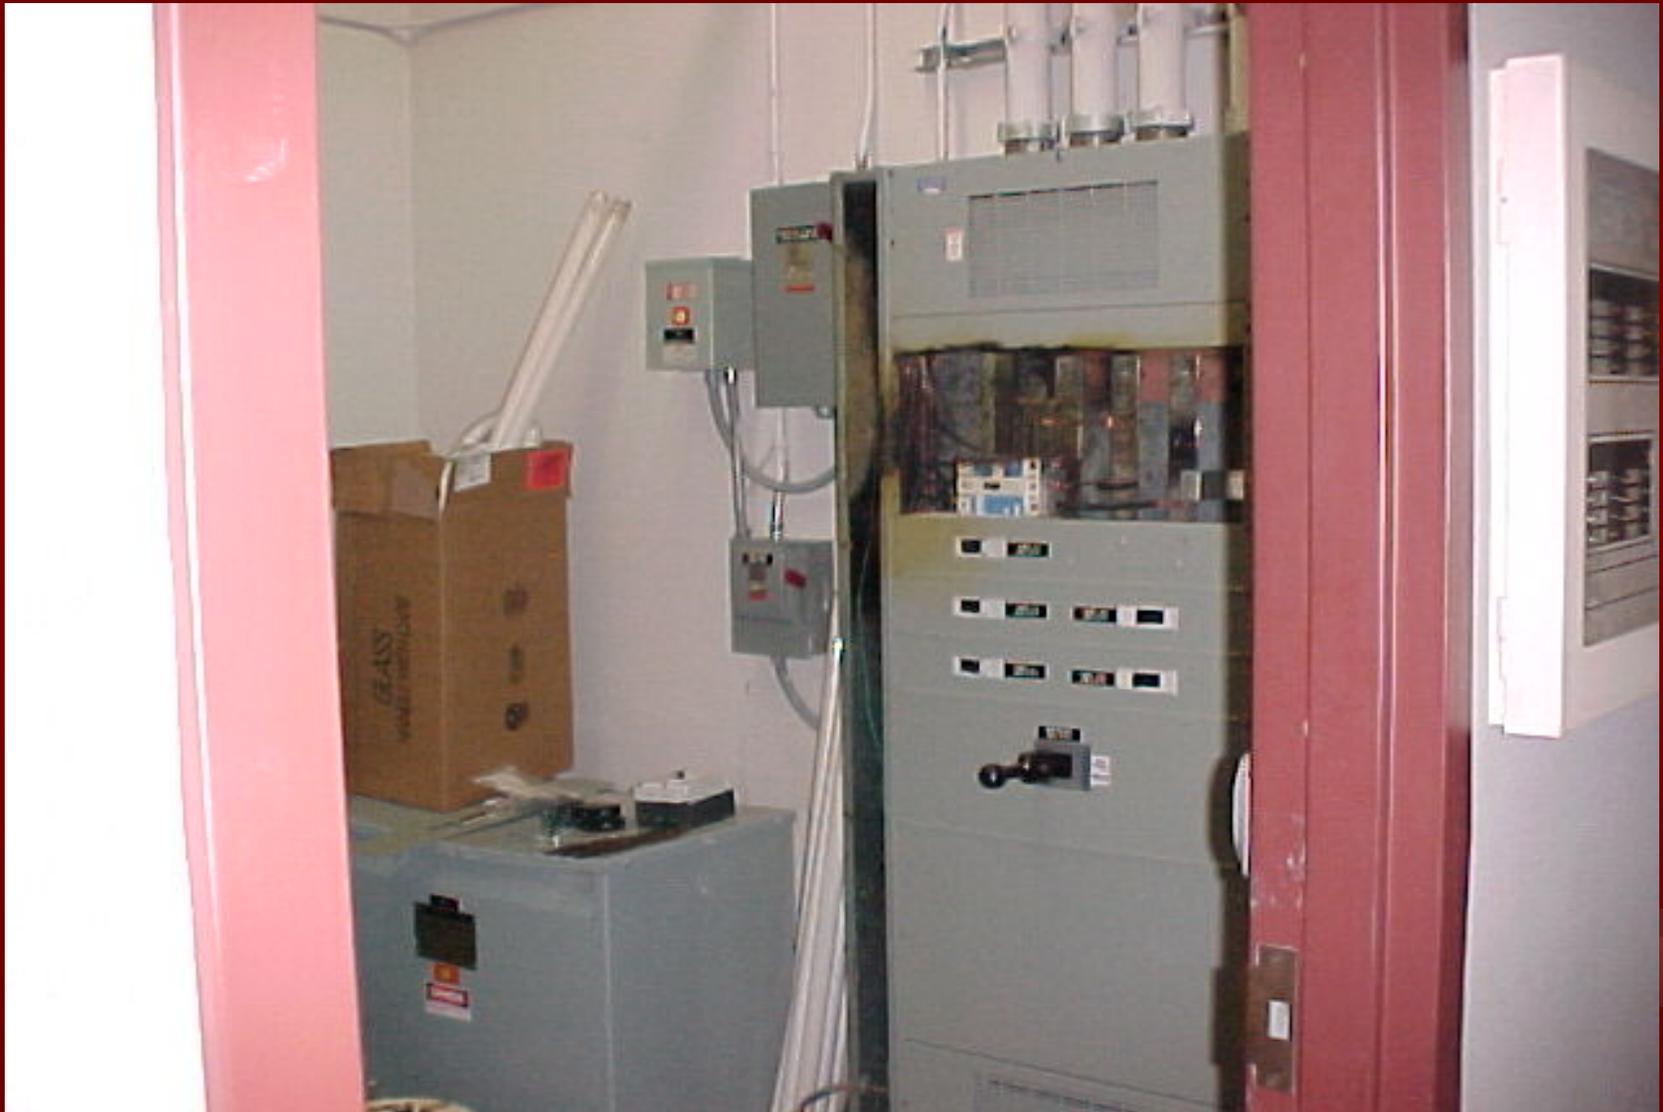
Incident Information

- The Crew (Master Electrician and (Journeyman Electrician) began work on the MDP, removing the old breaker and contacts (fingers)

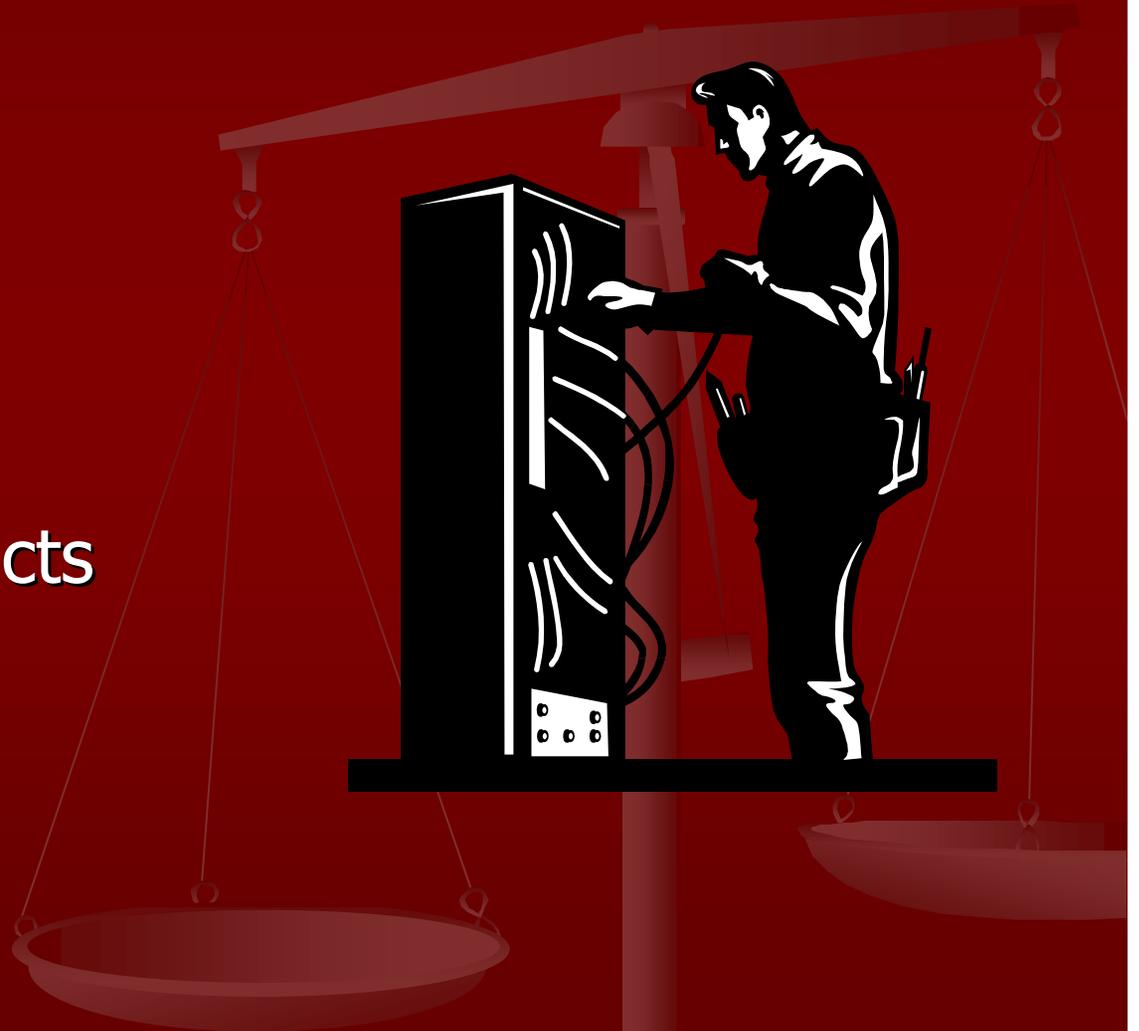
Incident Information

- With just the use of a pair of Salisbury Class 1 Type 1 electrical gloves and a pair of Kunz insulated glove protectors, as the only Personal Protective Equipment being used.
