Analysis of Safety Aspects And Mining Practices For Effective Ground Control in Surface Mining

Suresh K. Bhatt, *Mining Engineer*
Christopher Mark, *Supervisory physical scientist*
National Institute for Occupational Safety and Health
Pittsburgh Research Laboratory
Pittsburgh, PA.

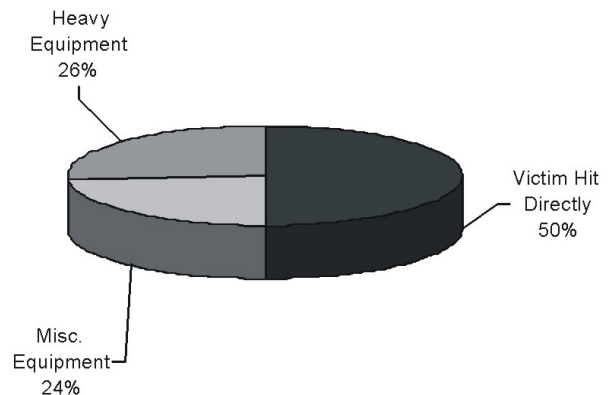
Approximately 26% of all accidents caused by highwall failure involved heavy earth moving equipment, such as the drill, front-end loader, dozer, shovel/dragline, and trucks. Approximately half of the injuries were caused when the failed material hit the victim directly. The remaining 24% involved miscellaneous equipment items (over 40). Figure 1 shows this breakdown.

Figure 1. Accidents by worker involvement
