Surface Haulage Accidents...

...Ways to
Prevent Them

MSHA's investigations of surface haulage accidents reveals two key points:

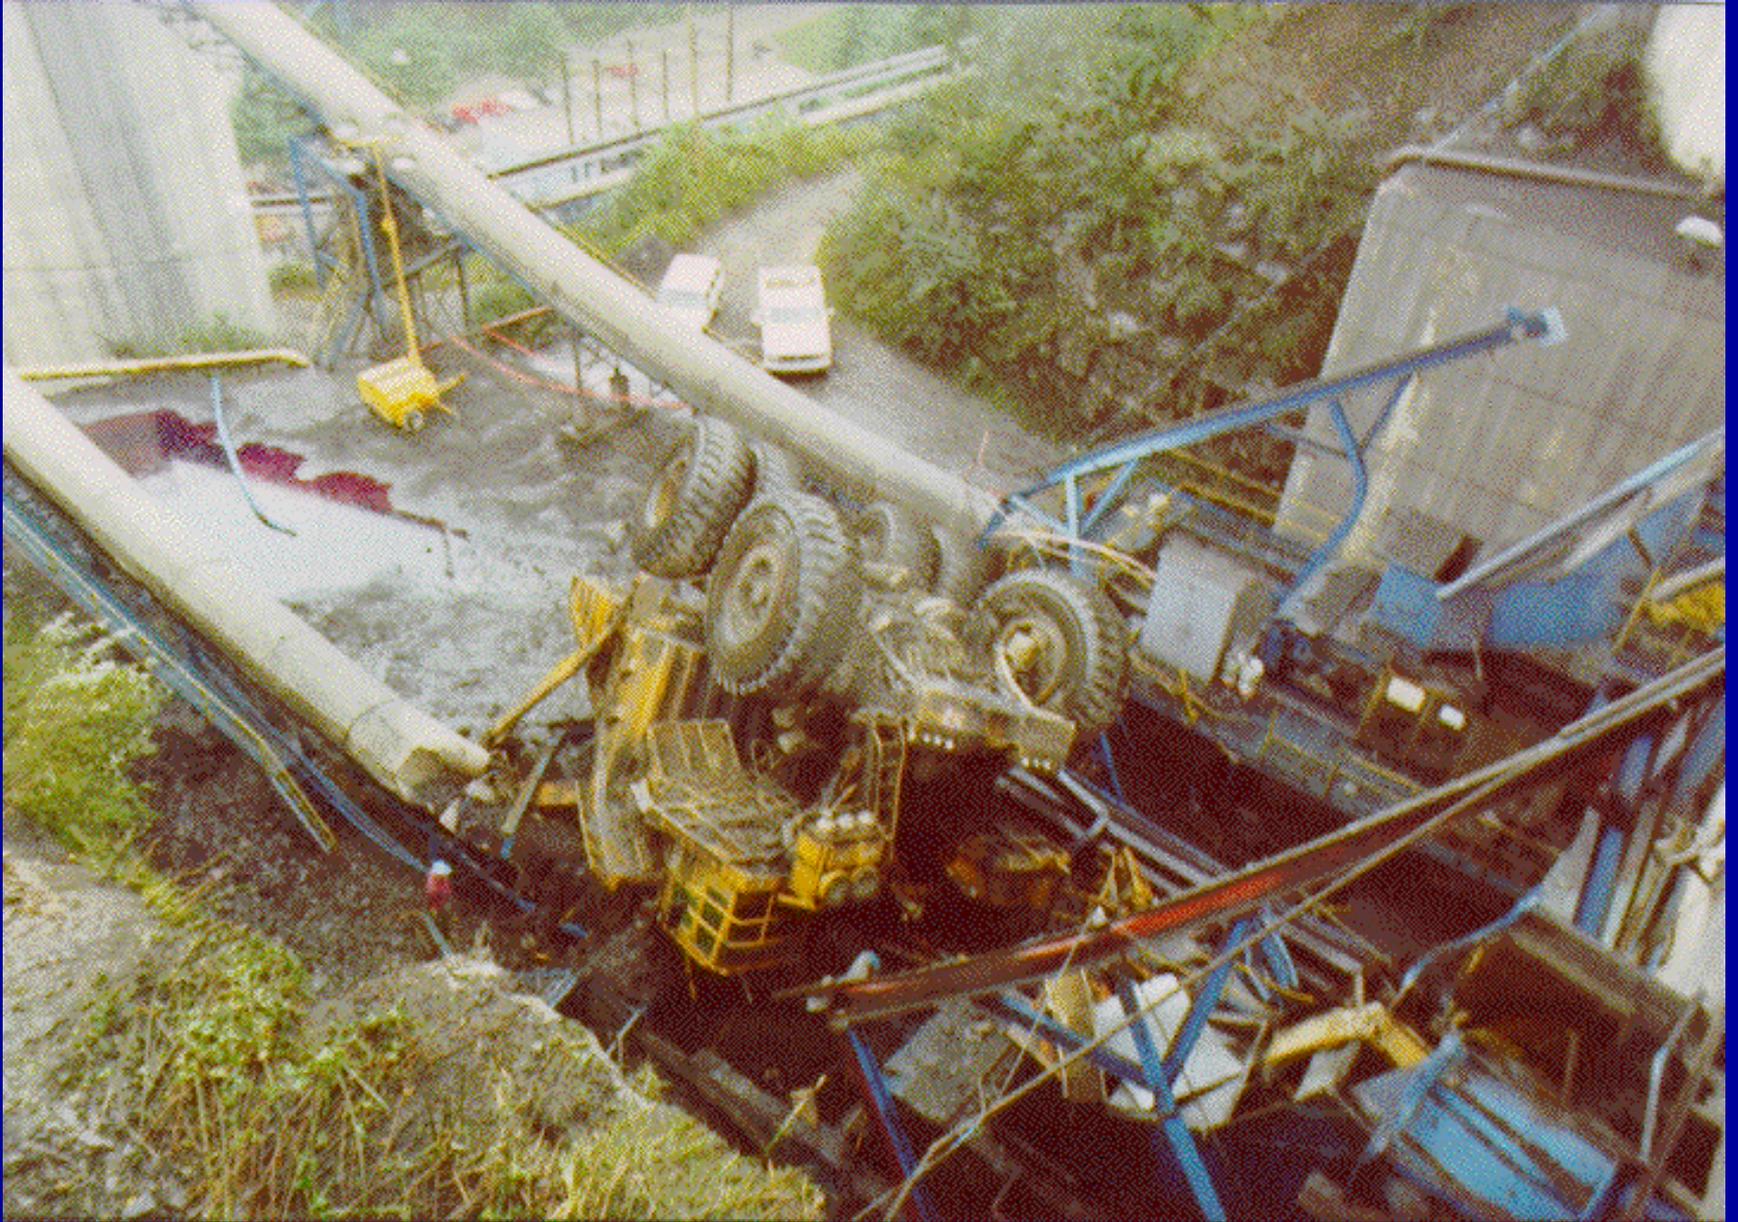
Example of a fatal haul-truck accident: The operator of this 170-ton capacity haul truck was killed when his truck went out of control as he descended an 8-percent grade.

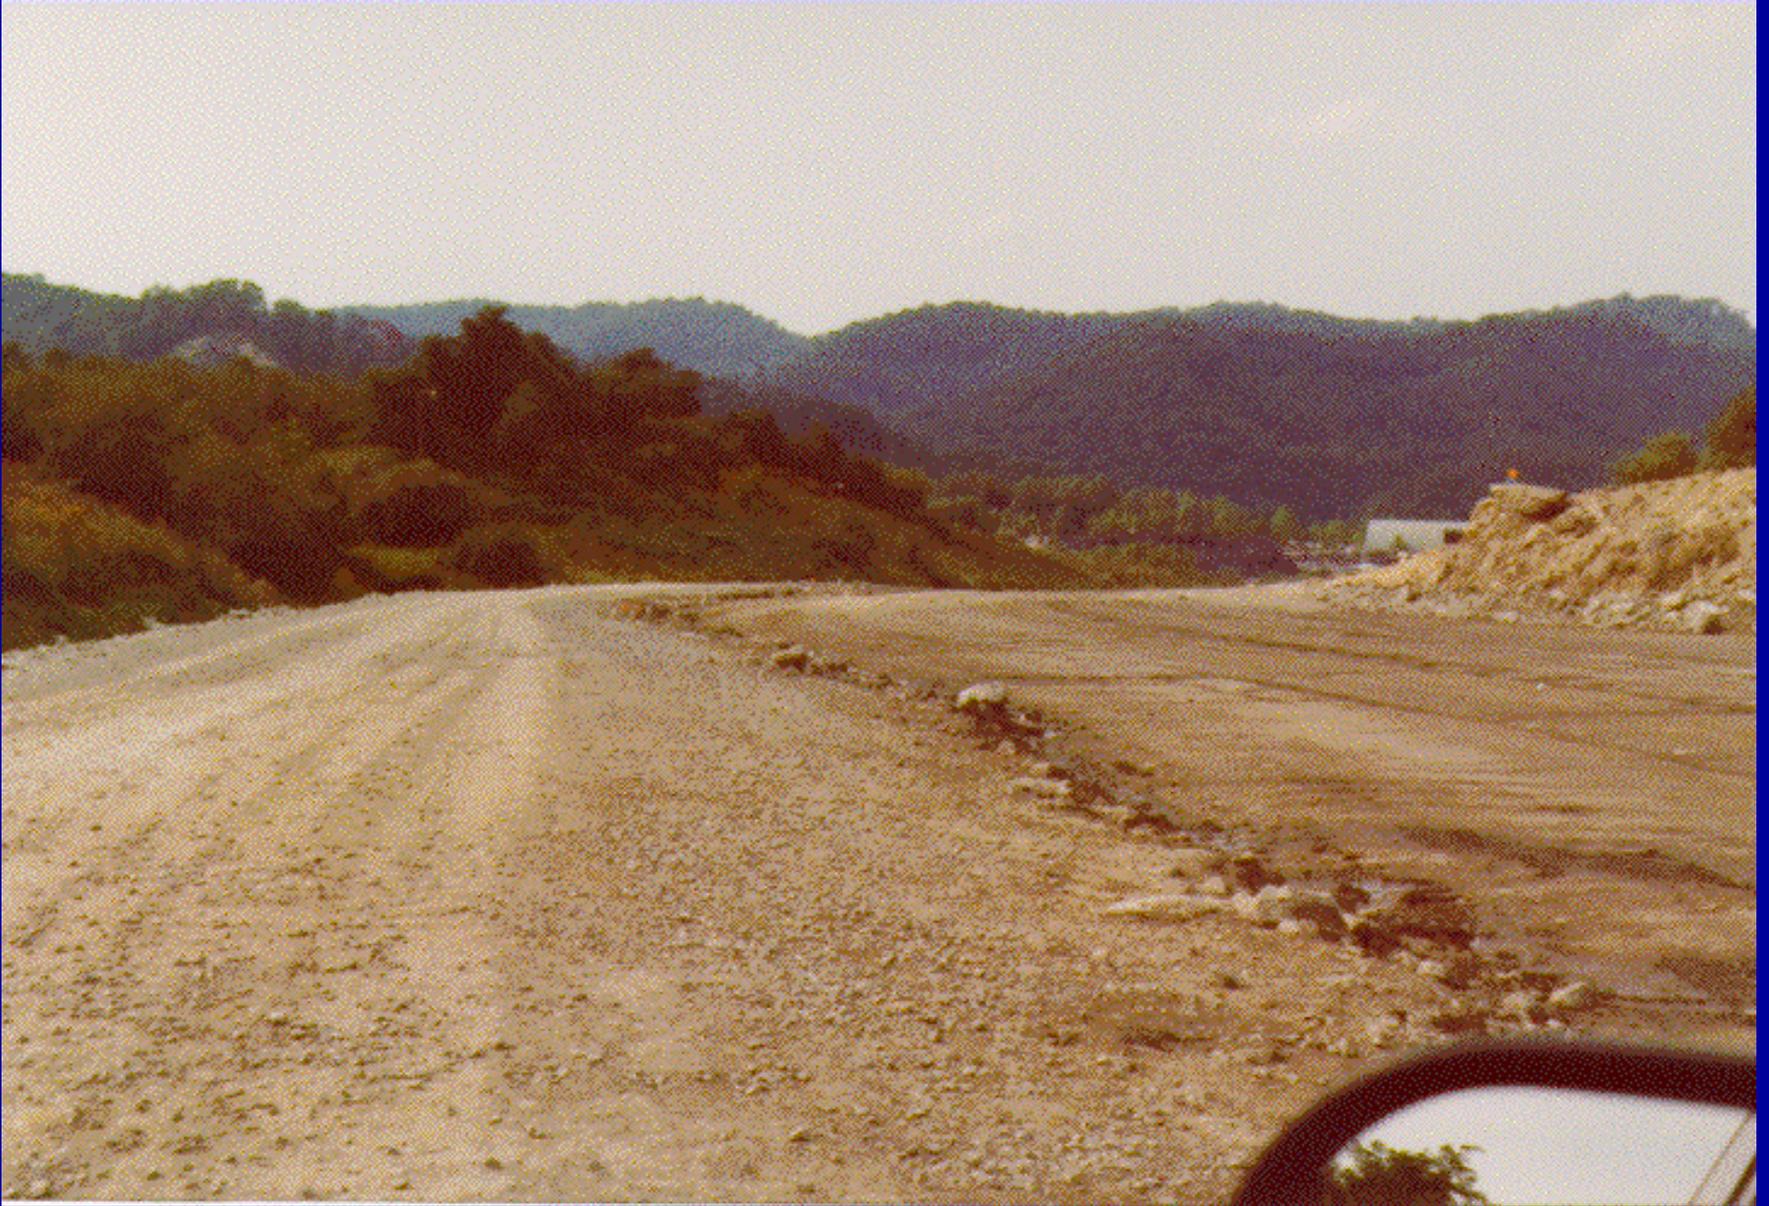
The contract truck driver had 22 years of experience. At the end of a 4-mile long haul, he was descending this grade to the dump point just around the curve. It was his fifth haul of the shift.

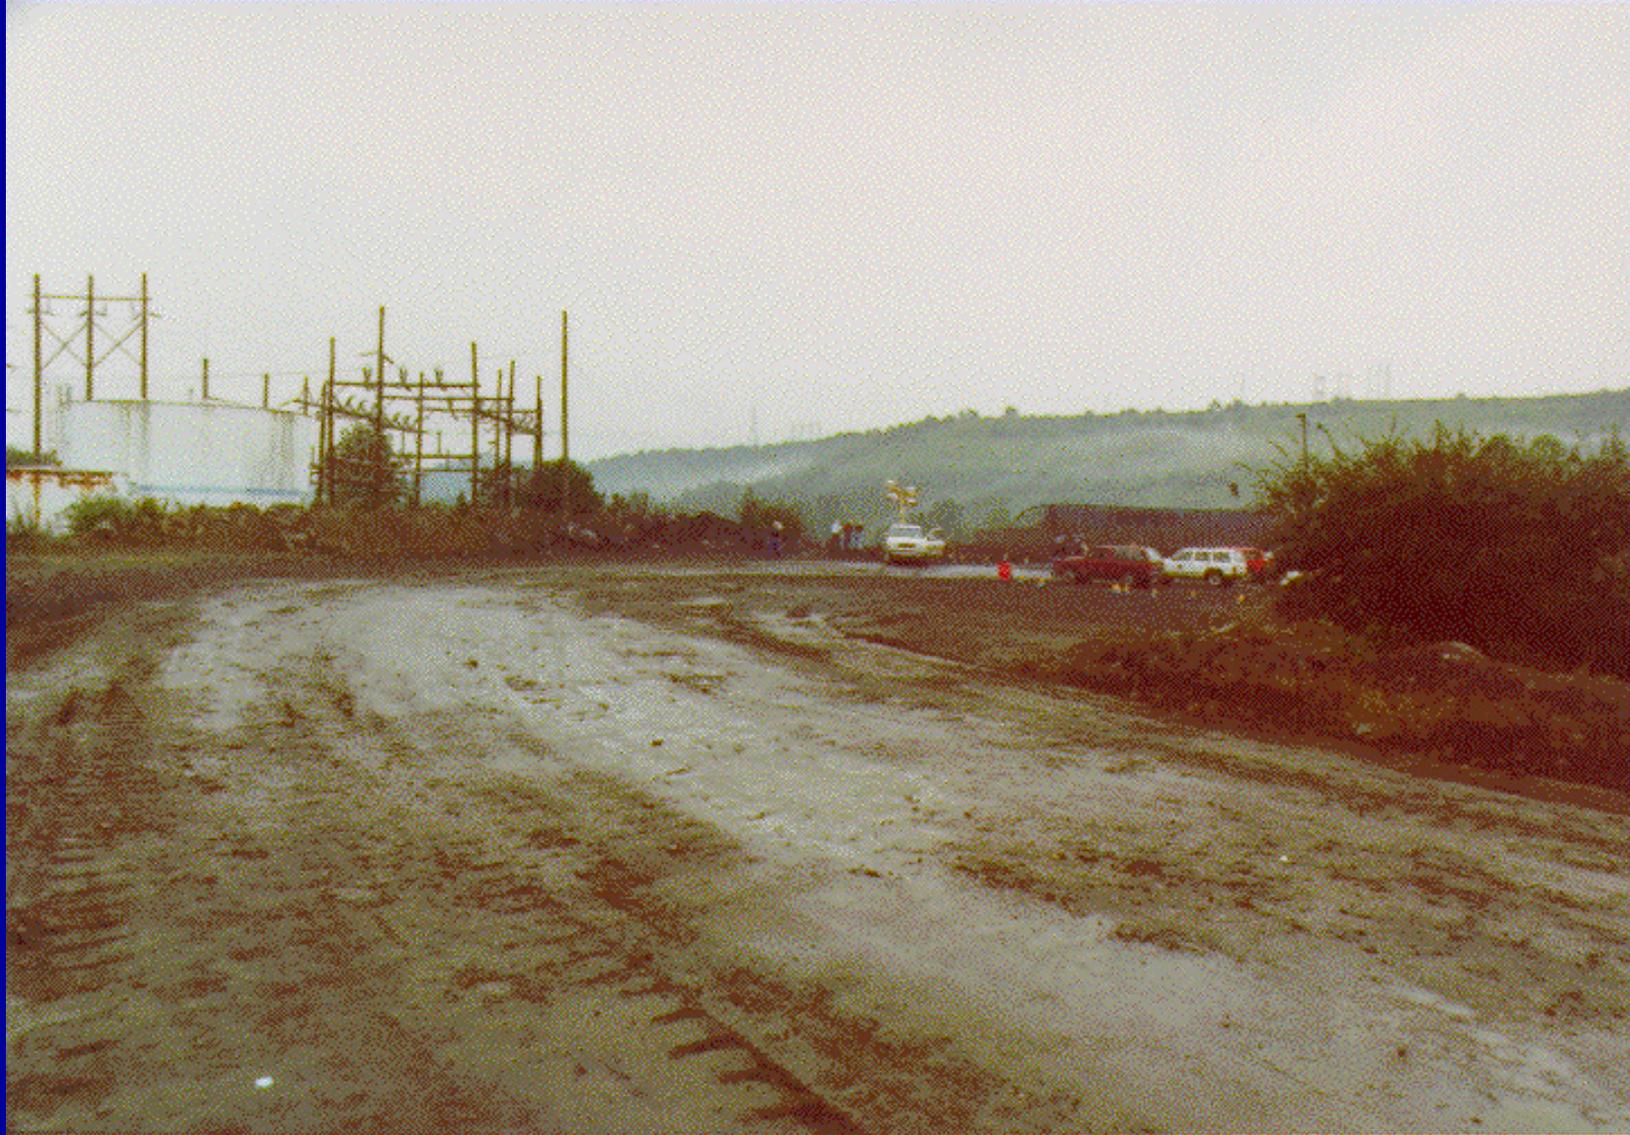
A witness reported that as the truck was descending the grade it appeared to be going at an excessive rate of speed and flames were coming out of the rear wheels. The truck failed to make the curve to the right and left the road at the point where the white truck is parked facing the camera.

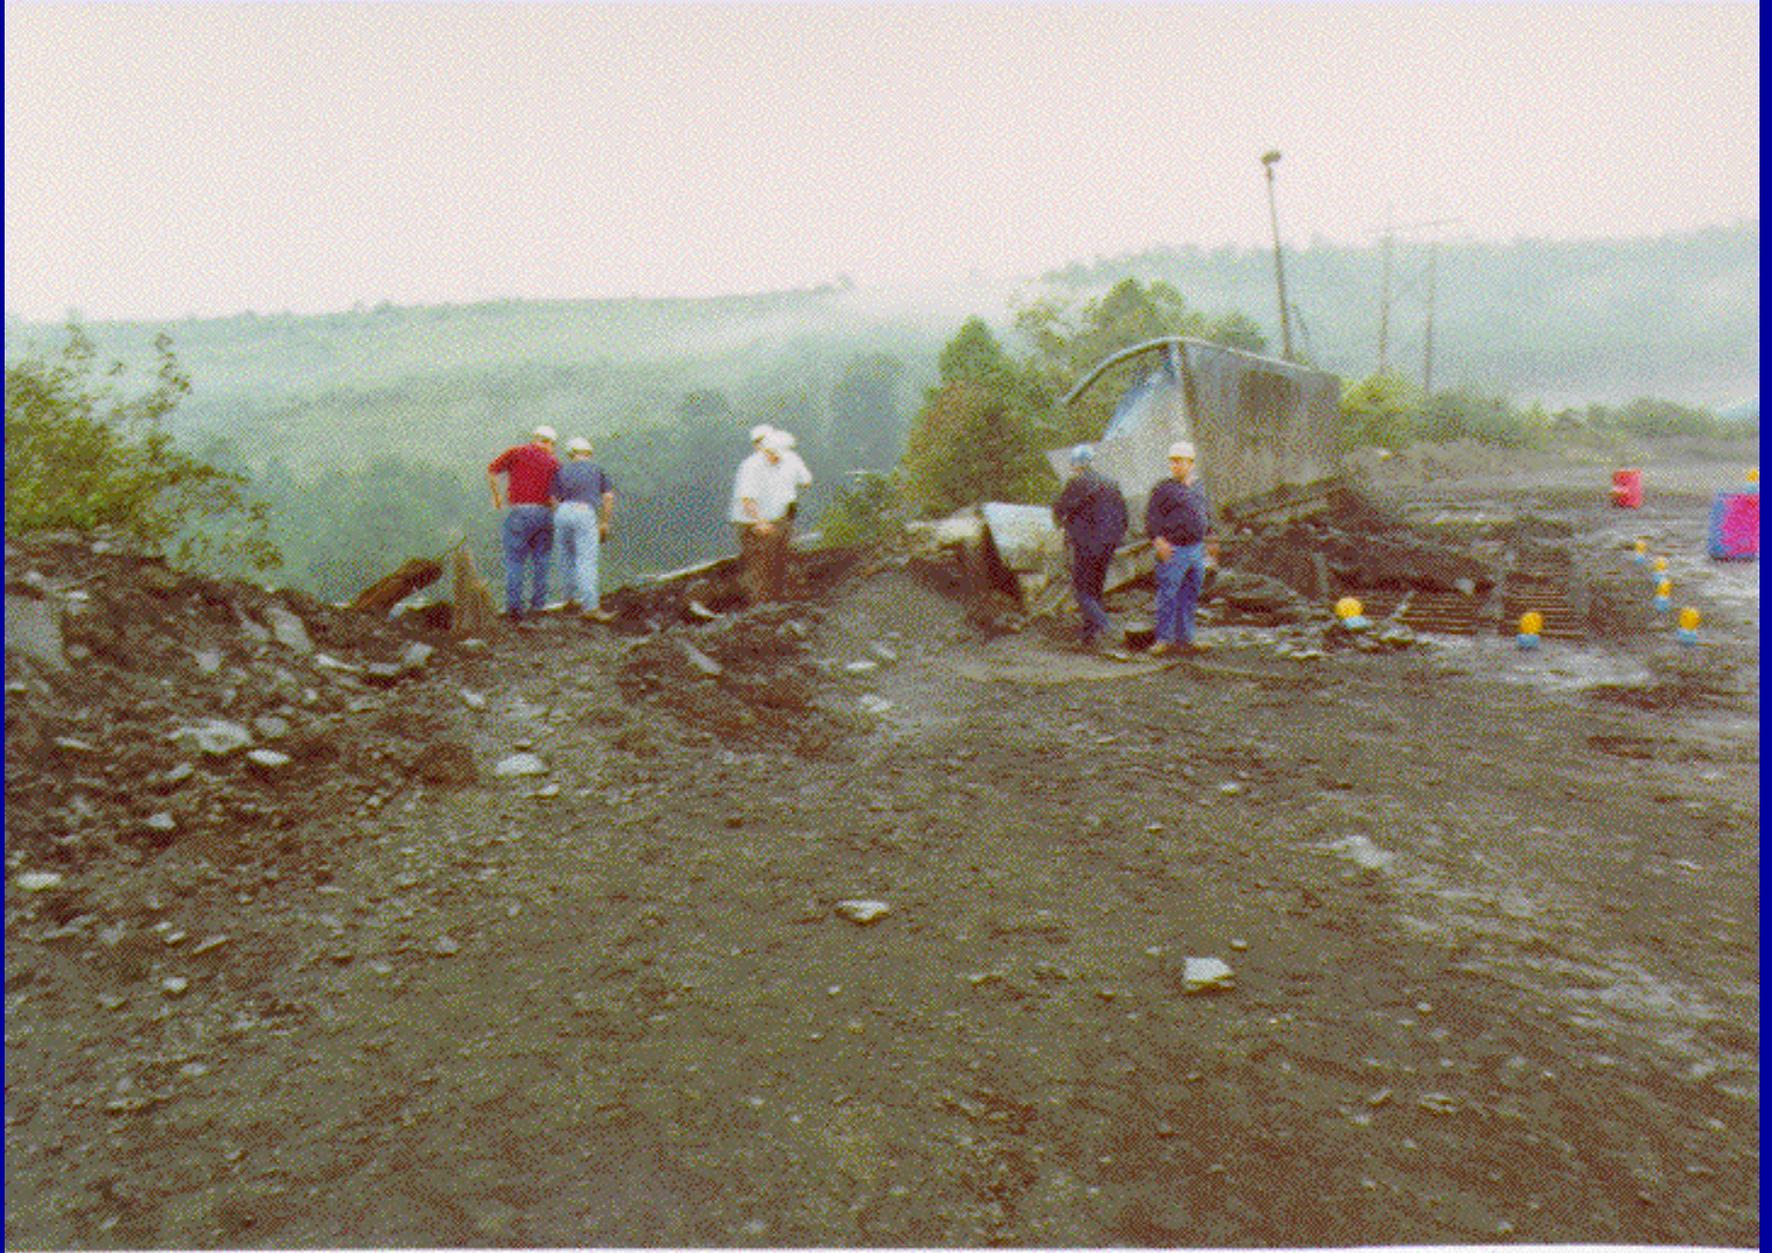
This is a close-up view of the area where the truck left the haul road...

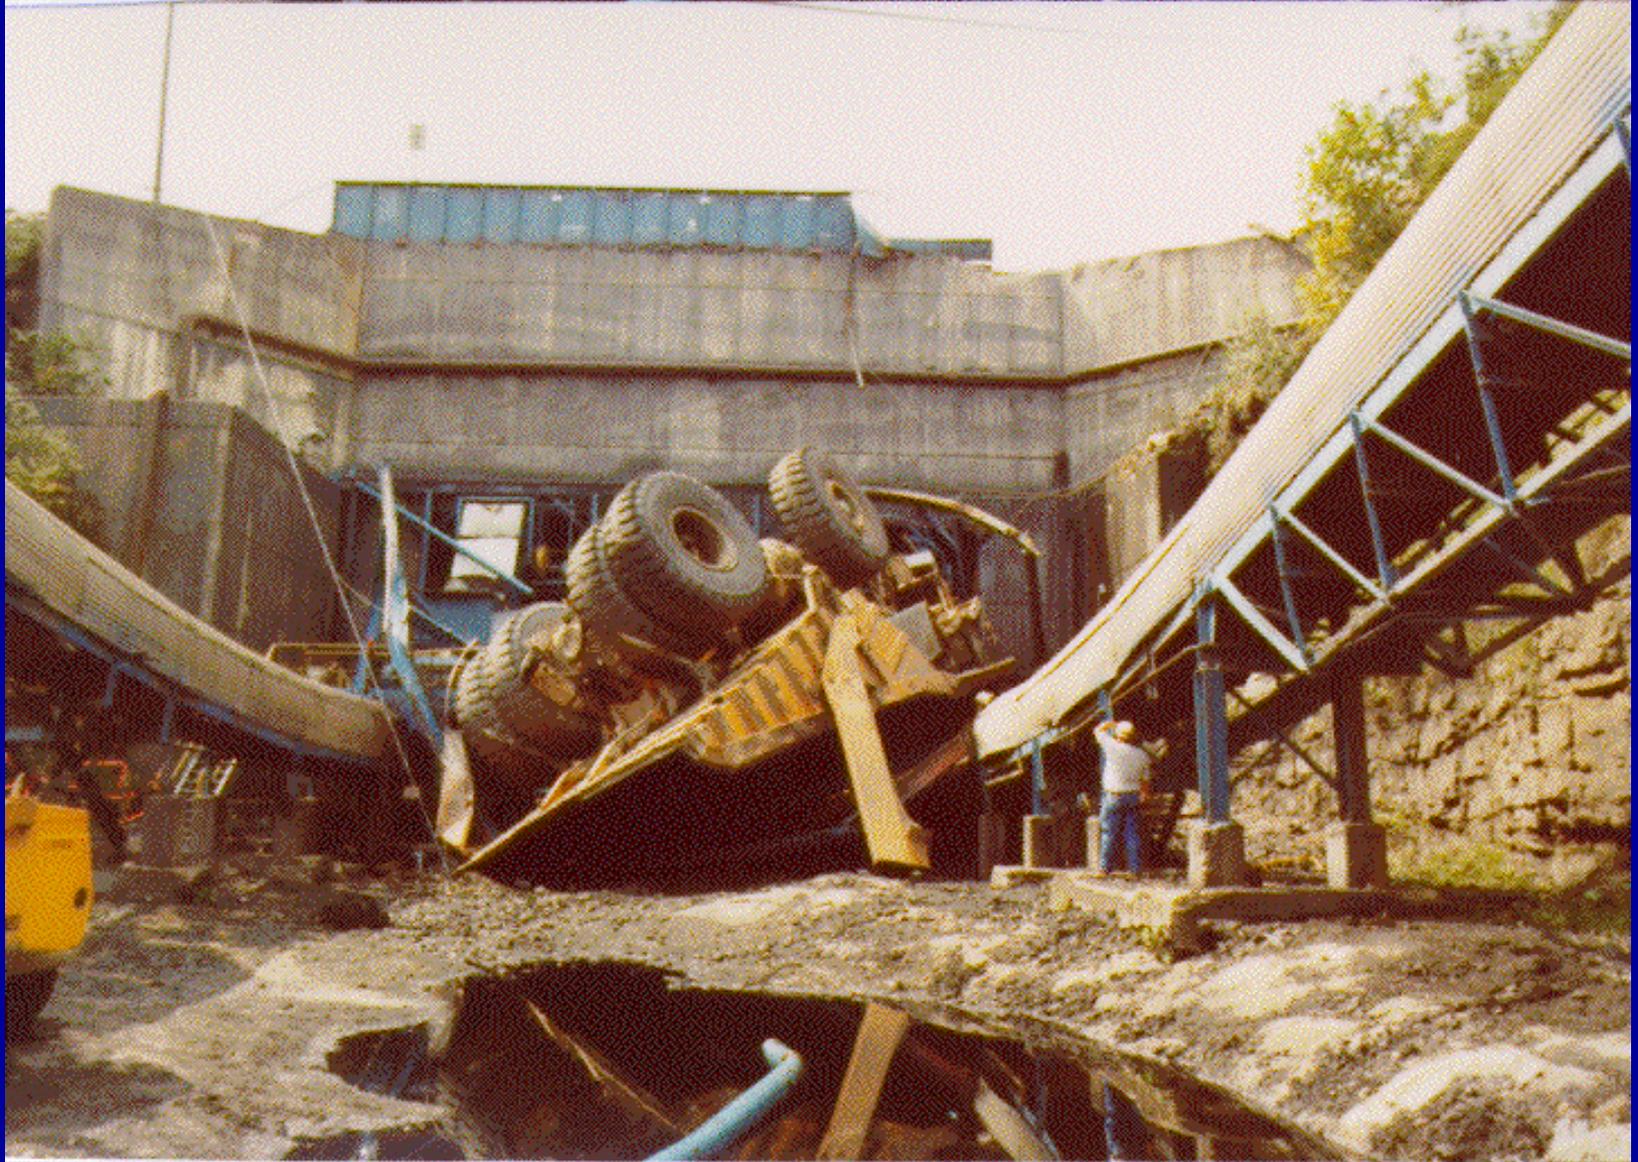
The truck went over the wall and ended up here. The victim was not wearing a seatbelt. The accident investigation revealed that the electrical retarder had failed to operate because of a problem with the contacts between the brushes and the commutator.

In summary, this fatal accident occurred because the truck's retarder system was defective and the inadequately maintained service brakes could not provide enough braking force to stop the truck.

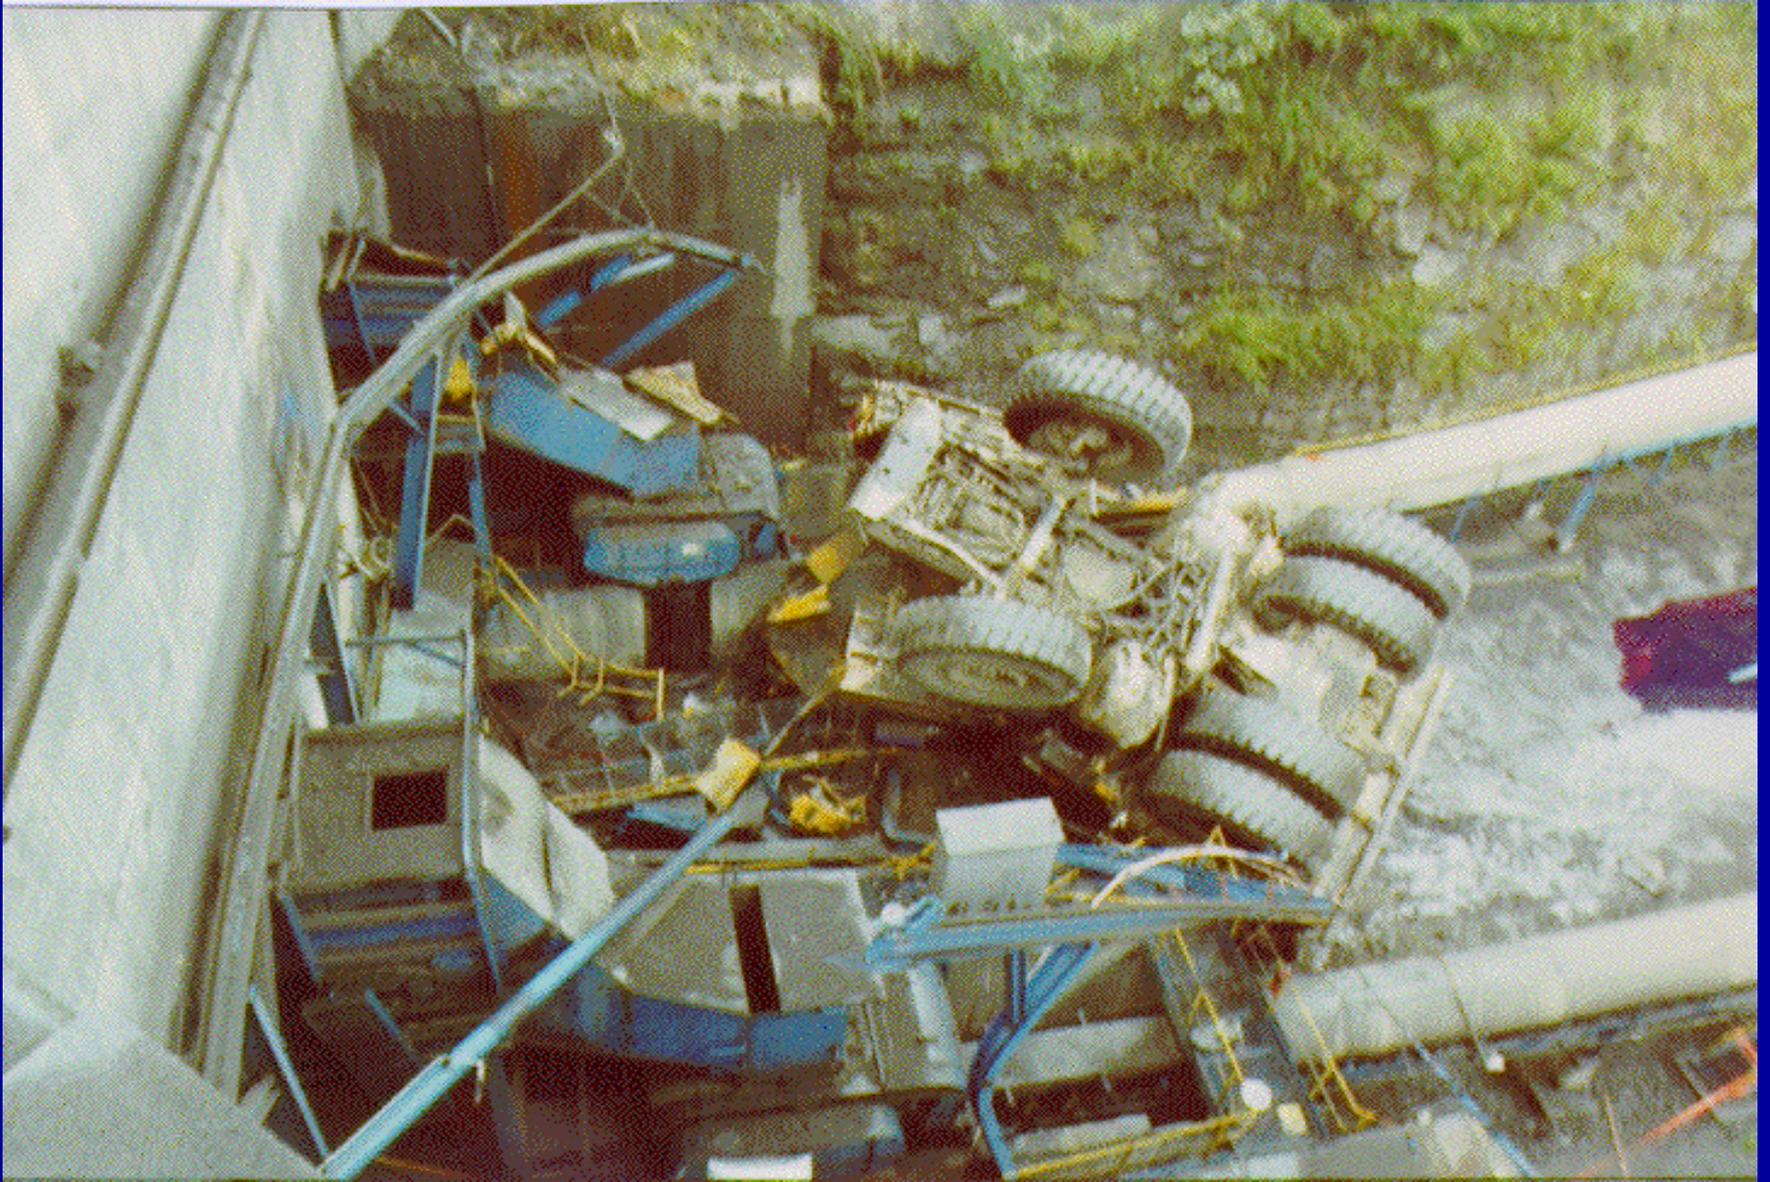
The accident investigation also revealed that there was no braking effort available from the front service brakes because of a leaking seal. The rear service brakes were found to be capable of providing 78 % of their design braking capacity.

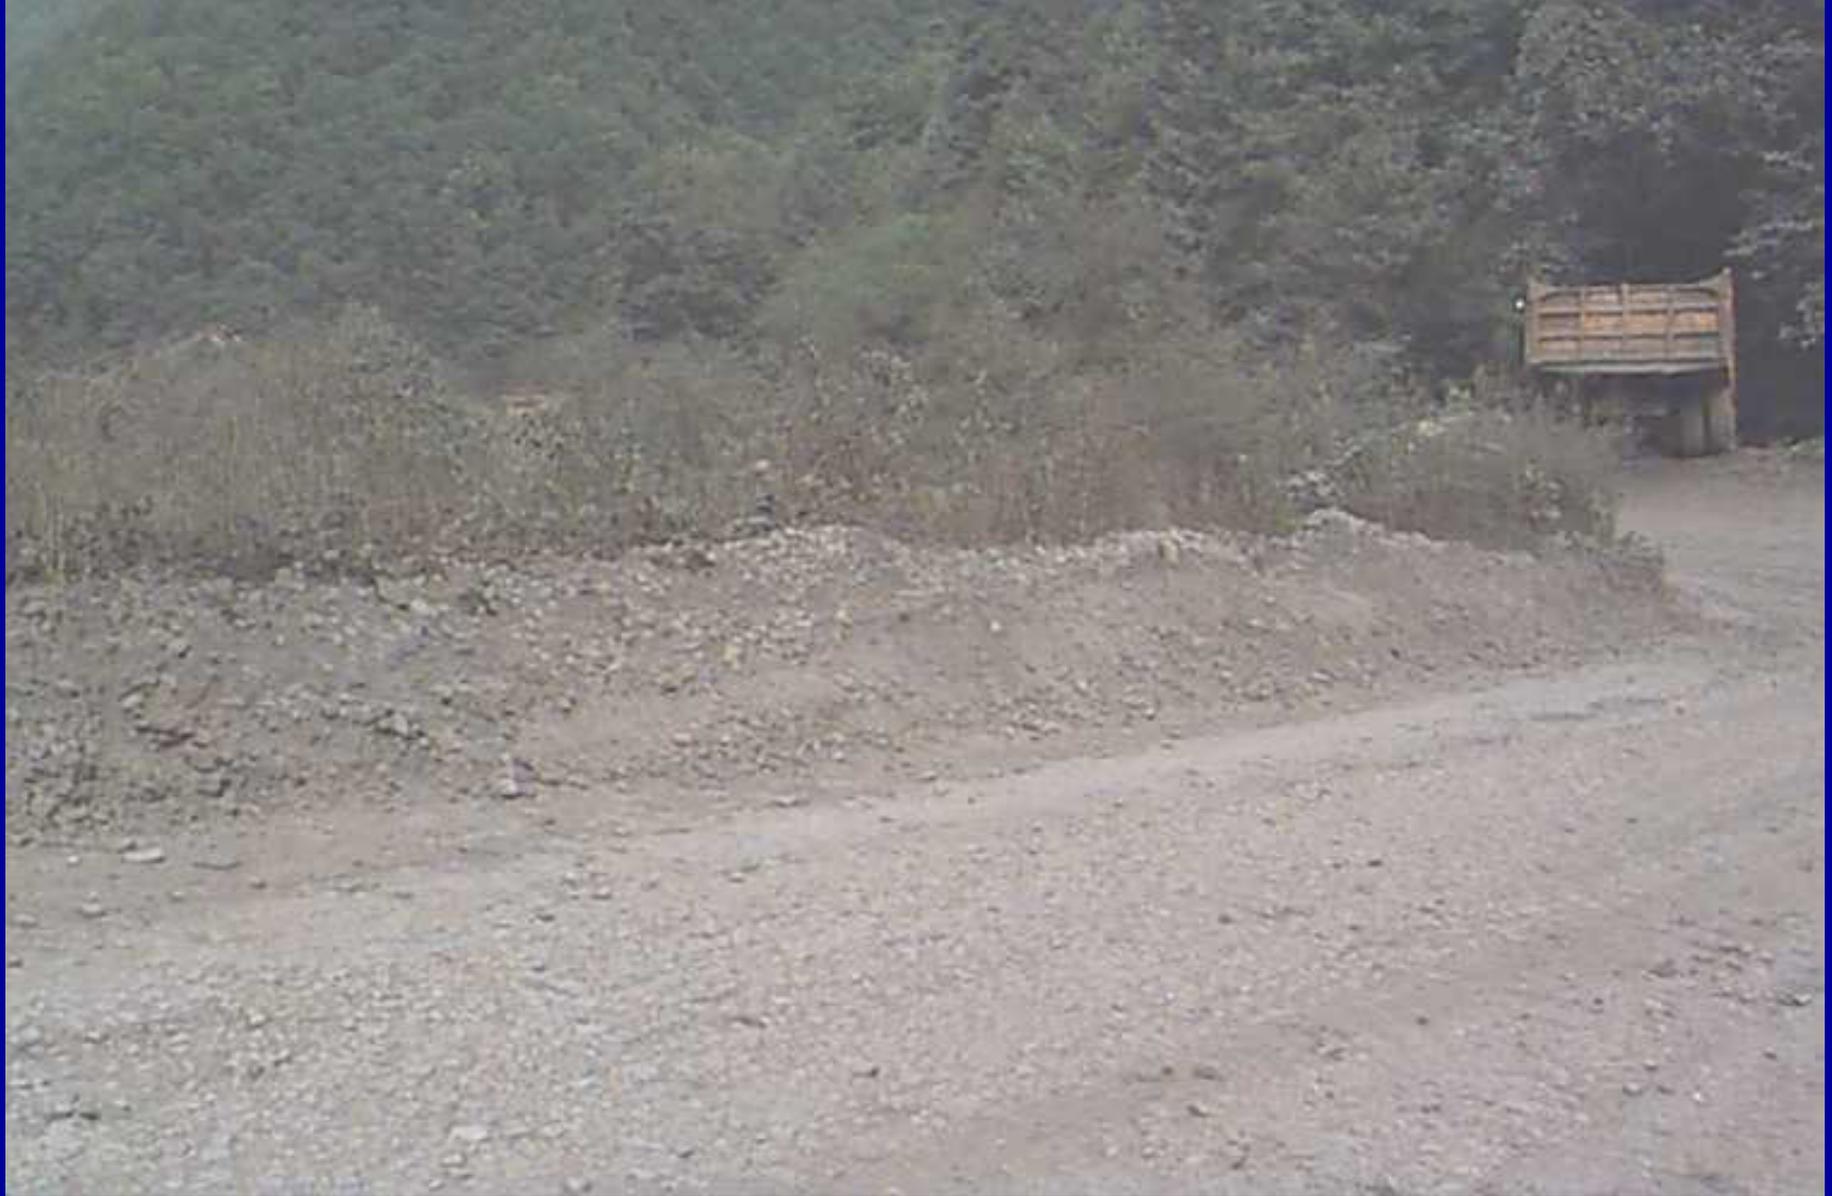
The accident occurred at a point where the grade was near 19%. The road was wet and the victim had reporting “spinning his wheels” on the way up. On the return trip the empty truck skidded off the road, as shown above.

The conclusion on this accident was that the deficient and uneven braking, combined with speed too fast for the wet and steep-road conditions, resulted in the truck leaving the haul road. The victim was not wearing a seatbelt and was thrown through the windshield.

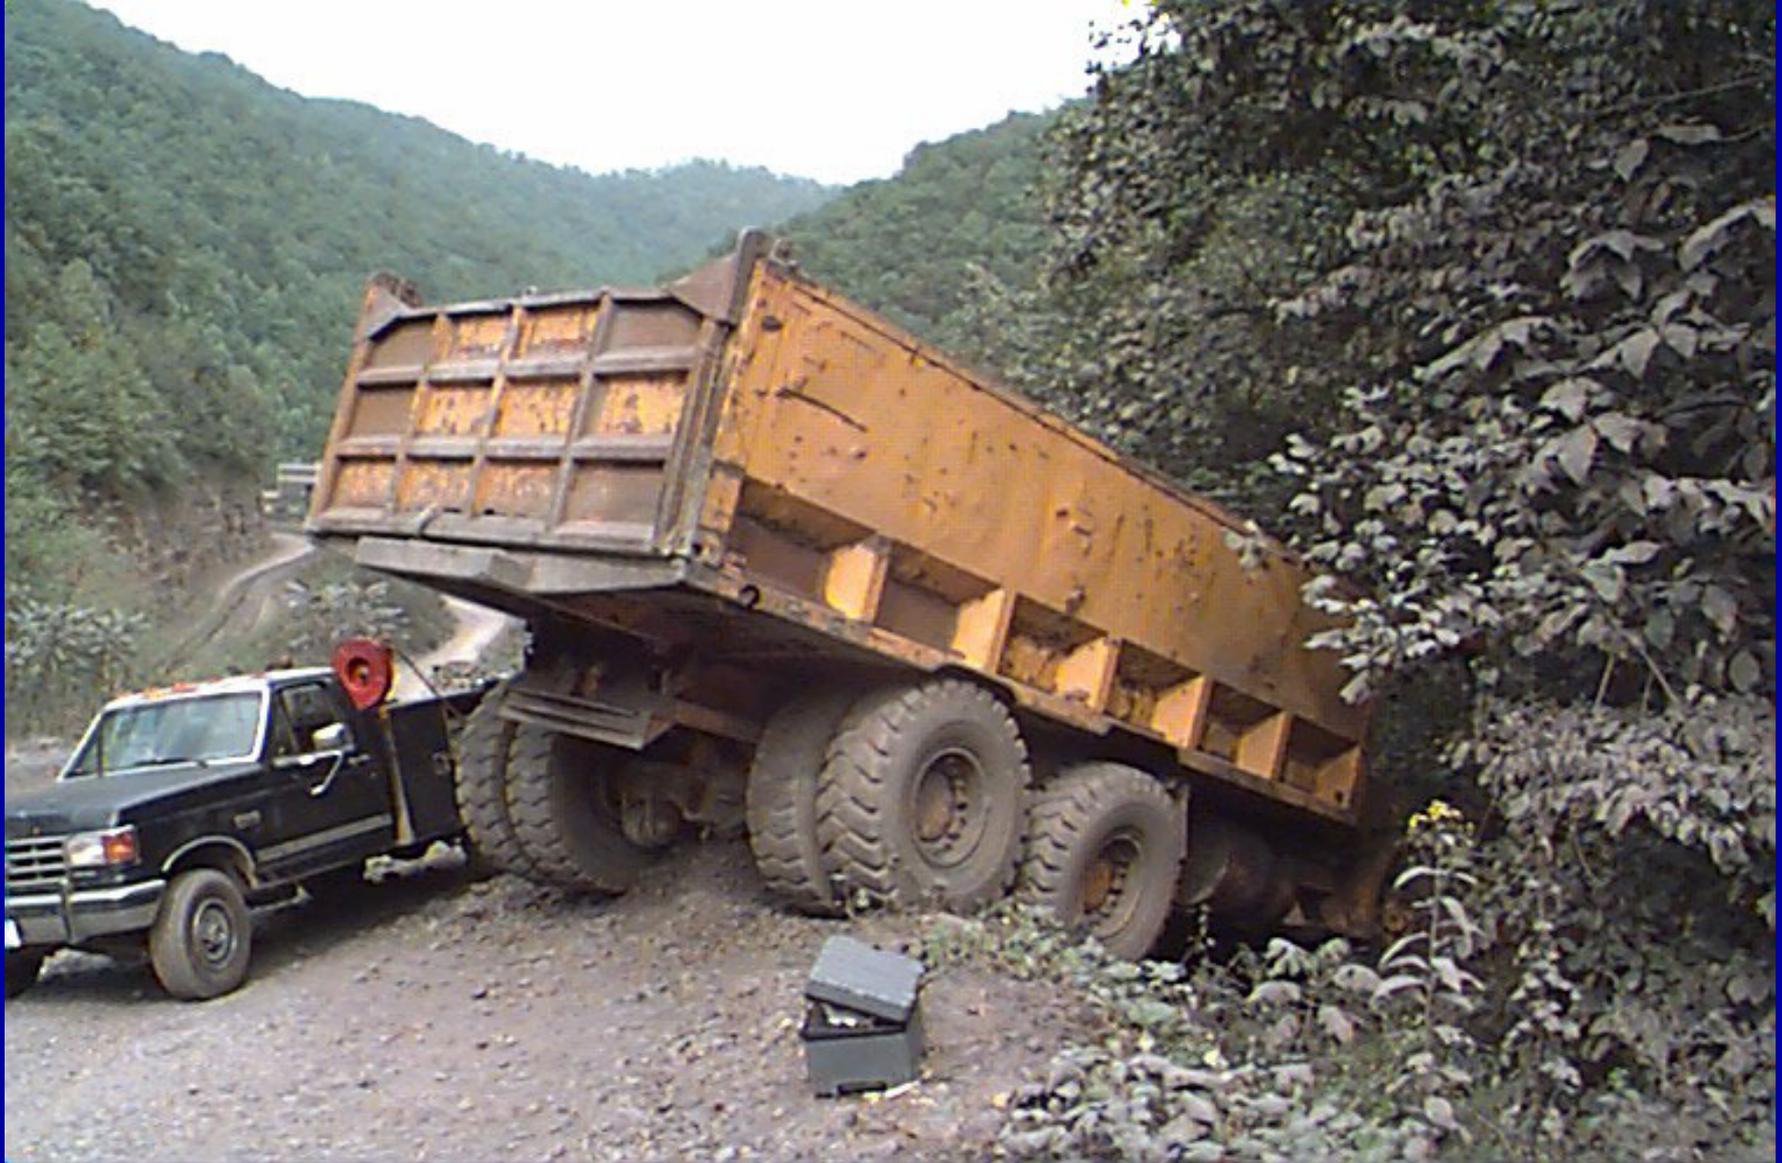
The accident investigation revealed that the front brakes were inoperative and there was no braking force from the right rear brake.

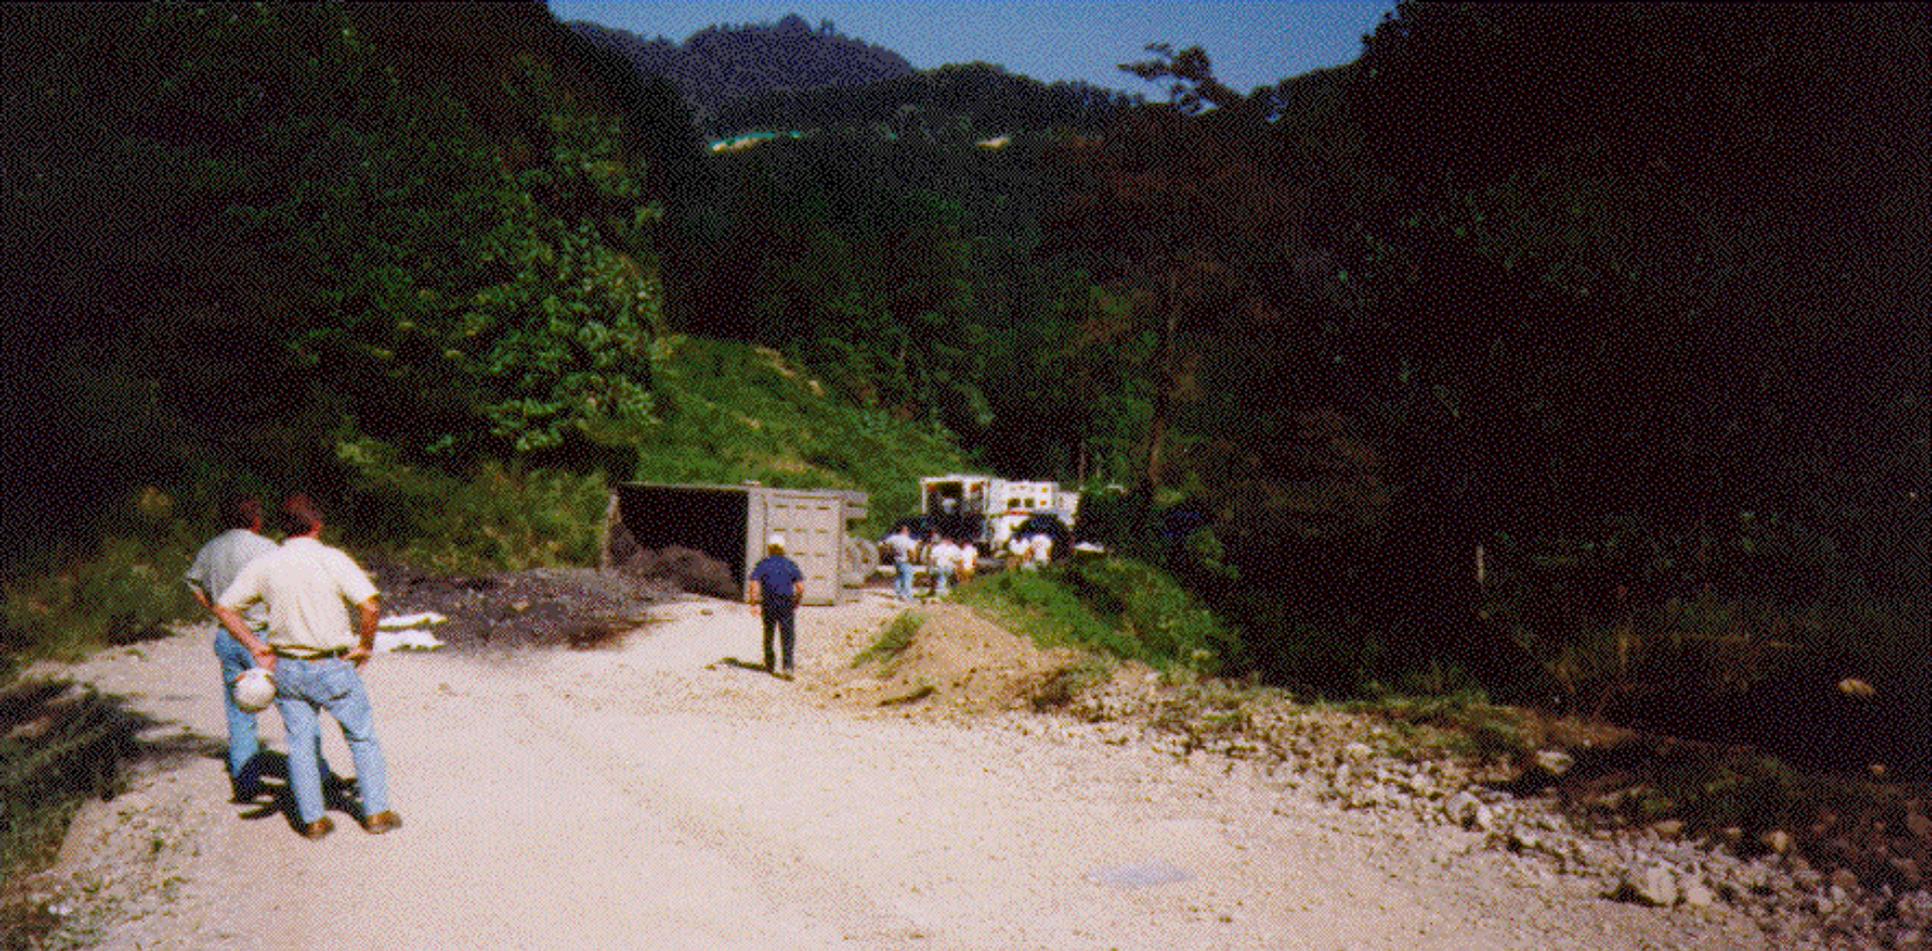
This fatal accident occurred on an 11% downgrade. The accident investigation found that there were problems with the brakes and the truck was overloaded.

- Three of the six service brakes were found to be providing no braking force - grease was found on the brake linings. The other three service brakes had brake drums which exceeded their allowable diameter.**
- The truck was loaded to the point where it exceeded the truck manufacturer's maximum recommended gross vehicle weight by over 30,000 pounds.**

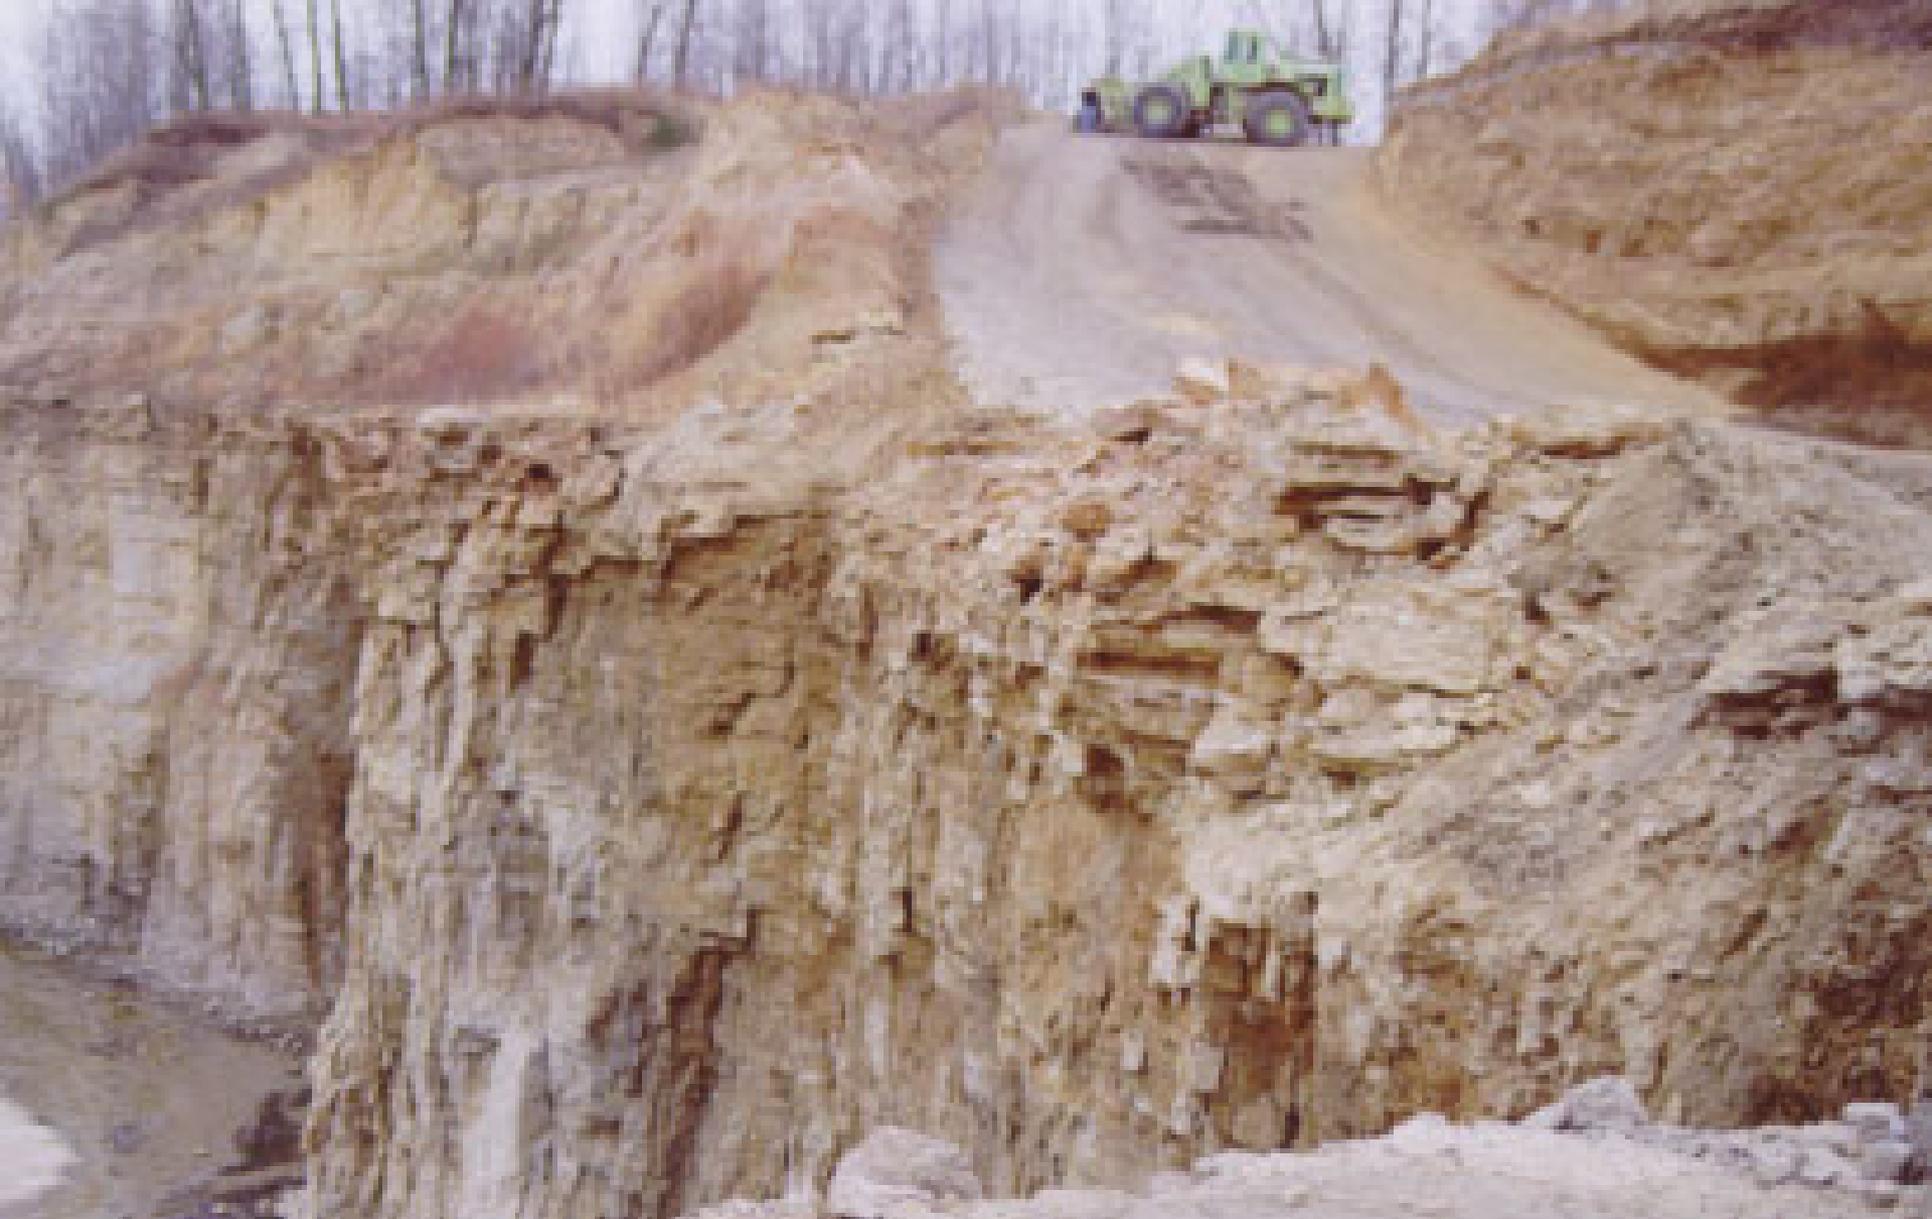
The mine uses a left-hand traffic pattern in this area.

As the scraper neared the top of the ramp it stalled and rolled backwards.
