Surface Haulage Accidents...

...Ways to
Prevent Them

MSHA's investigations of surface haulage accidents reveals two key points:

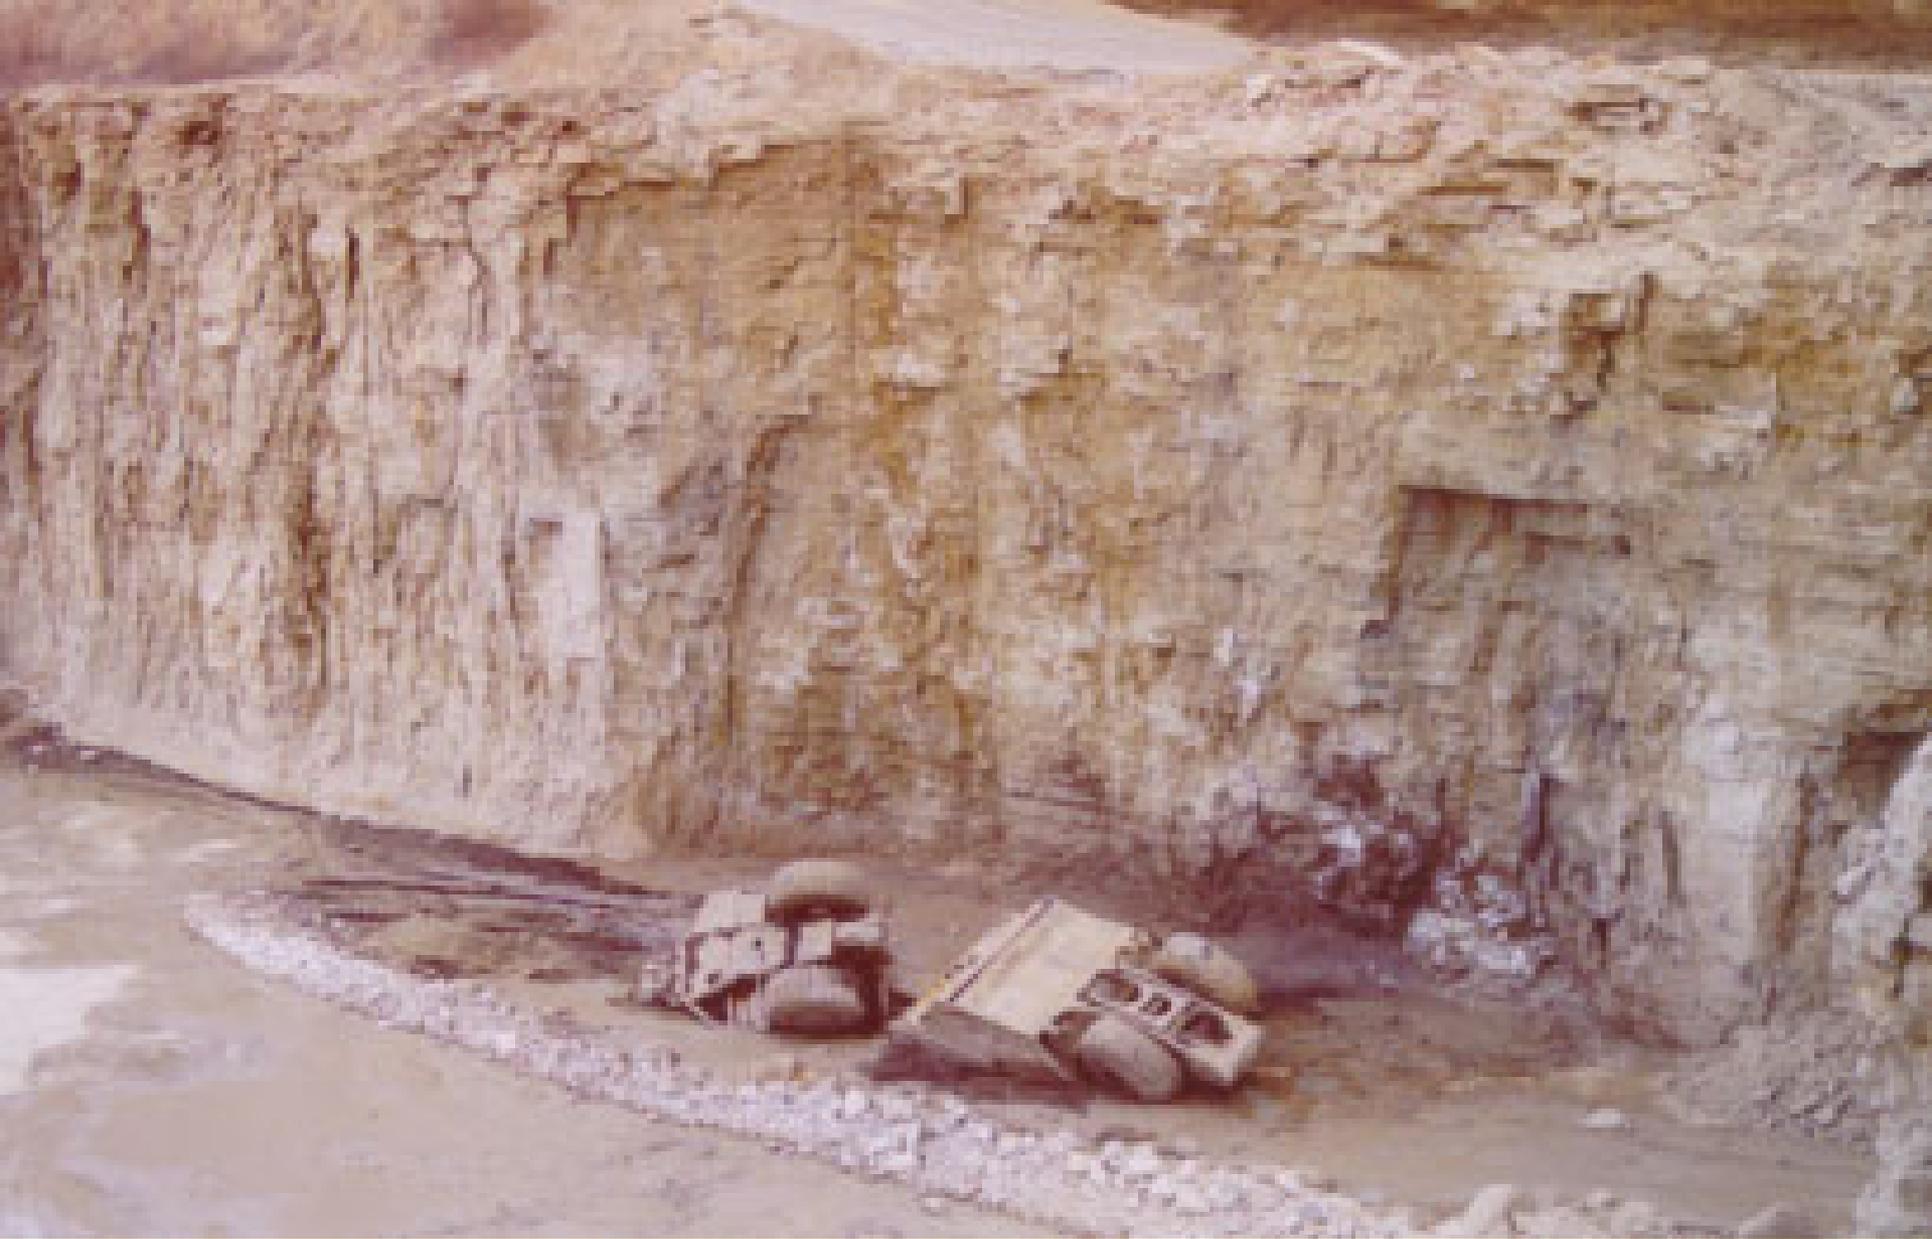
The scraper went over the highwall at a point where there was virtually no berm for a distance of about 65 feet.

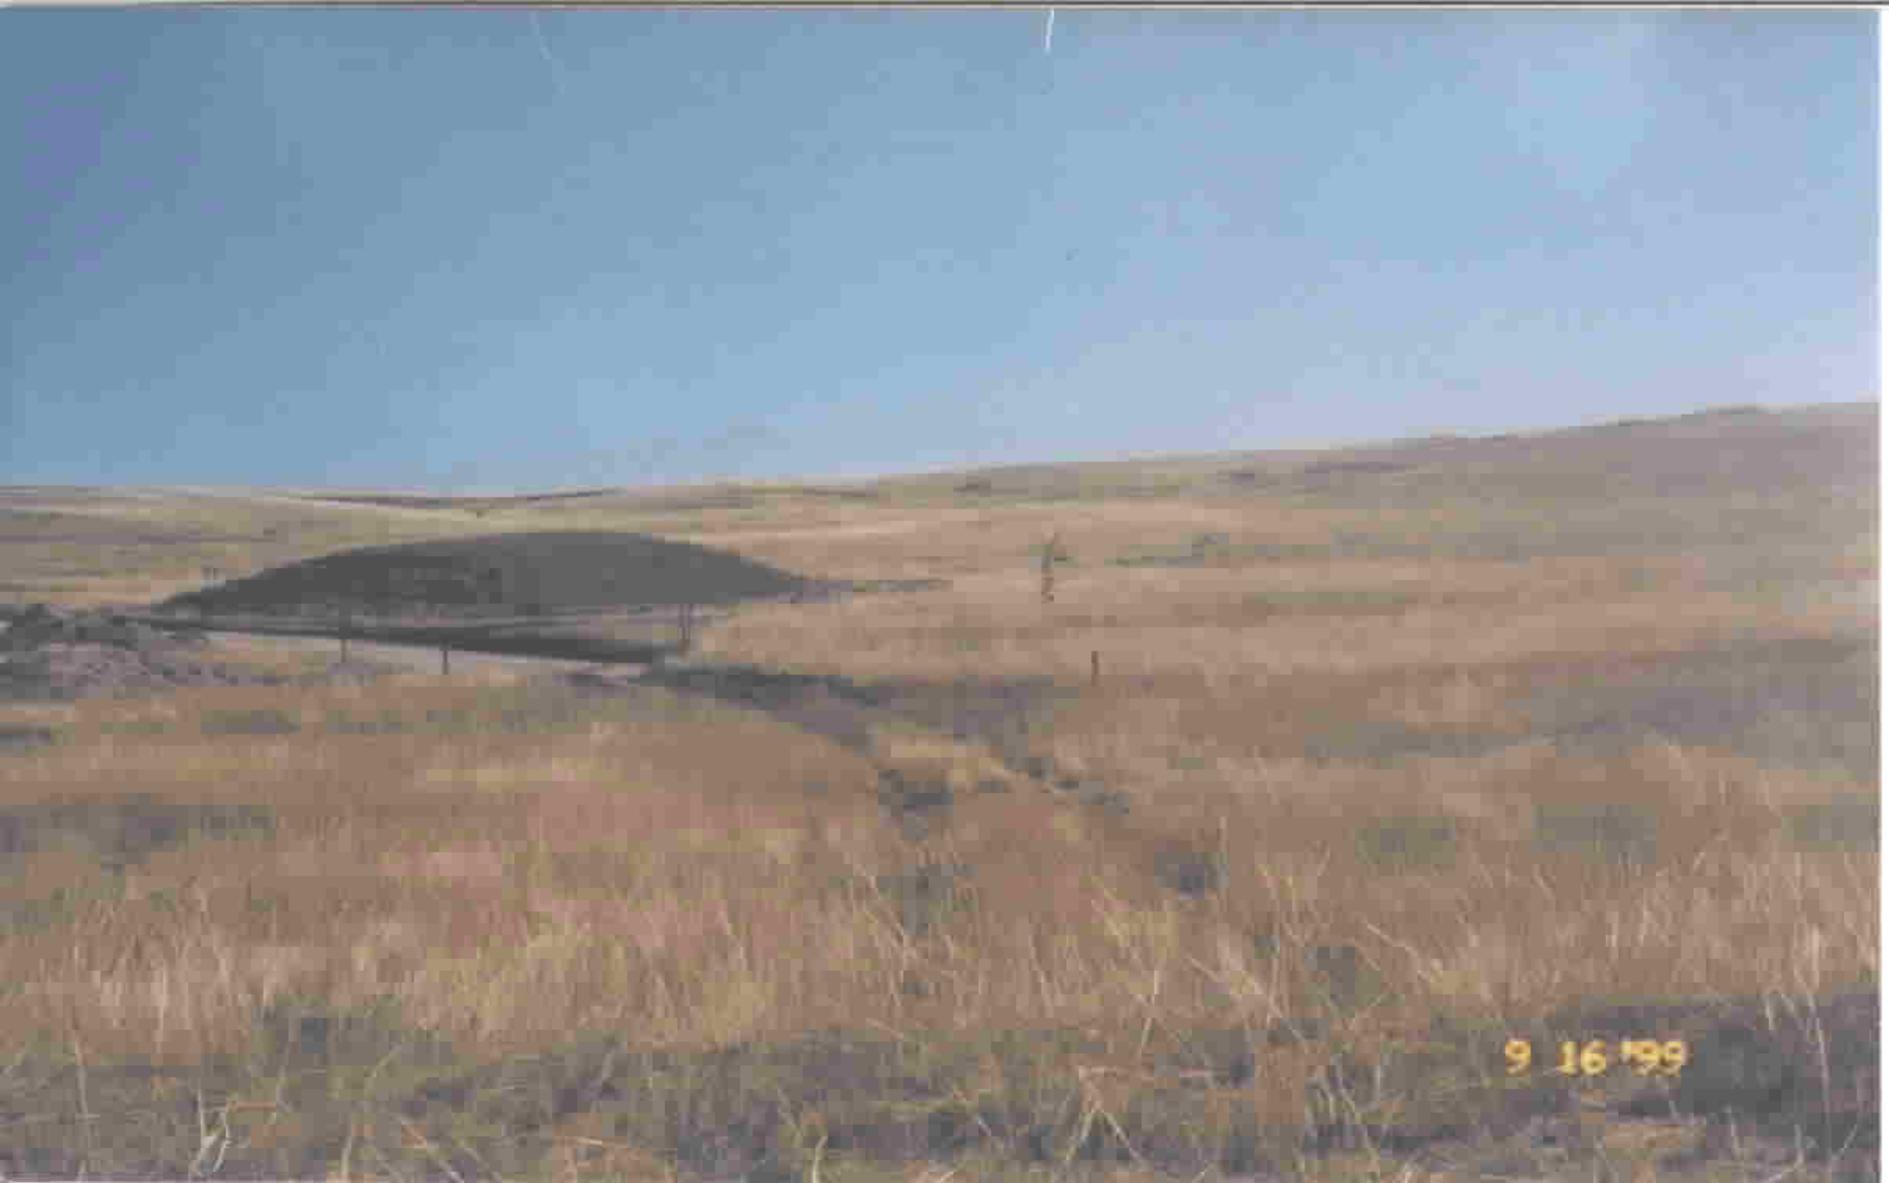
In this case a water truck went out of control while descending a 1000-foot long section of haul road on a 10% grade. The truck missed a curve at the bottom of the grade and ran across this field. This could have been a fortunate circumstance, but unfortunately...

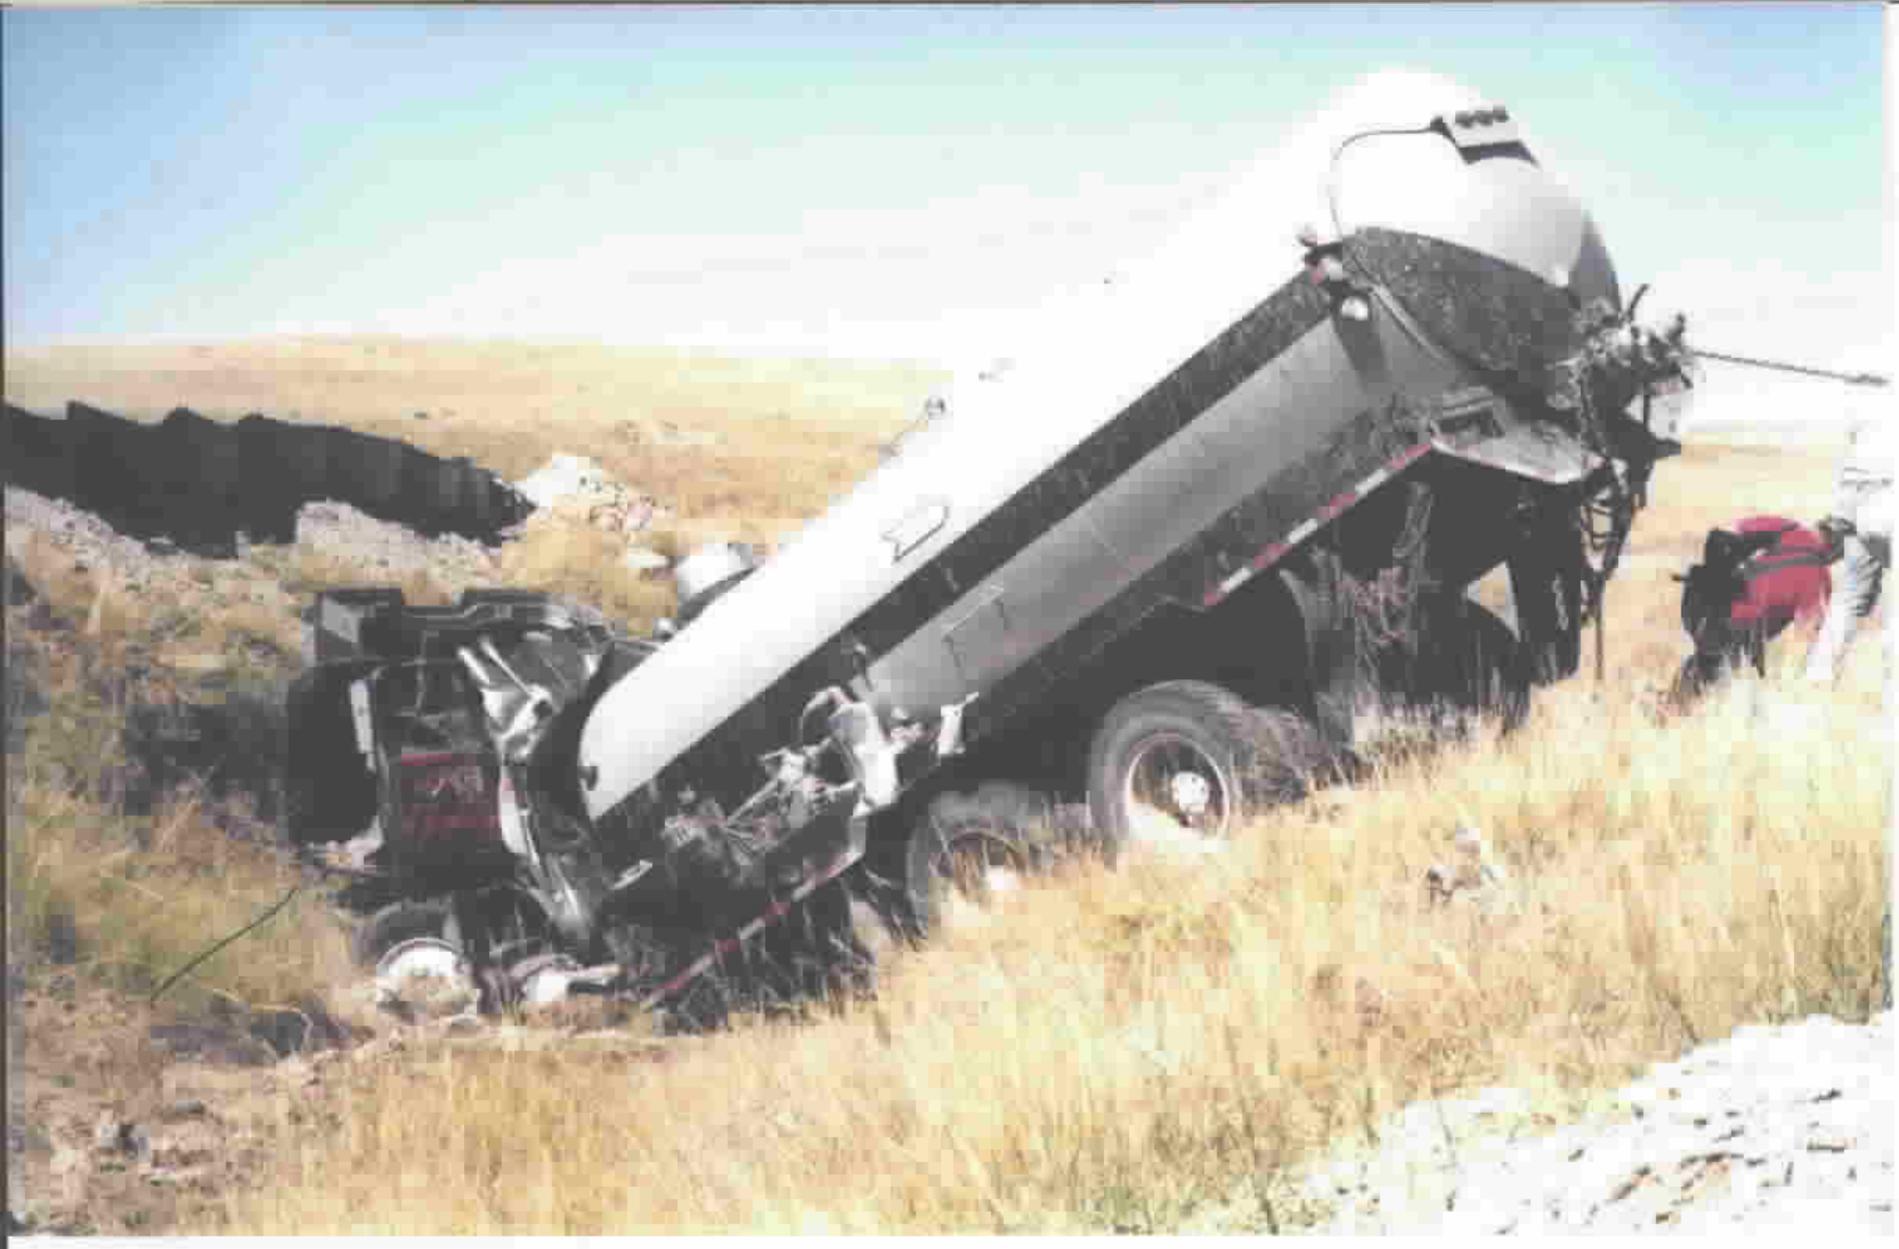
...the water truck crashed into a ravine that ran through the field.

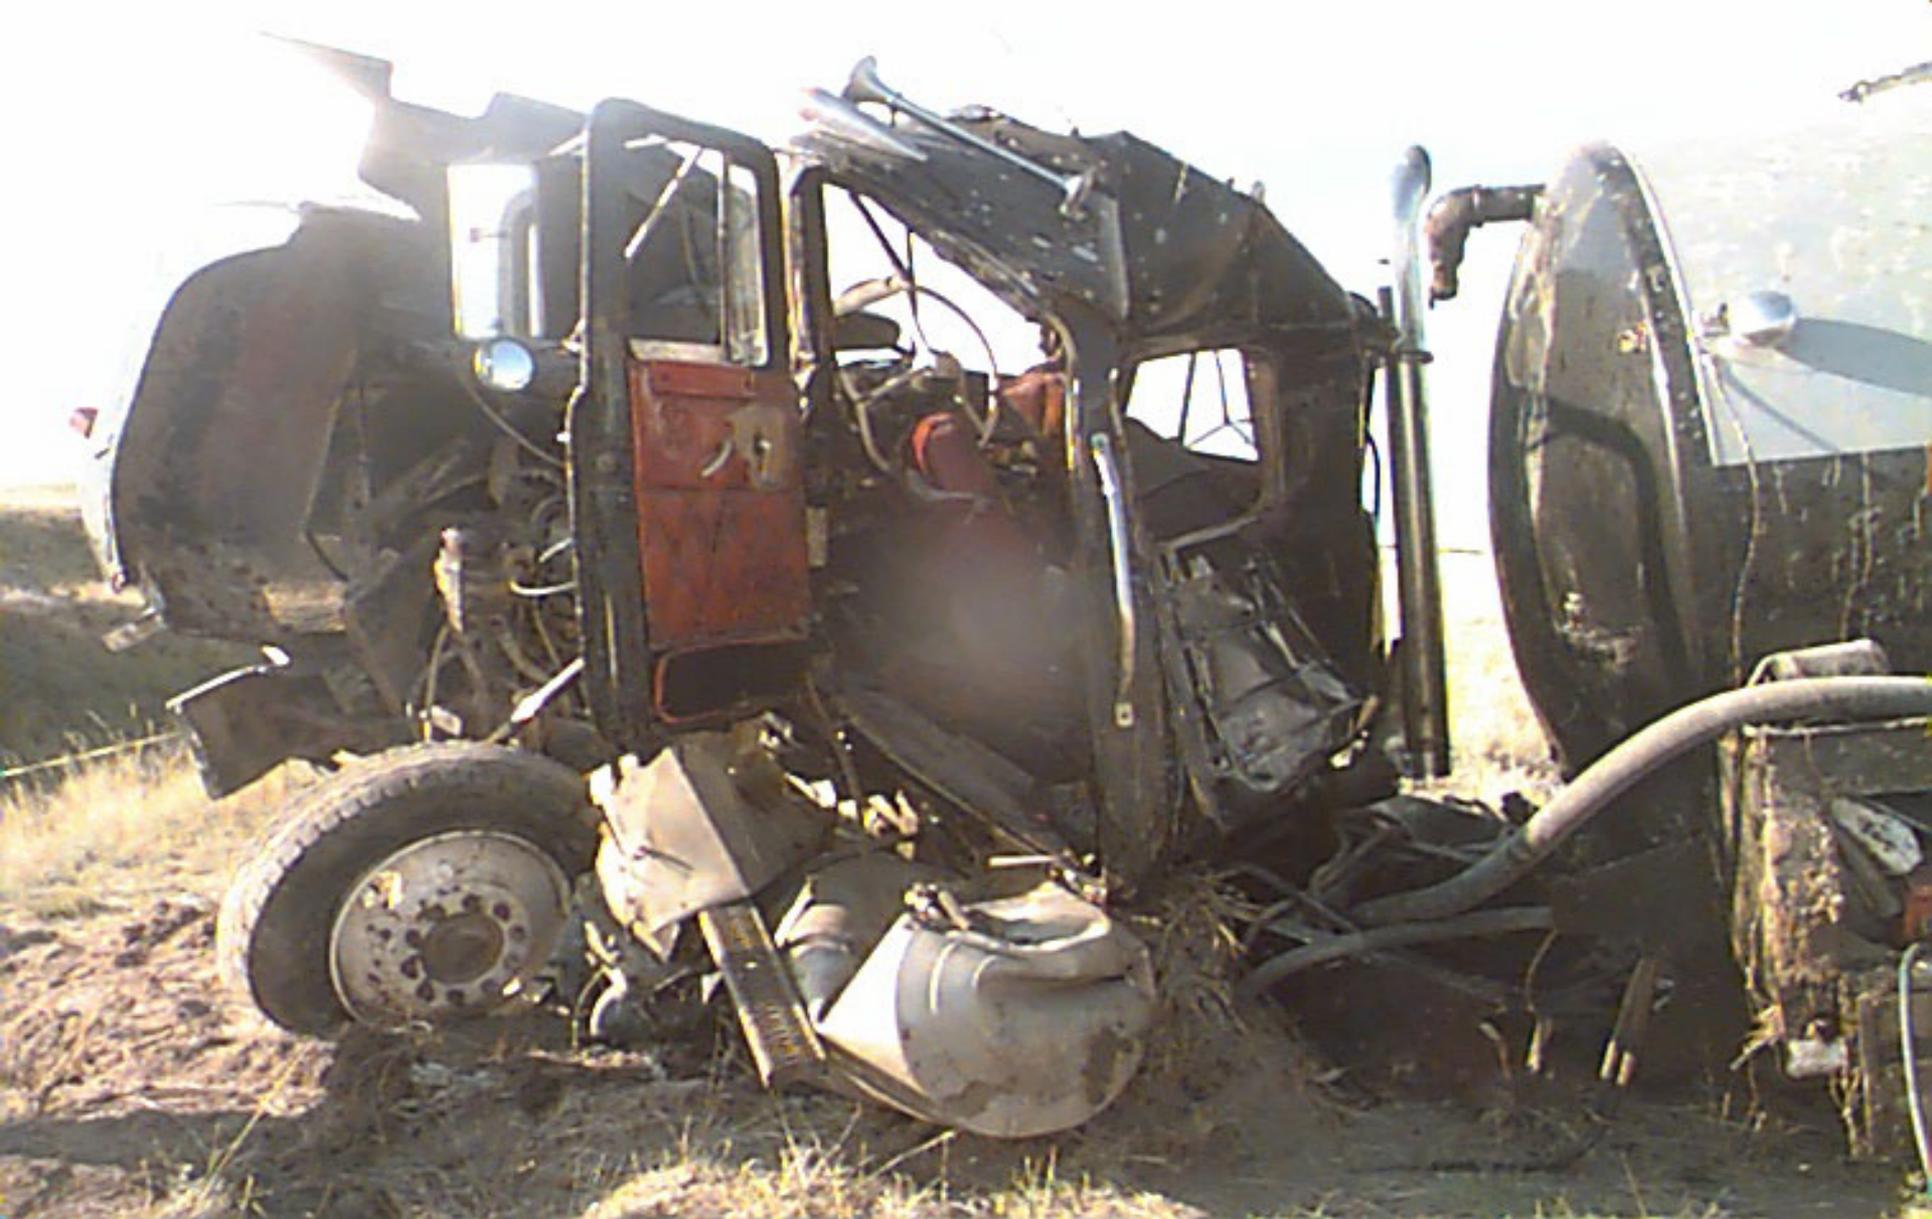
The truck driver was 37 years old with one year of driving experience. He was not wearing a seatbelt.

The accident investigation revealed that the truck's front brakes had been removed and the rear brakes were defective. Rear brake problems included a severe air leak, oversized brake drums, and excessive pushrod stroke...

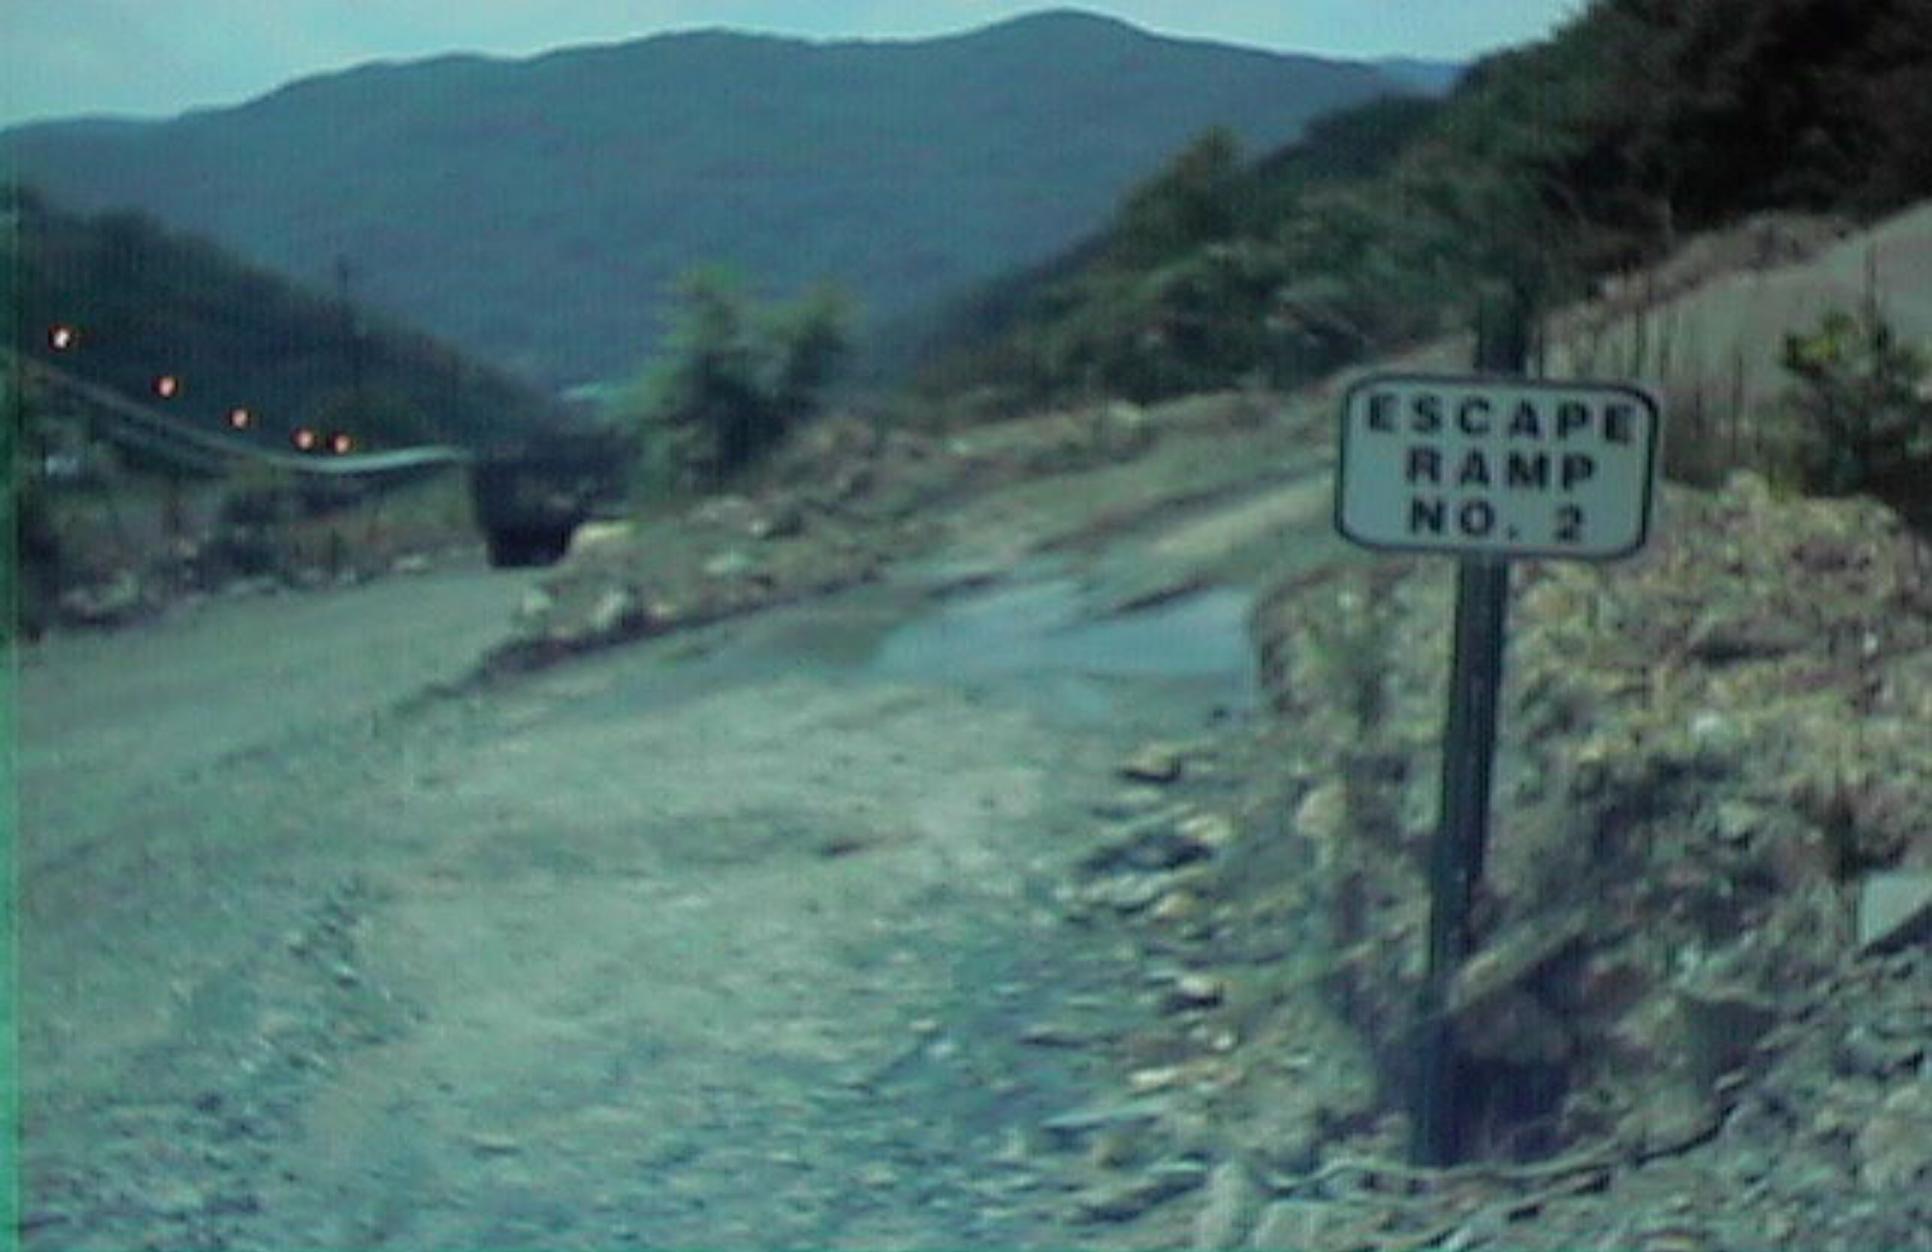
When a fatal accident occurred at this site, it was only the second time that the victim had driven down this haul road and the first time in the particular model truck. The road had an 18 % grade.

Three runaway-truck escape ramps had been constructed on the steep grade as a safety measure.

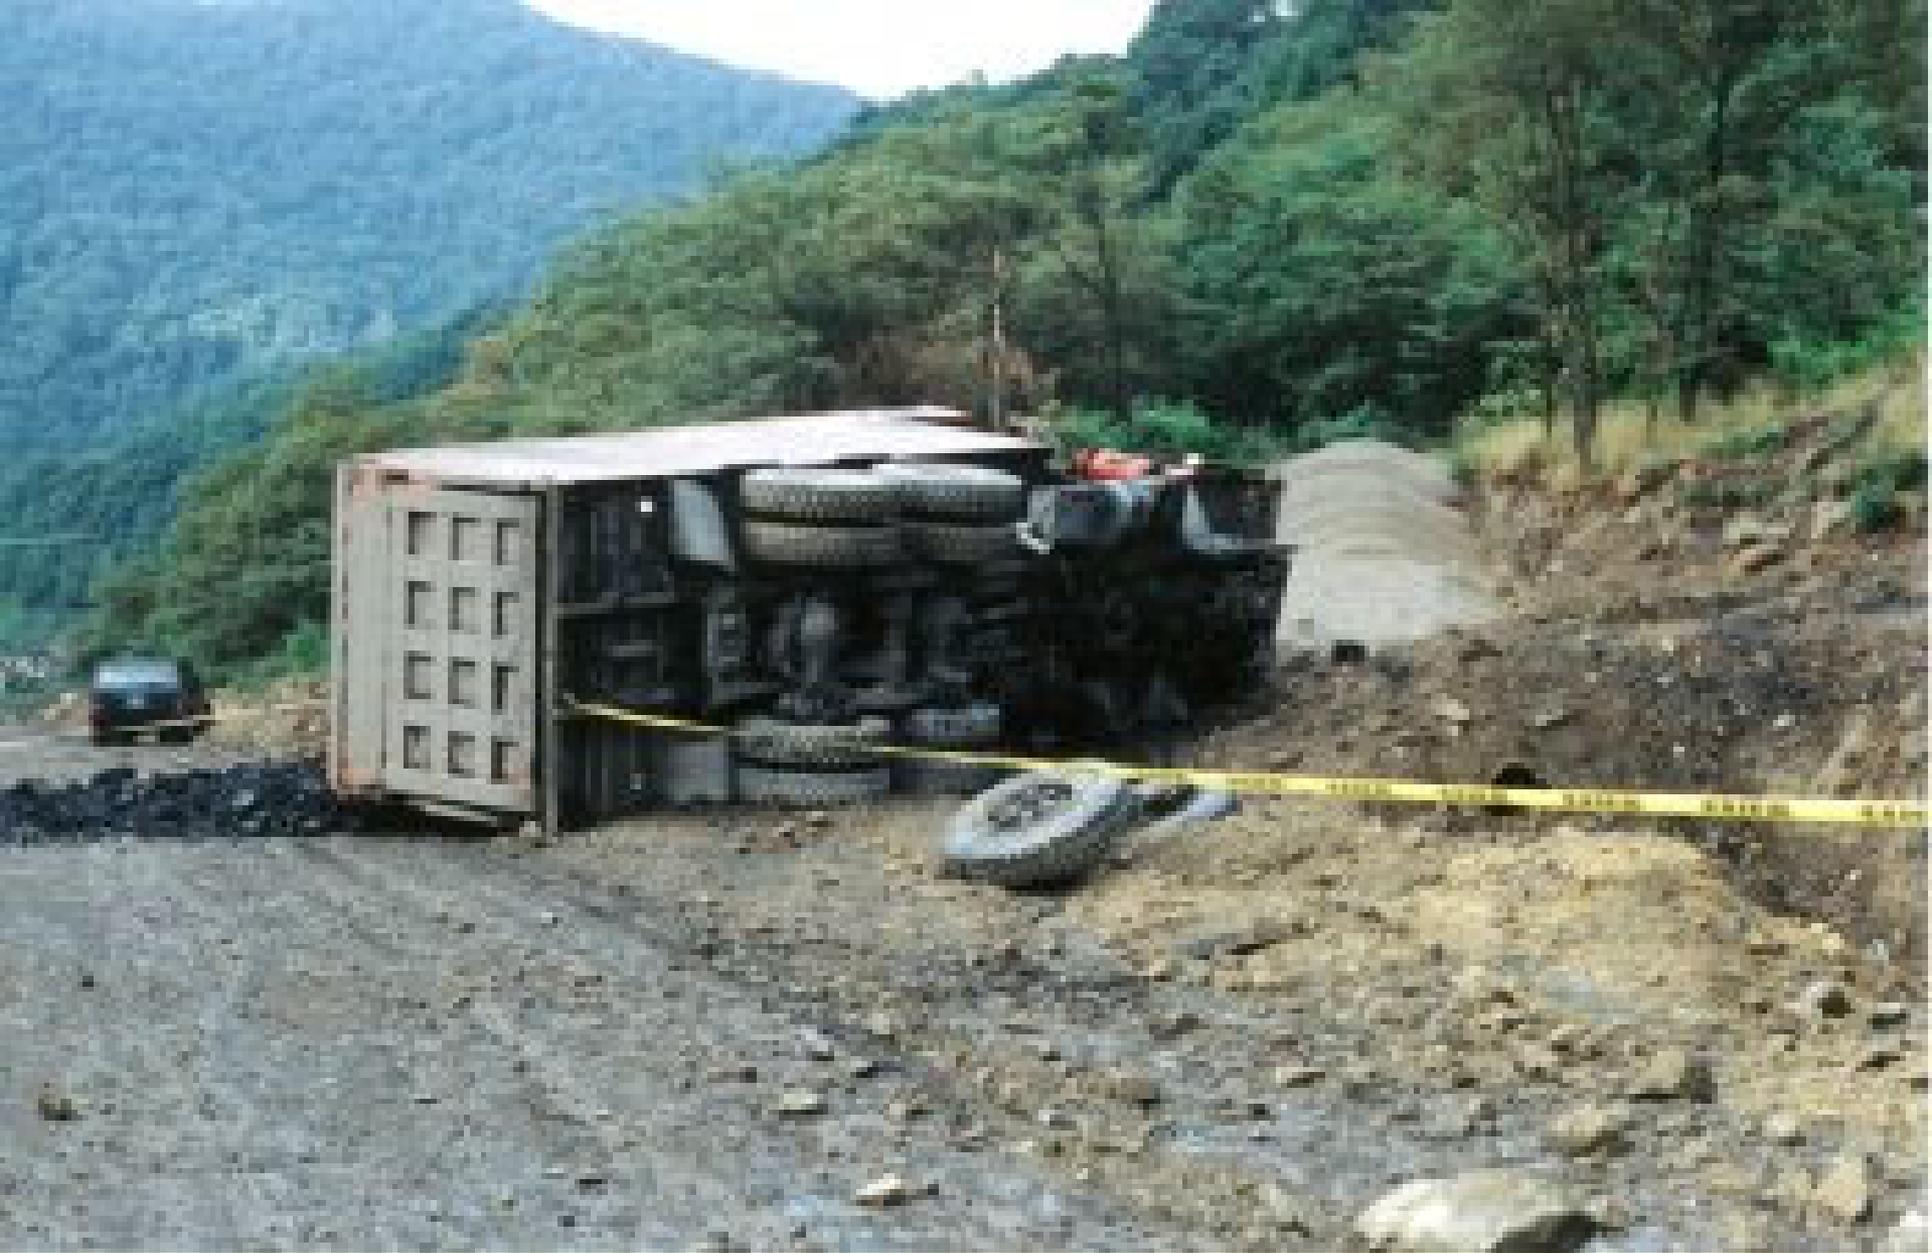
The victim apparently had jumped from the truck and was found about 200 feet below the second escape ramp. The truck went into a ditch and ended up on its side near the third escape ramp, which can be seen to the right of the truck. This ramp was 350 feet below the second ramp.

The 20-ton capacity truck was found to have been loaded to about 45 tons. In addition, the driver apparently was not adequately trained on the operation of the truck and the escape-ramp safety features.

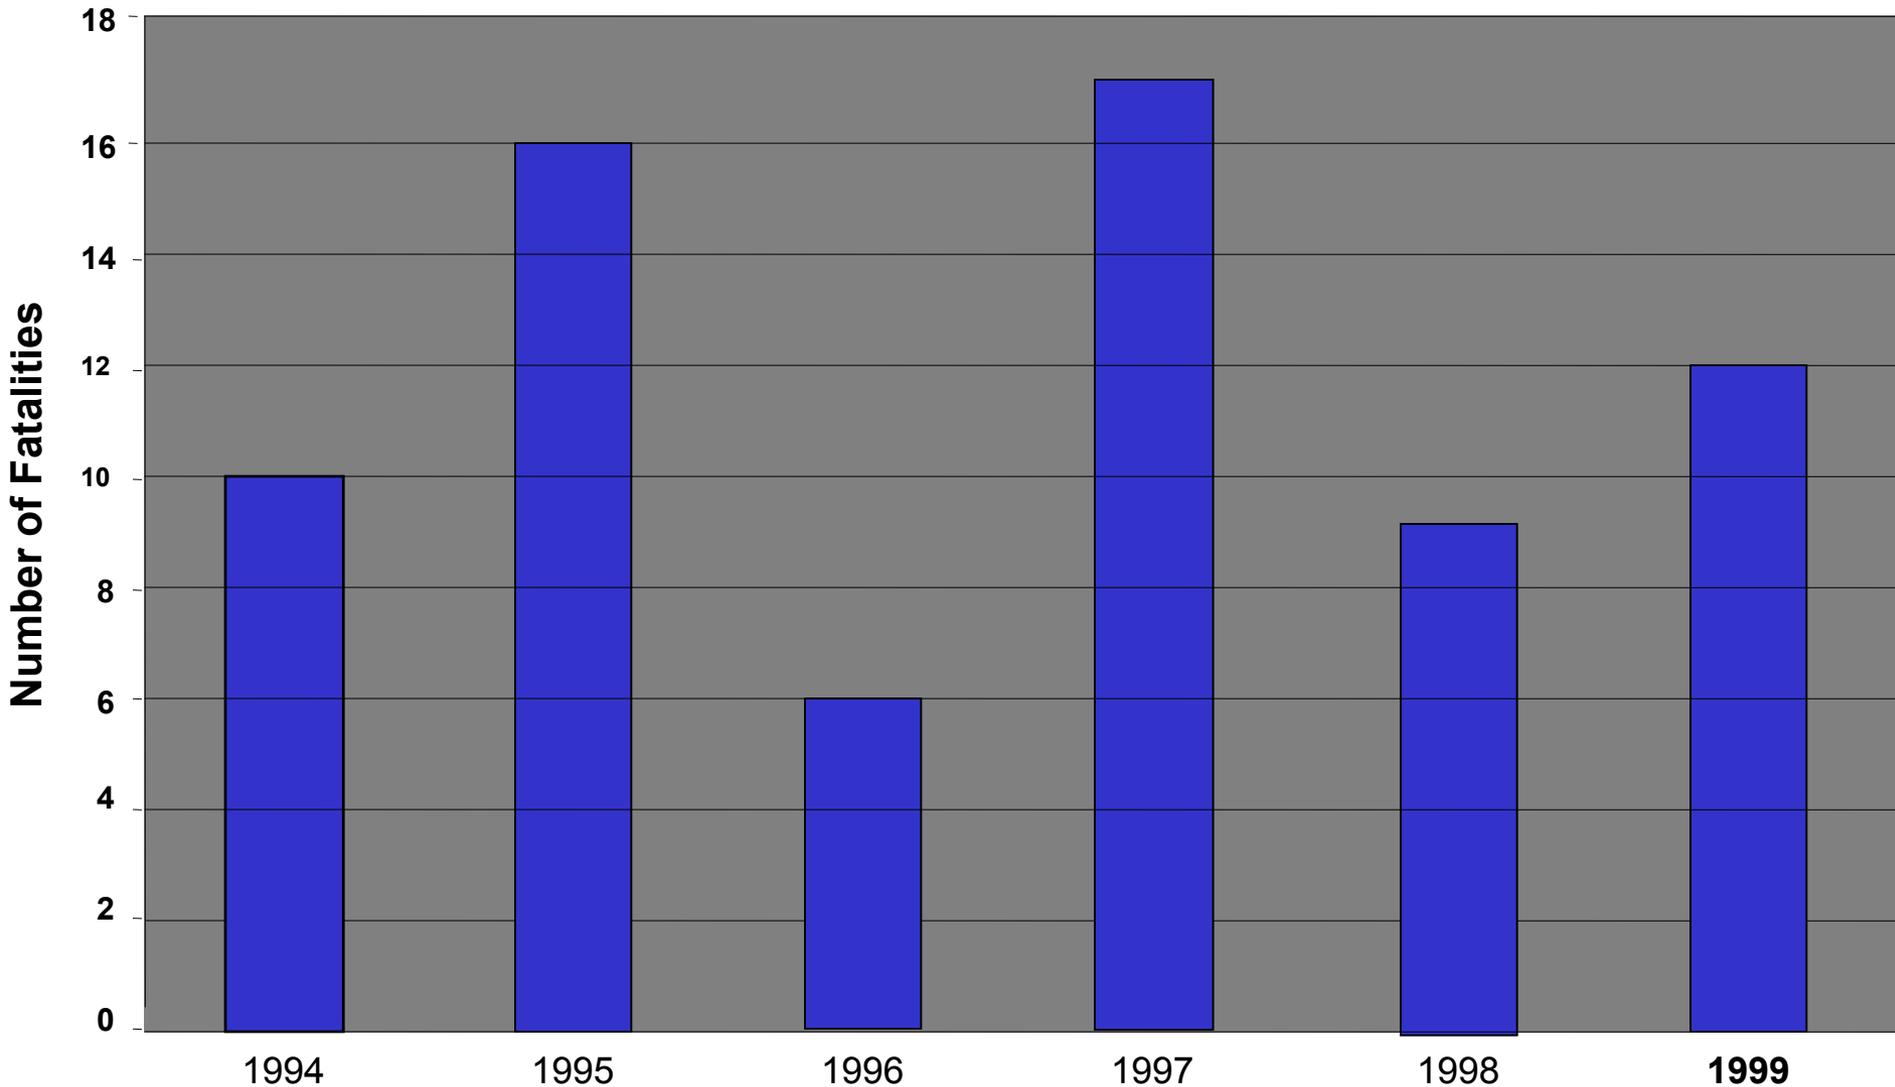
Number of "Truck Driver" Fatalities by Year

This graph shows the number of truck driver fatalities each year. The fluctuation likely reflects the increased emphasis on surface haulage safety that occurs when the number of truck accidents rise. But these variations also result from the fact that sometimes - even with very similar sets of accident circumstances - in one case a miner is seriously or fatally injured, while in another the miner may receive only minor injuries. Safety measures - as shown in this presentation - can be taken to prevent accidents and to increase the likelihood that when an accident does occur the consequences will not be as serious.

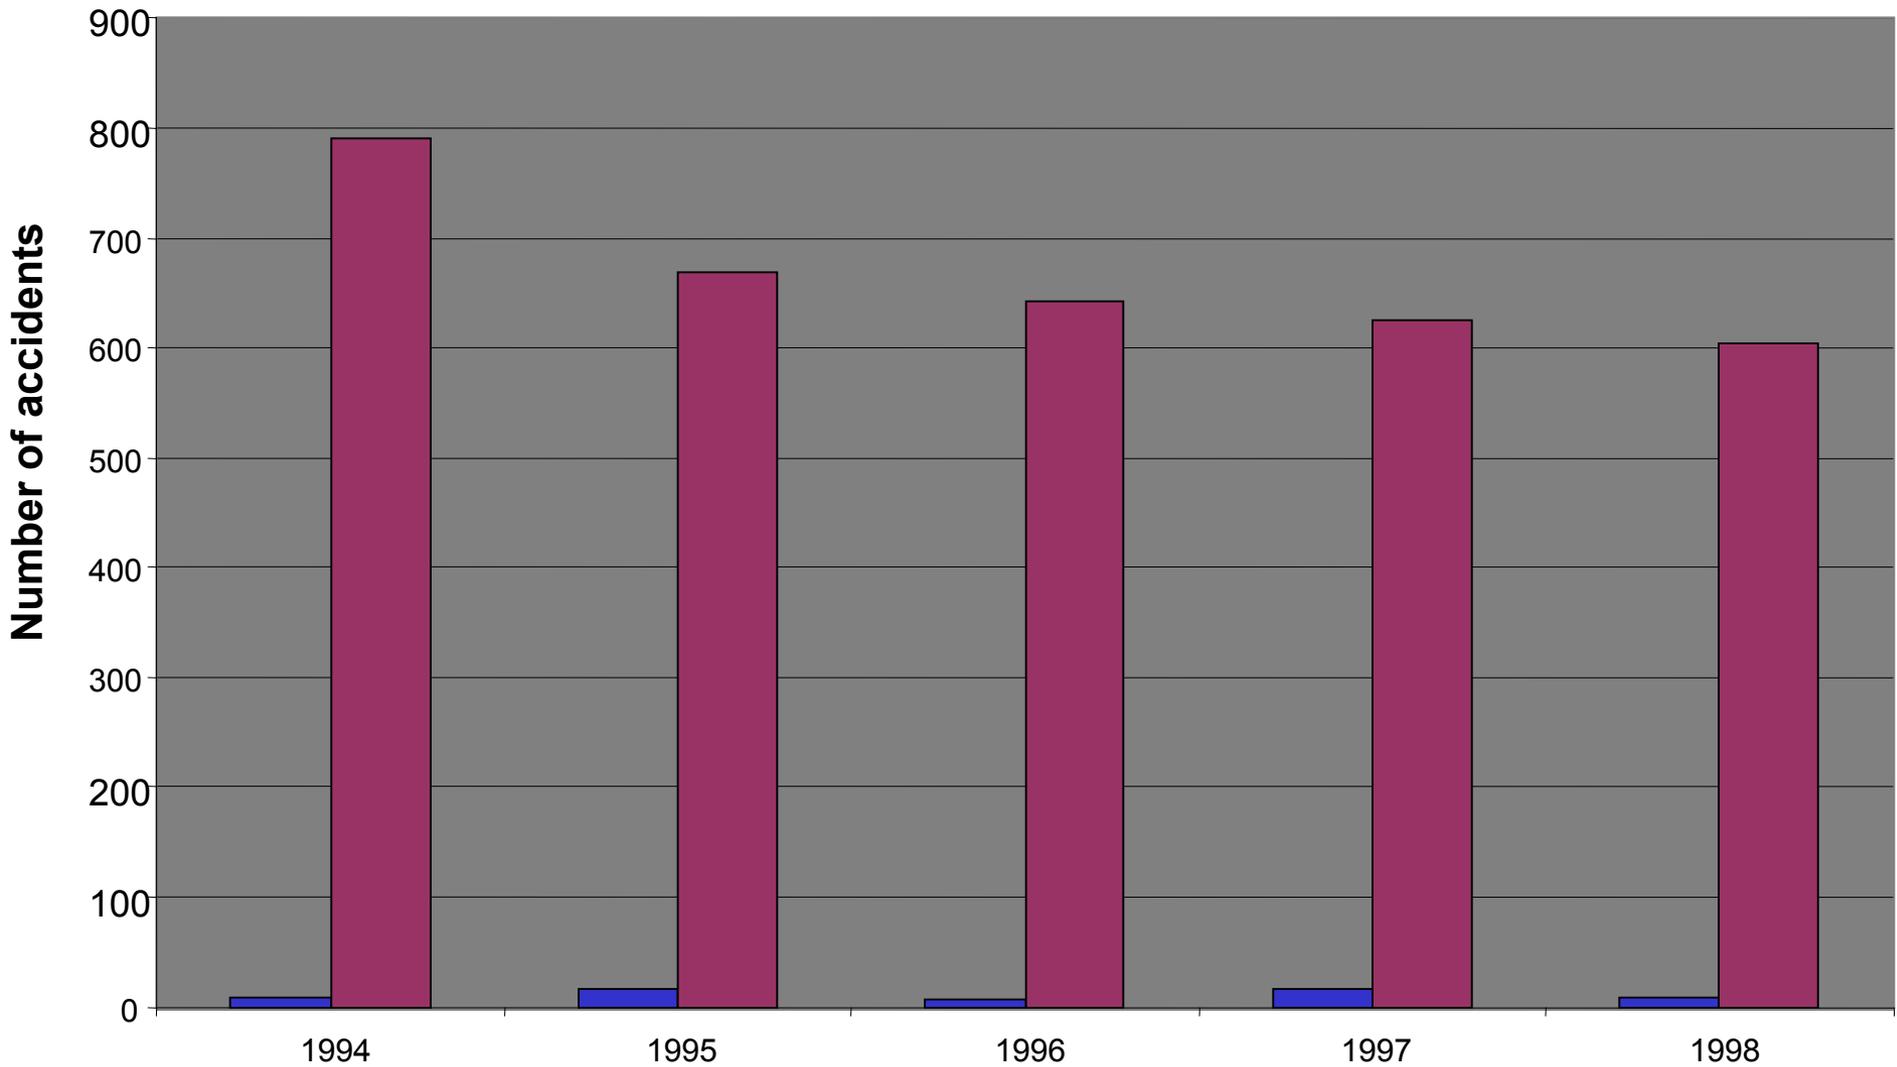
No. of "Truck Driver" Fatal Accidents (blue) vs. Lost-Time Accidents (red)

A goal of surface haulage safety must be to continue the trend of decreasing the number of lost-time accidents and to incorporate measures to reduce the seriousness of any accidents that do occur.

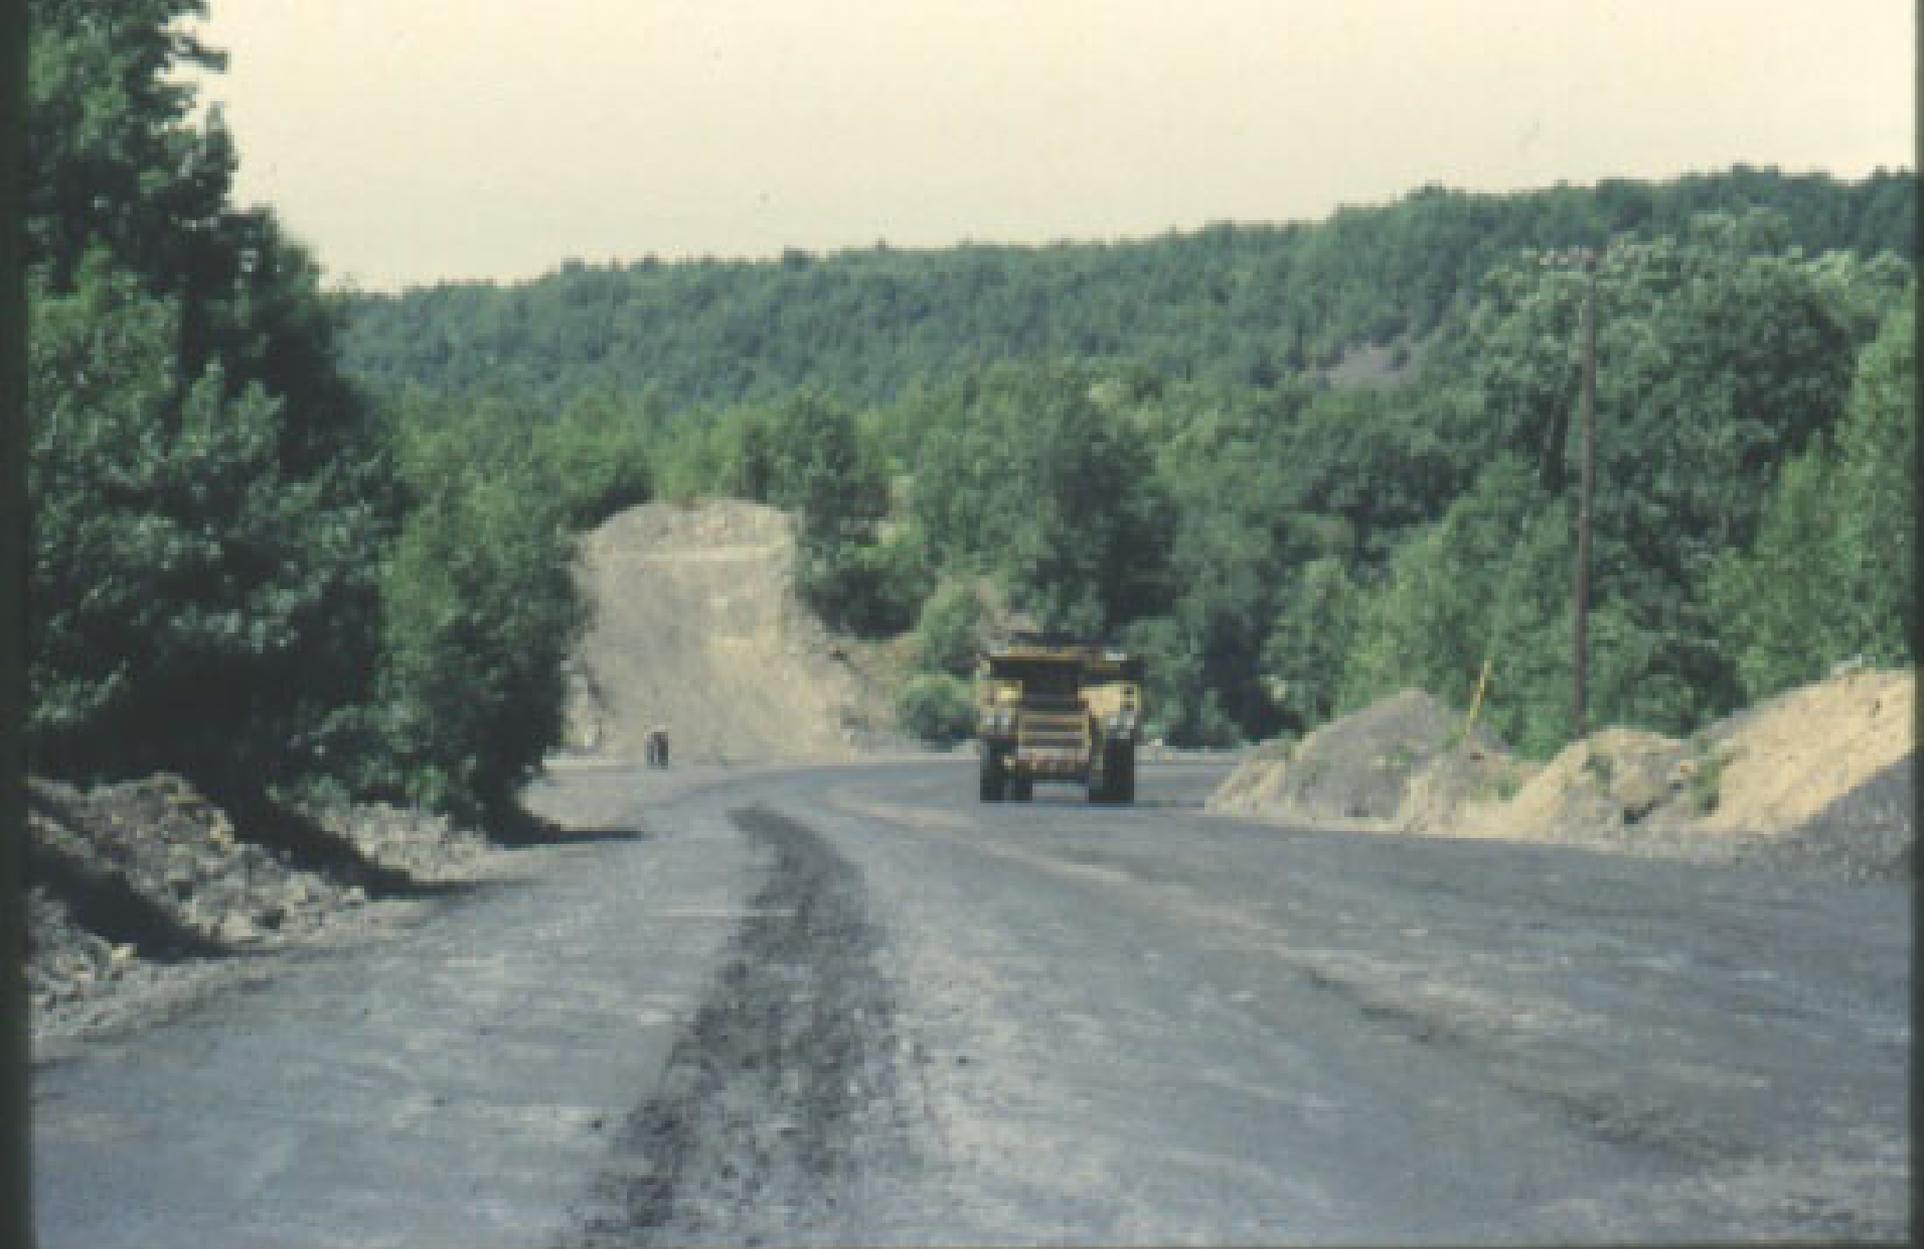
Here's an example of an escape ramp. The ramp is still under construction in this picture, but in the first year after it was completed, a runaway truck was saved on the ramp.
