Surface Haulage Accidents...

...Ways to
Prevent Them

MSHA's investigations of surface haulage accidents reveals two key points:

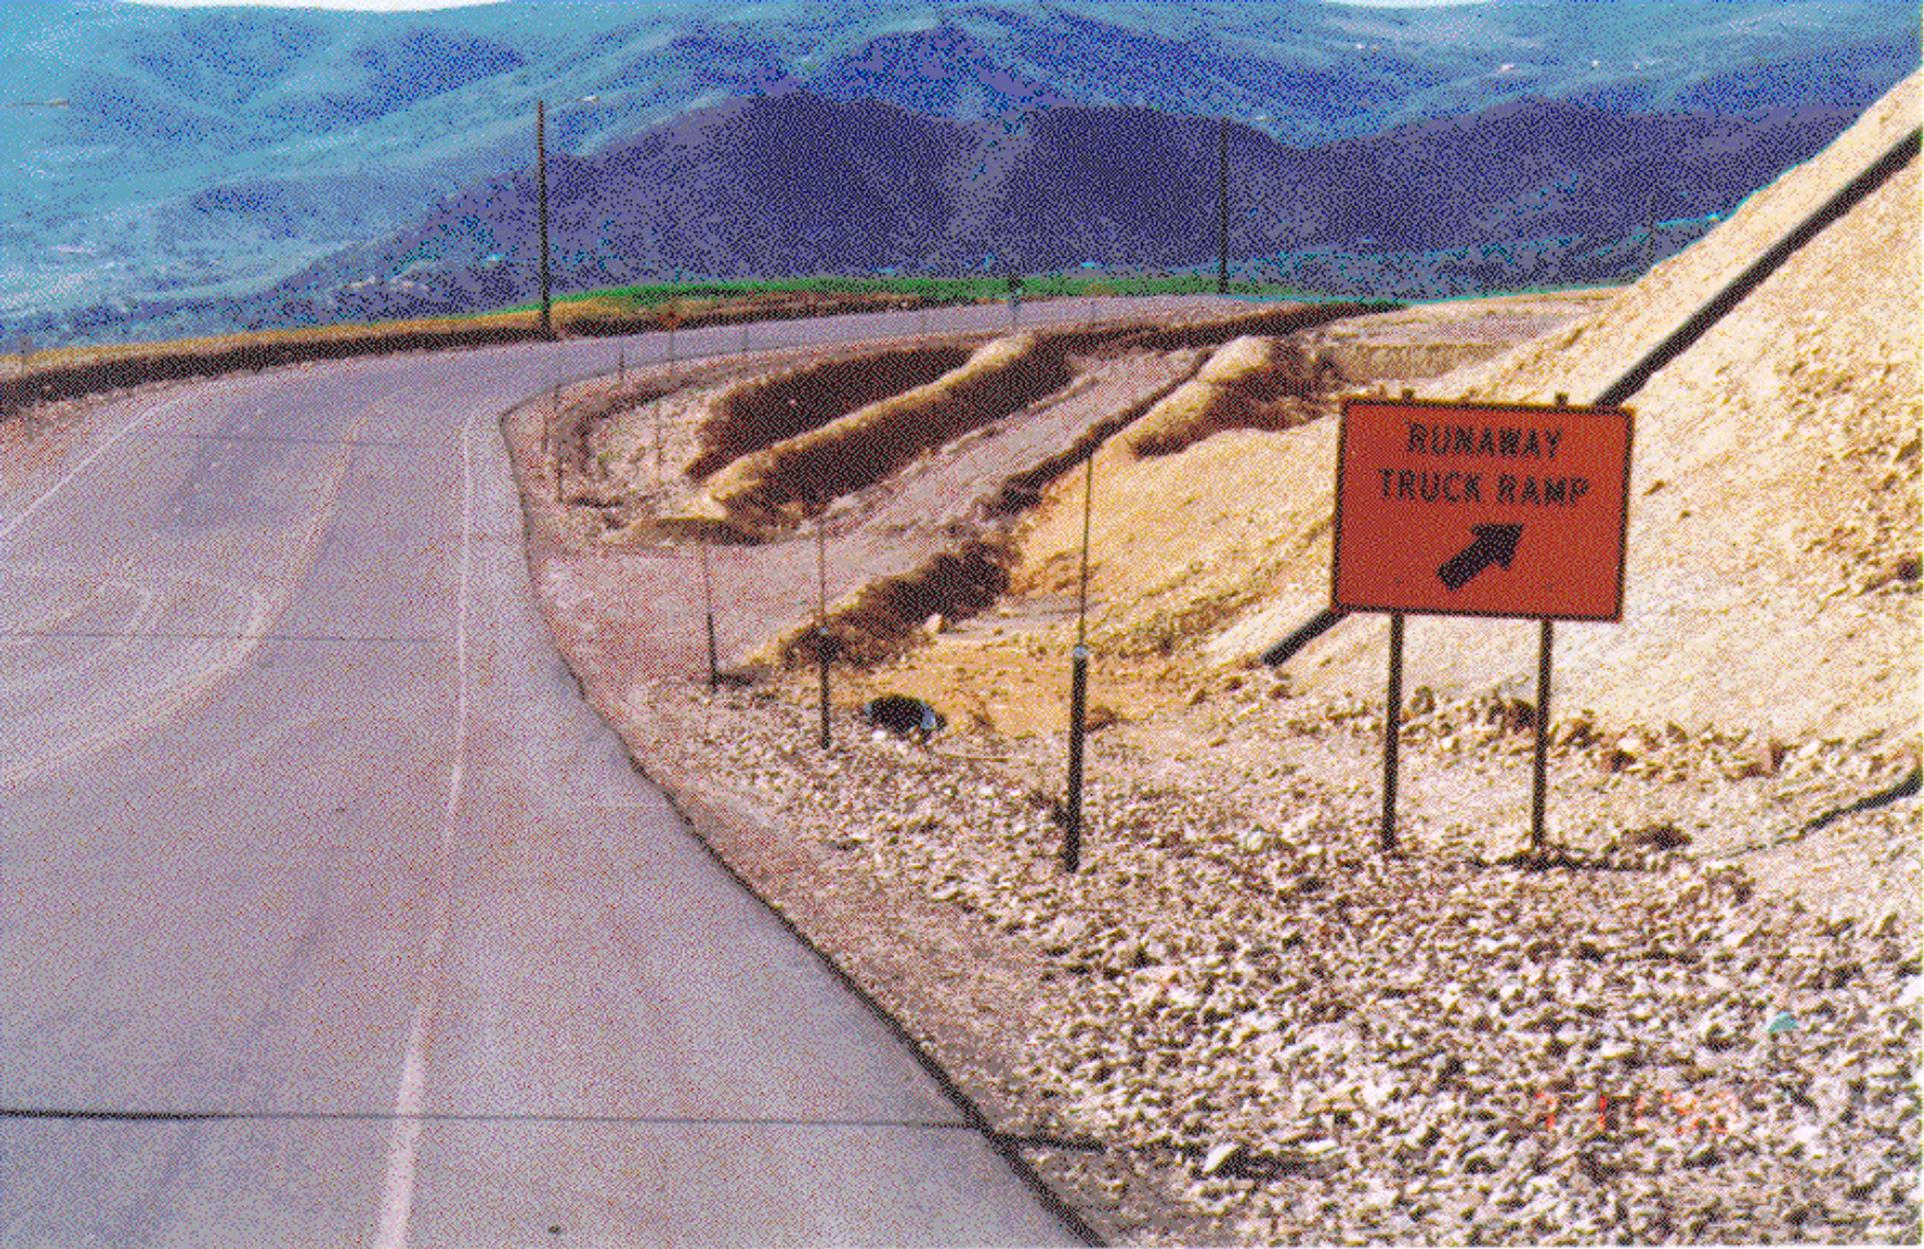
An example of a runaway escape ramp at a copper mine in Utah. A bed of loose gravel is used on the ramp to help bring a runaway truck to a controlled stop.

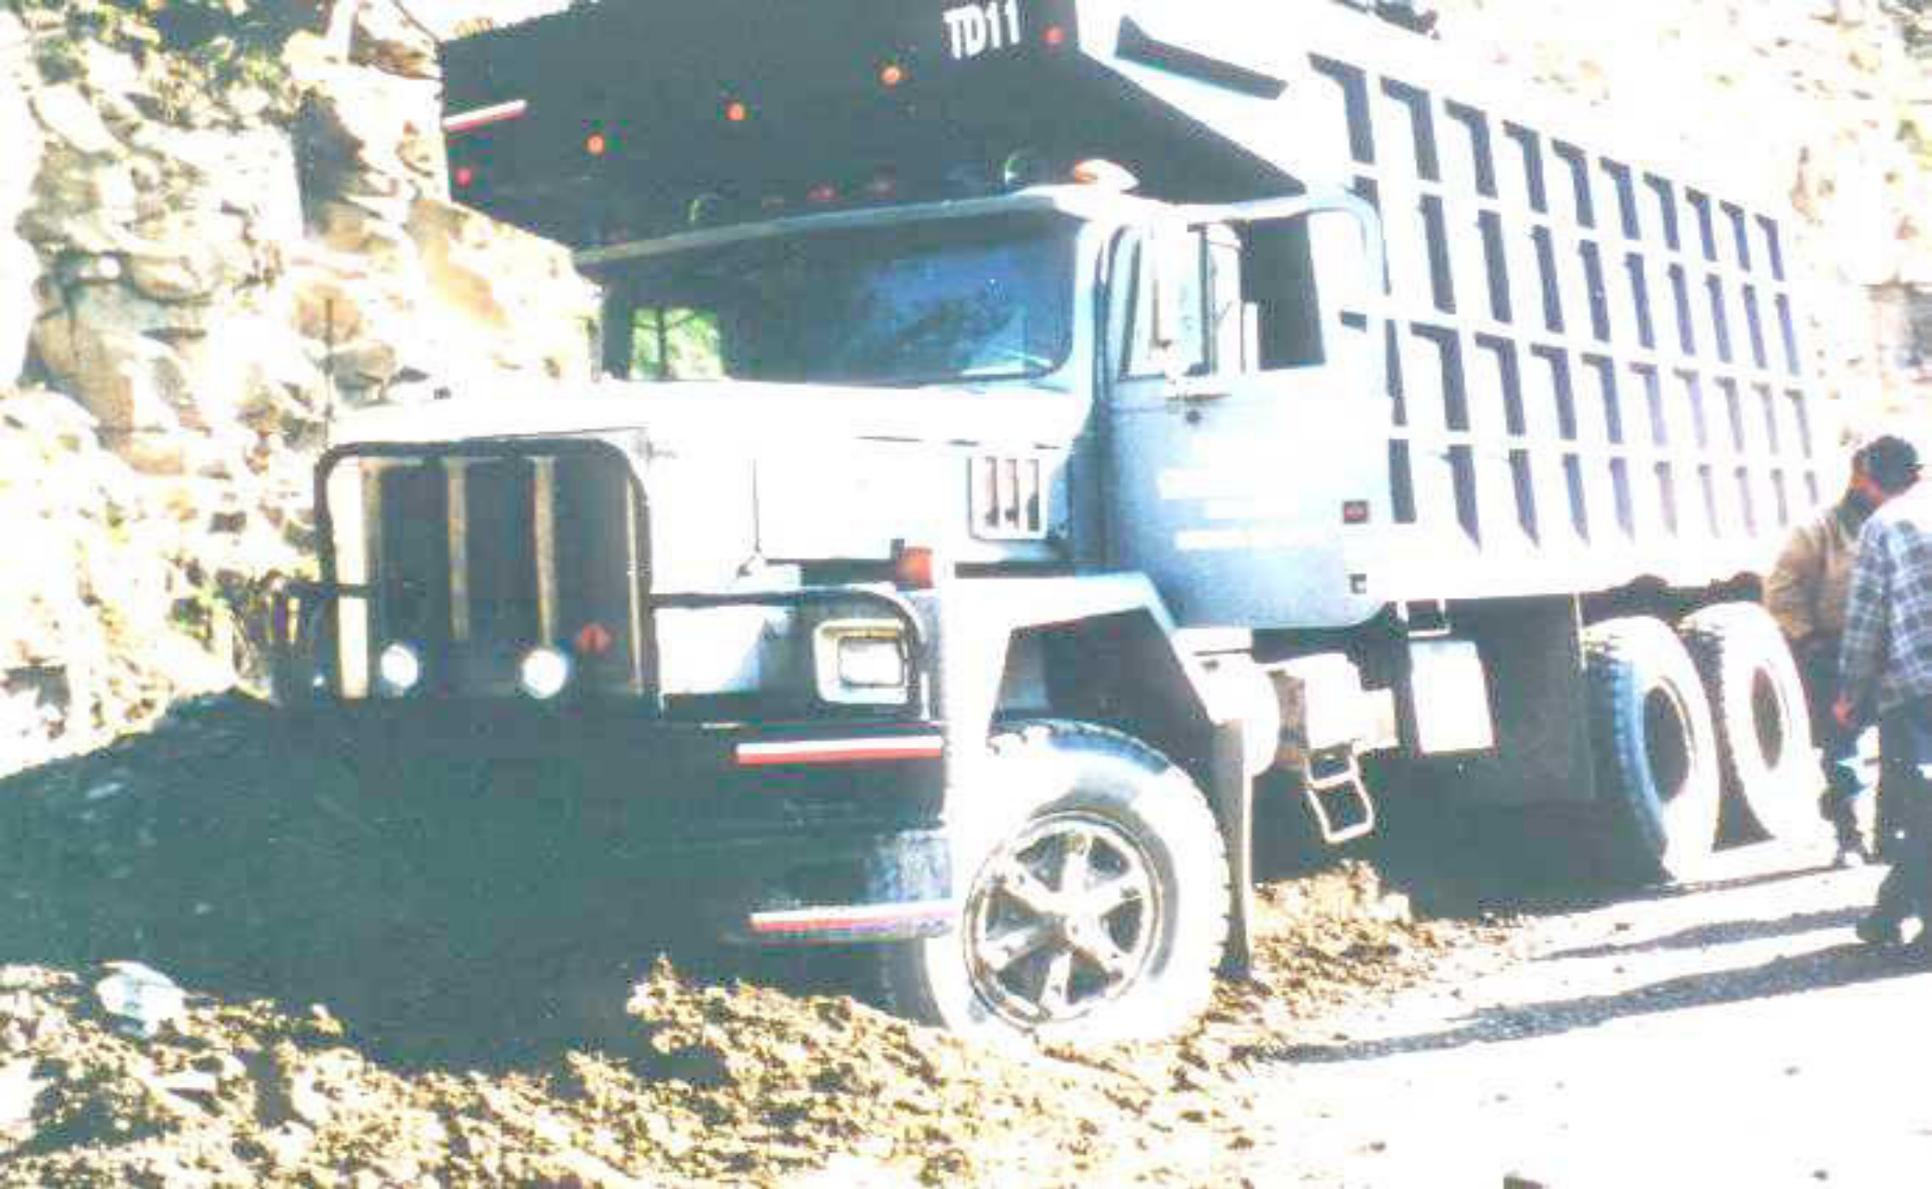
This was a save of a runaway truck at a mine in West Virginia. Where it may not be practical to construct a ramp, some mines have had success placing berms of loose material along the sides of the roads. As shown above and in the next picture, this driver brought his runaway truck to a stop by plowing into the loose berm material.

The driver stayed in the truck and was not injured.

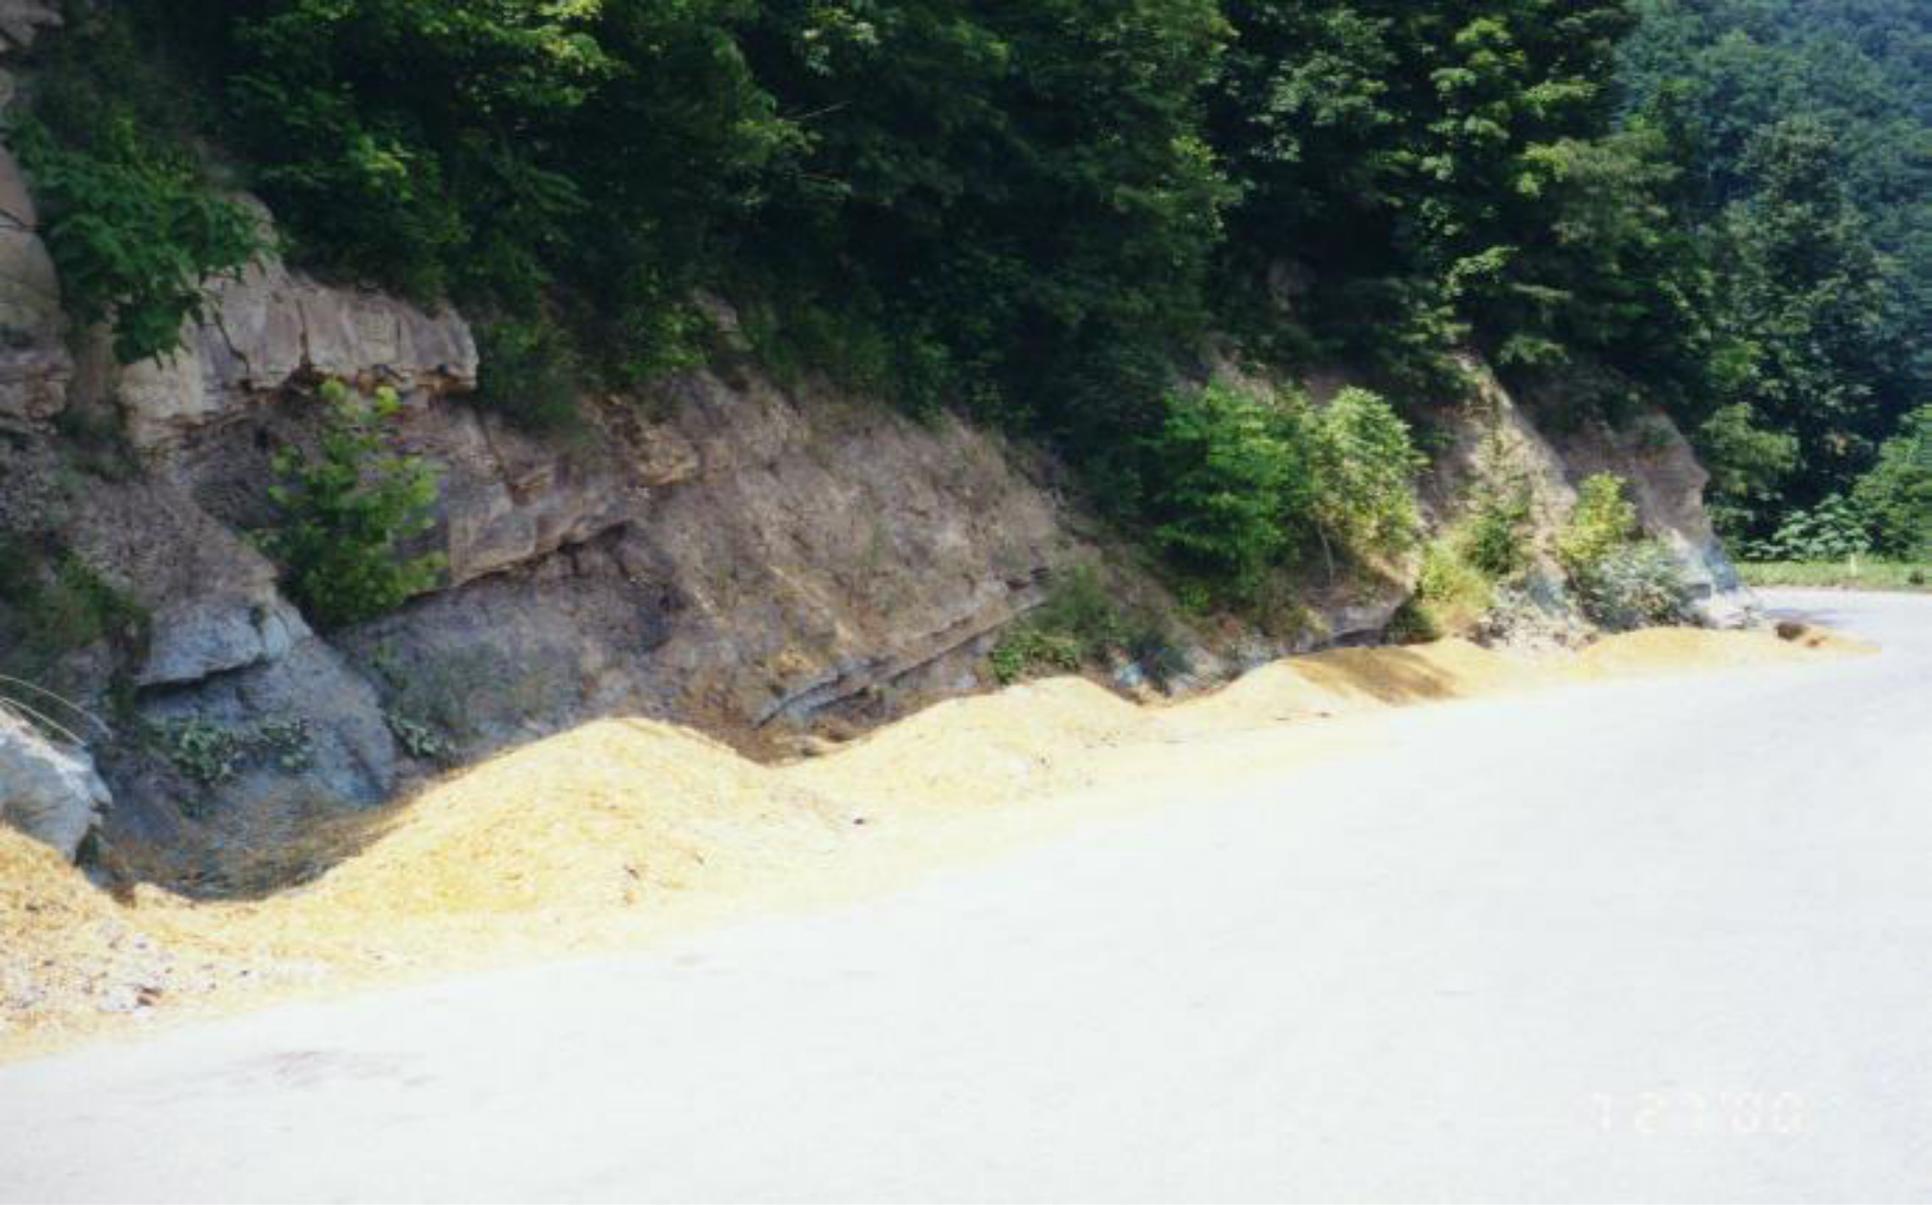
Here, loose material is placed in a “sawtooth” pattern to provide the driver with the opportunity to straddle the berm. Since the stopping power is limited, the driver must get into the berm as soon as he or she realizes there is a problem and before the truck picks up too much momentum.

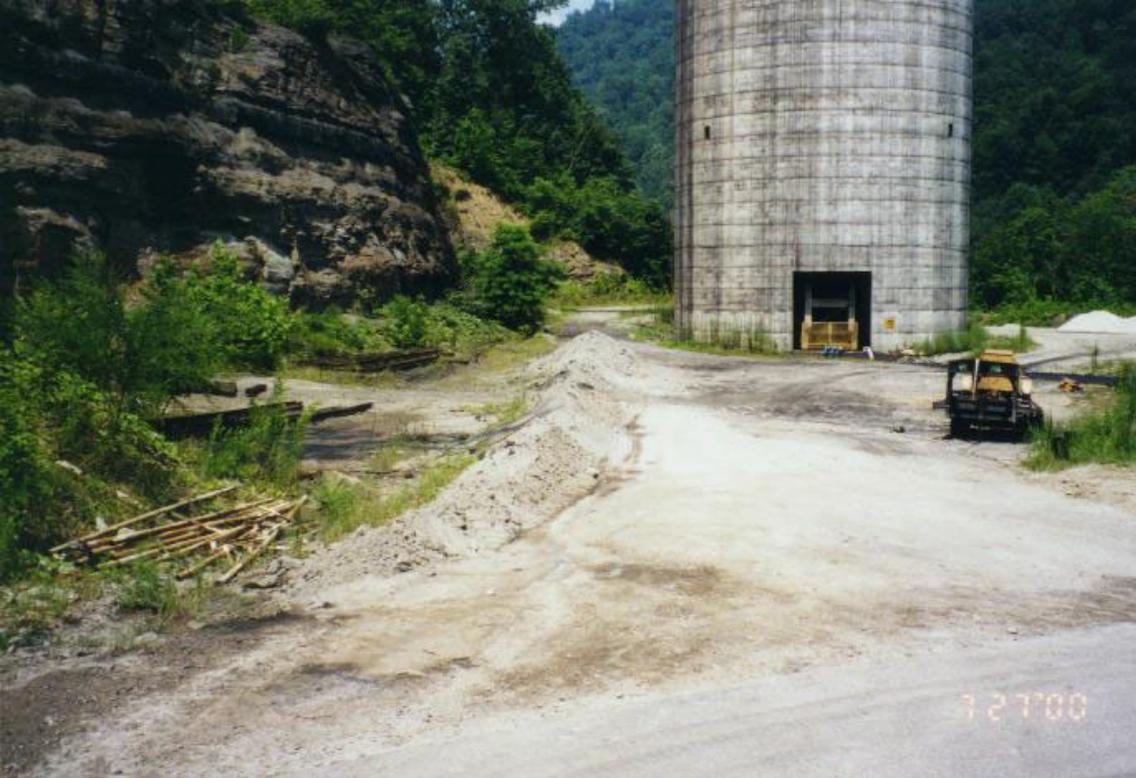
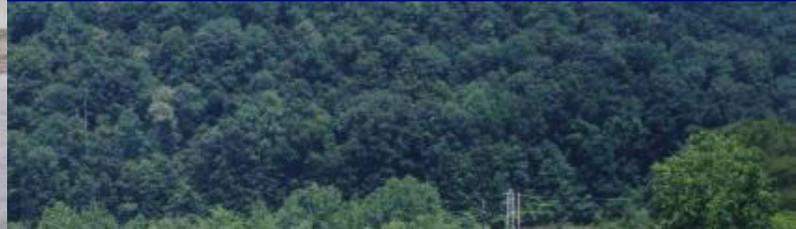
These are other examples where “straddle” berms of loose material have been placed in various locations where a truck driver may be able to use them to help bring an out-of-control truck to a stop.

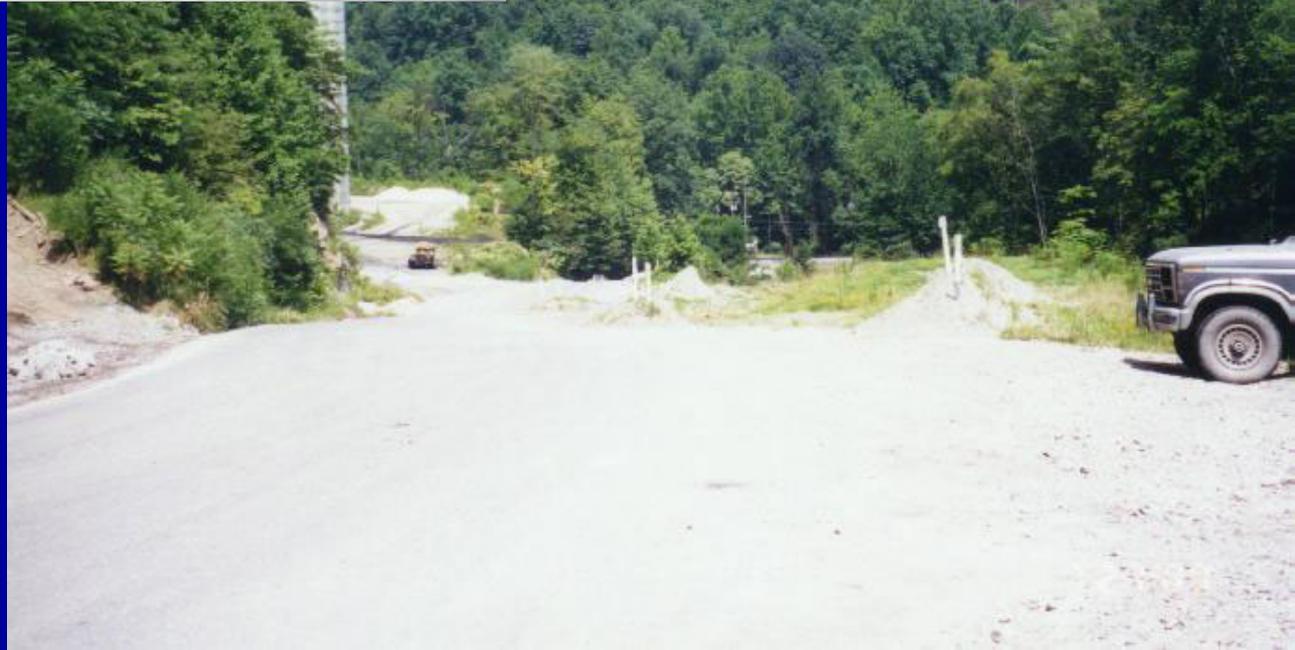
EXAMPLE OF RETARDER PERFORMANCE CHART

Use Retarder Chart Information

Make sure that trucks are operated within the manufacturer's recommendations. Retarder charts, for example, indicate the combinations of loads, grades and speeds that should not be exceeded if the truck's retarder is to work properly. Use retarder chart information to set speed limits for downgrades and to train drivers on proper operation of the truck.

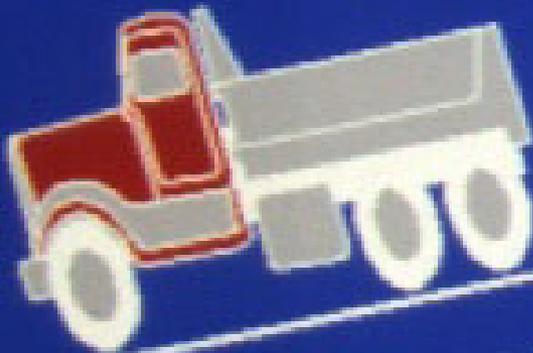
WARNING

DO NOT DESCEND GRADE AT SPEEDS
GREATER THAN LISTED, WHEN VEHICLE
IS LOADED AT MAXIMUM GVW.

Install decals in truck cabs with simplified retarder chart information. This reminds the driver - at a glance - of the retarder performance characteristics of that particular truck.

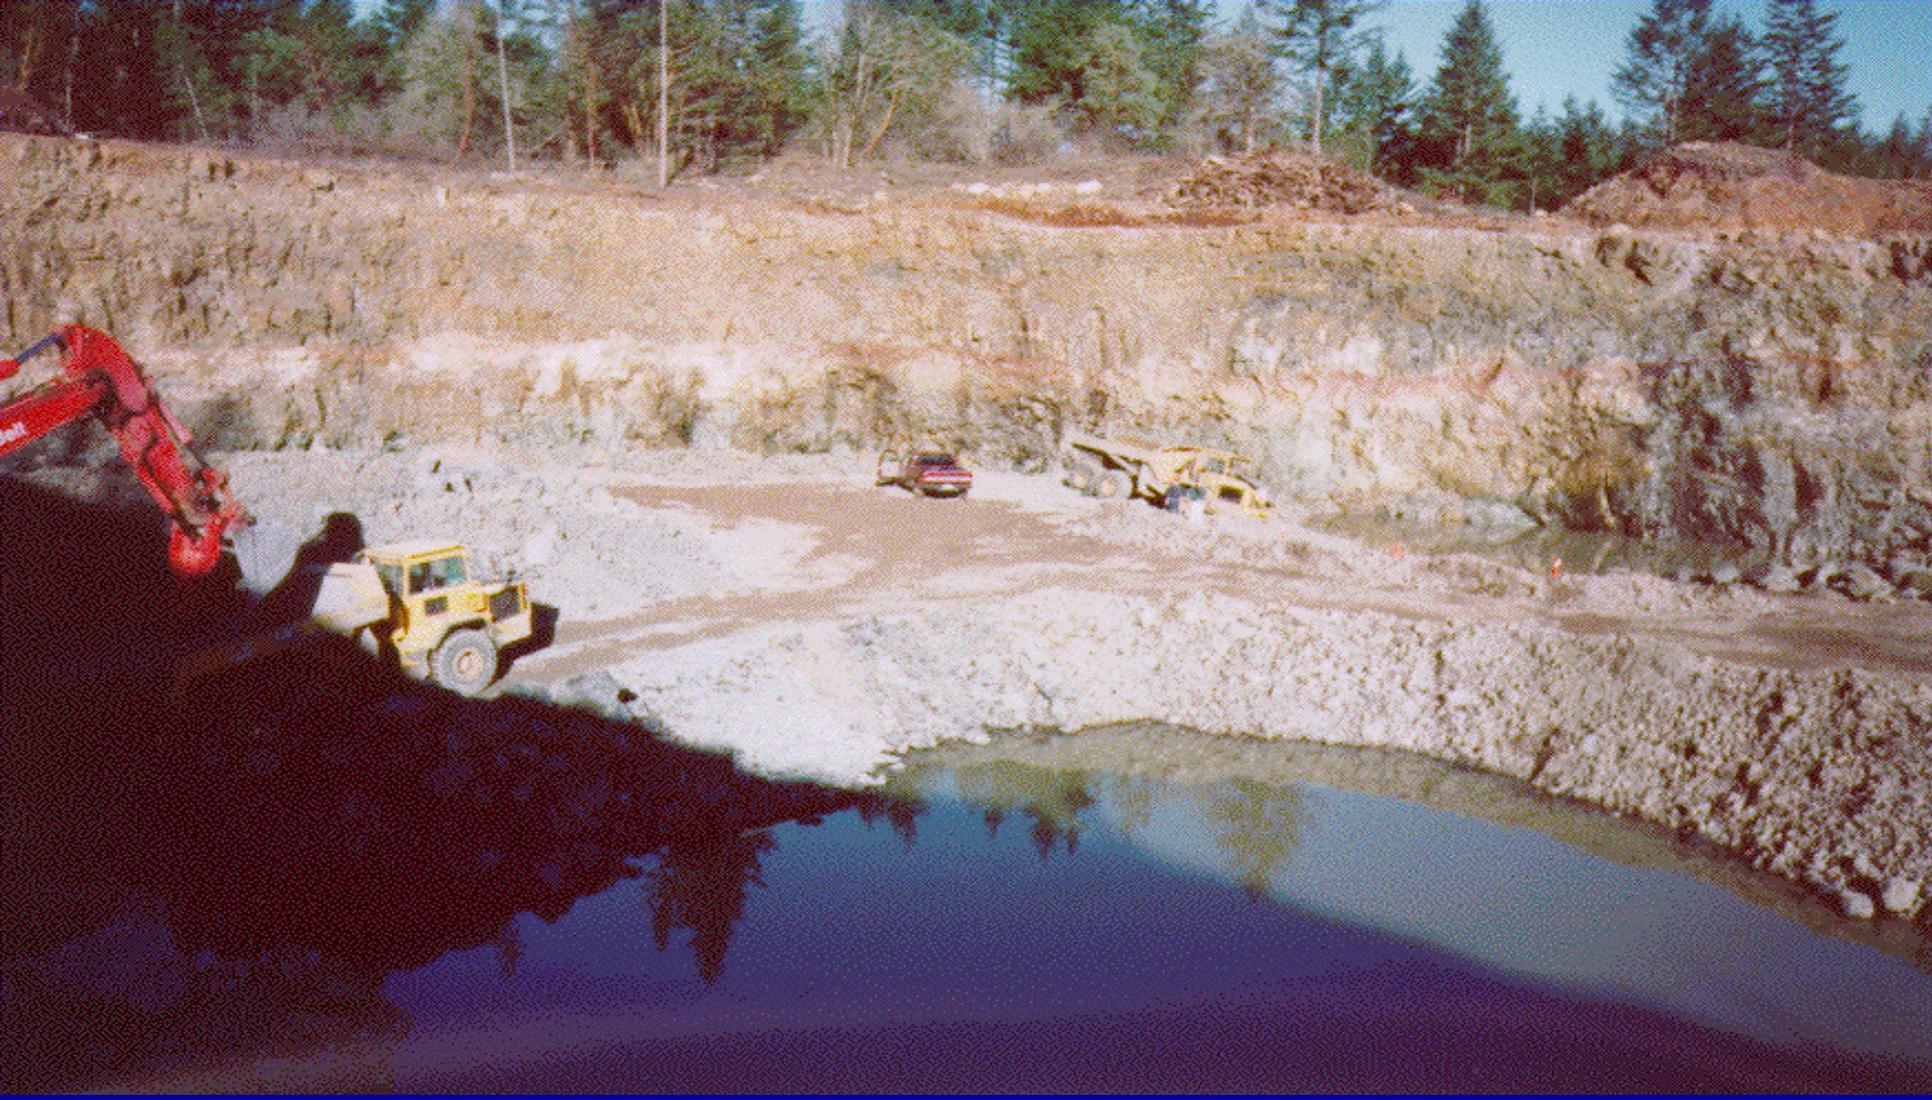
A fatal accident occurred at this mine when a truck failed to make a 90-degree right turn. The road was narrow and there was little or no berm. The trucks normally took two attempts to make the sharp turn. When the driver attempted to make the turn on one try, he ended up going into a small pond. Even though the water was only 10 deep, the truck ended up on its side and the operator drowned. The lessons here were that roads should be adequately widened on curves and substantial berms should be provided where equipment travels near ponds.

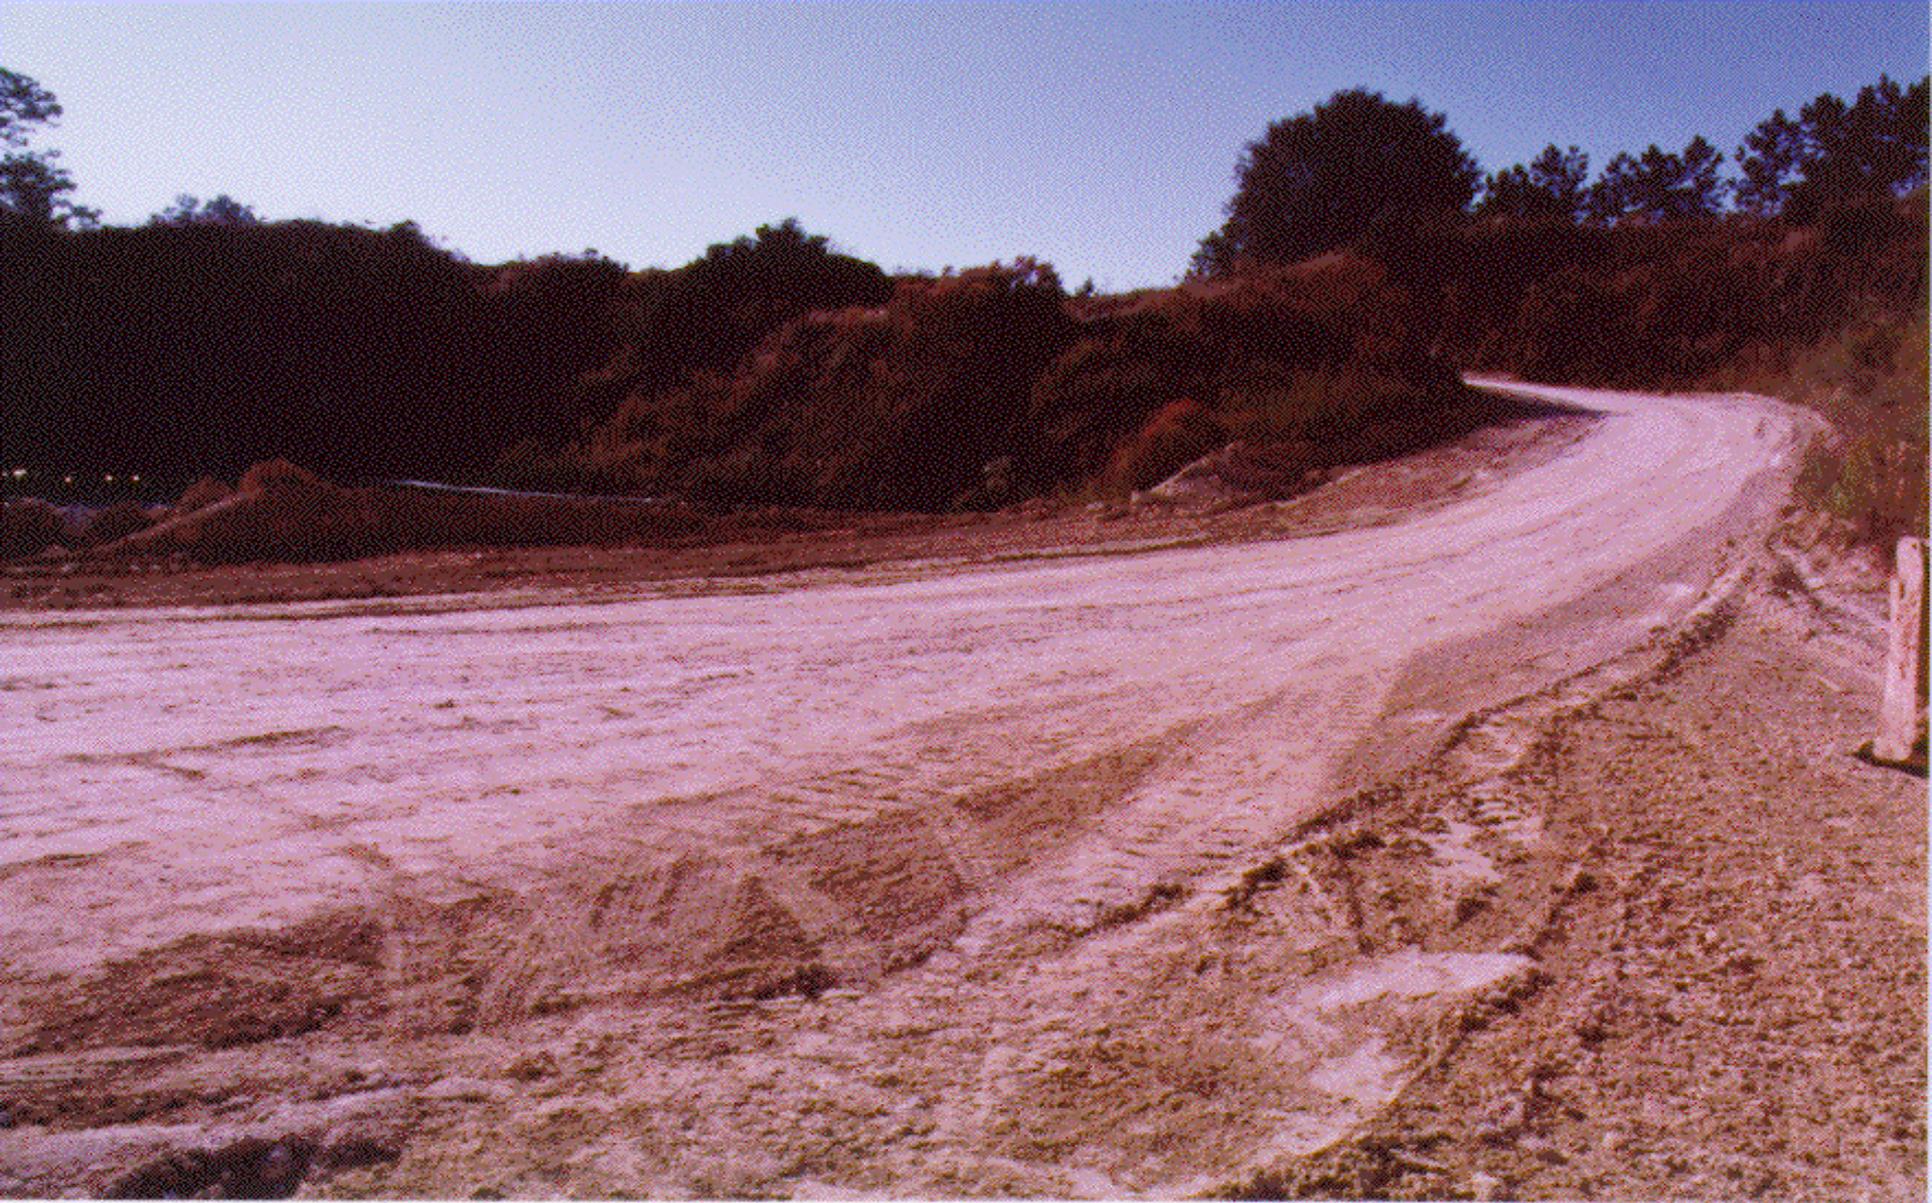
Here's another example. In this accident a 40-ton capacity truck was returning empty to the pit. The truck was descending this 10 percent grade and negotiating the curve when a mechanical problem with the truck caused it to continue turning to the right where it plunged into a pond.

The accident investigation revealed a defective gear selector control cable, which apparently caused the truck to be shifted into reverse instead of 1st gear. Apparently the truck stalled and the emergency steering became depleted. The pond was 42 feet from the road and was not bermed.

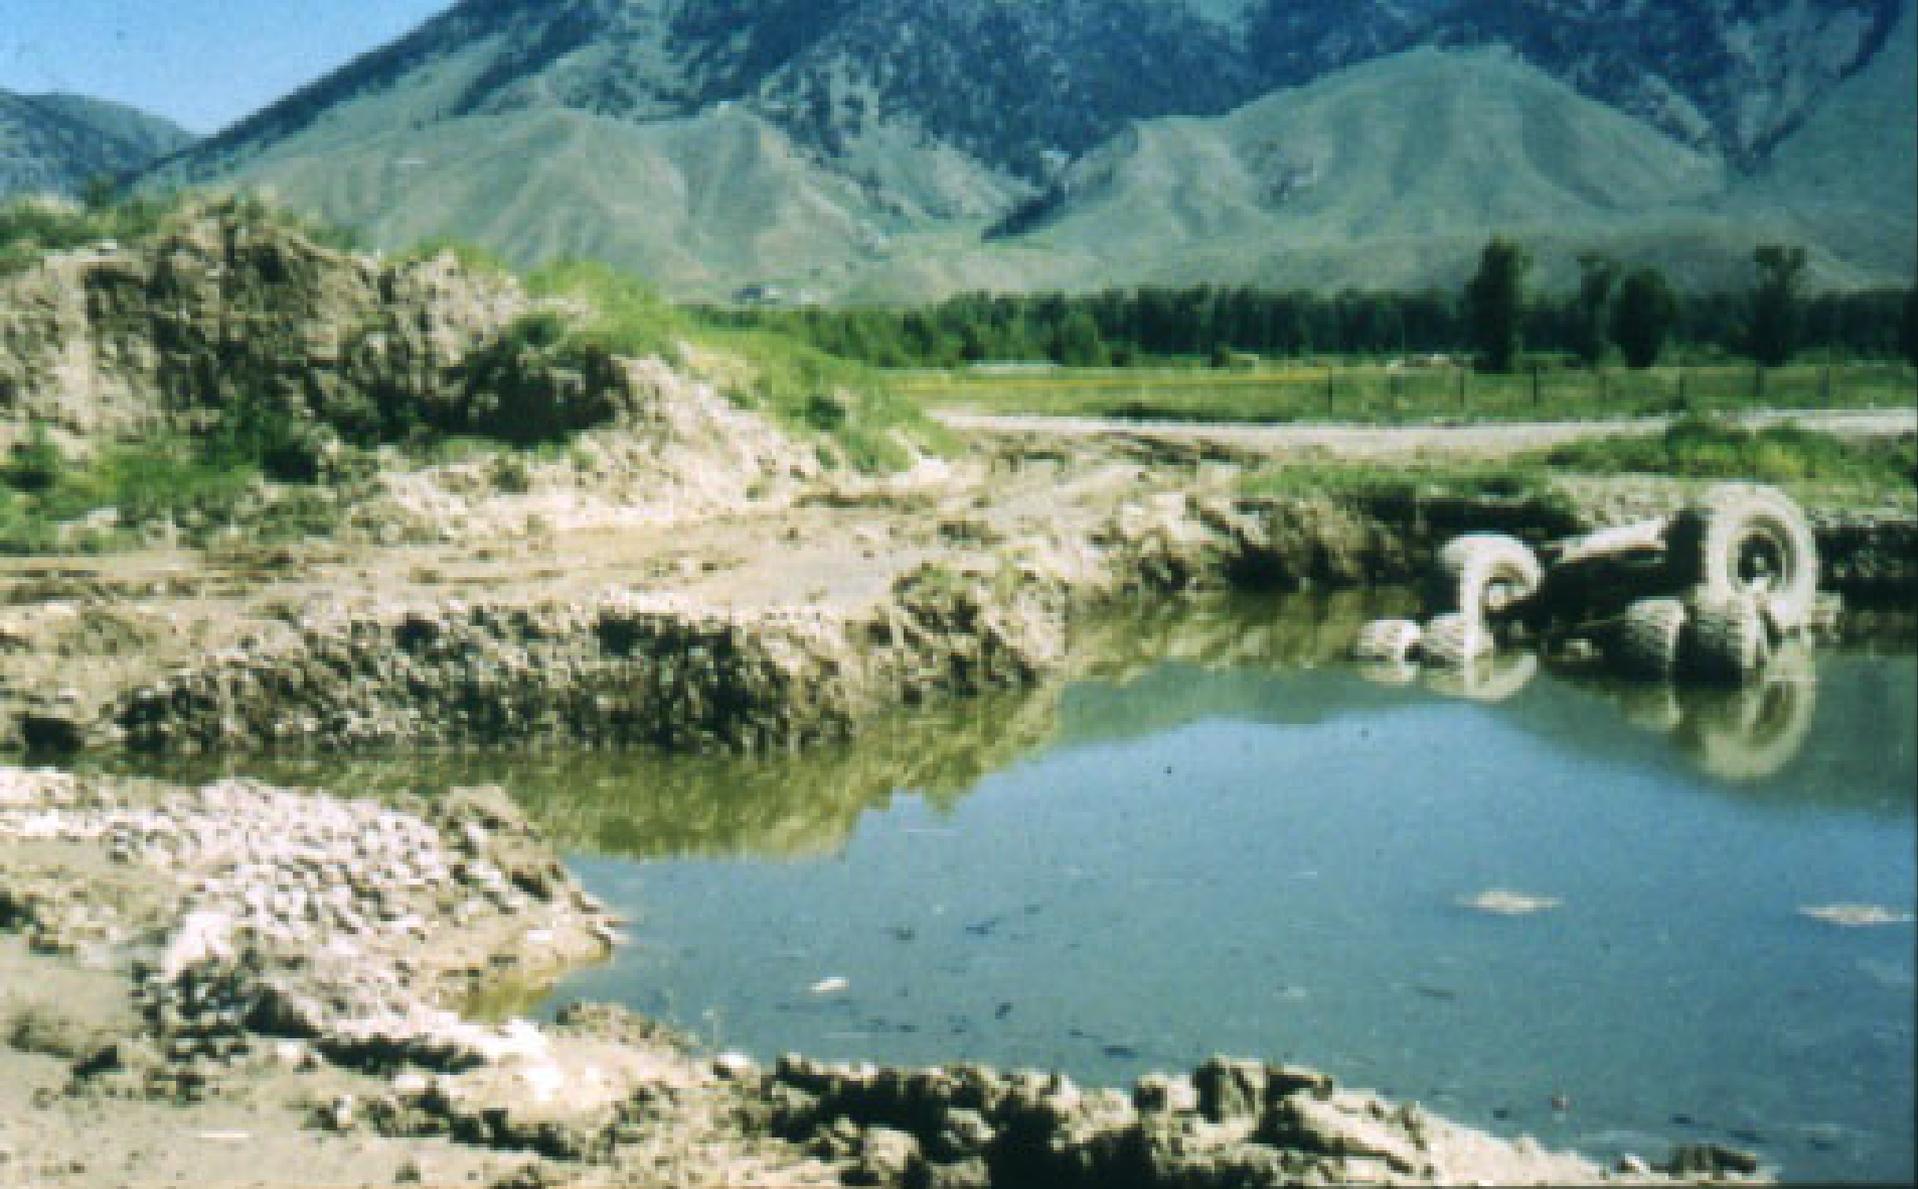
In this fatal accident the truck was backing up past this pond when the rear wheels got too close to the edge. No berm had been provided. A berm should serve the three functions of providing a good visual indicator of the edge of a drop off; impeding equipment from going over the edge; and keeping the weight of the equipment back a safe distance from the potentially unstable edge of a drop off.

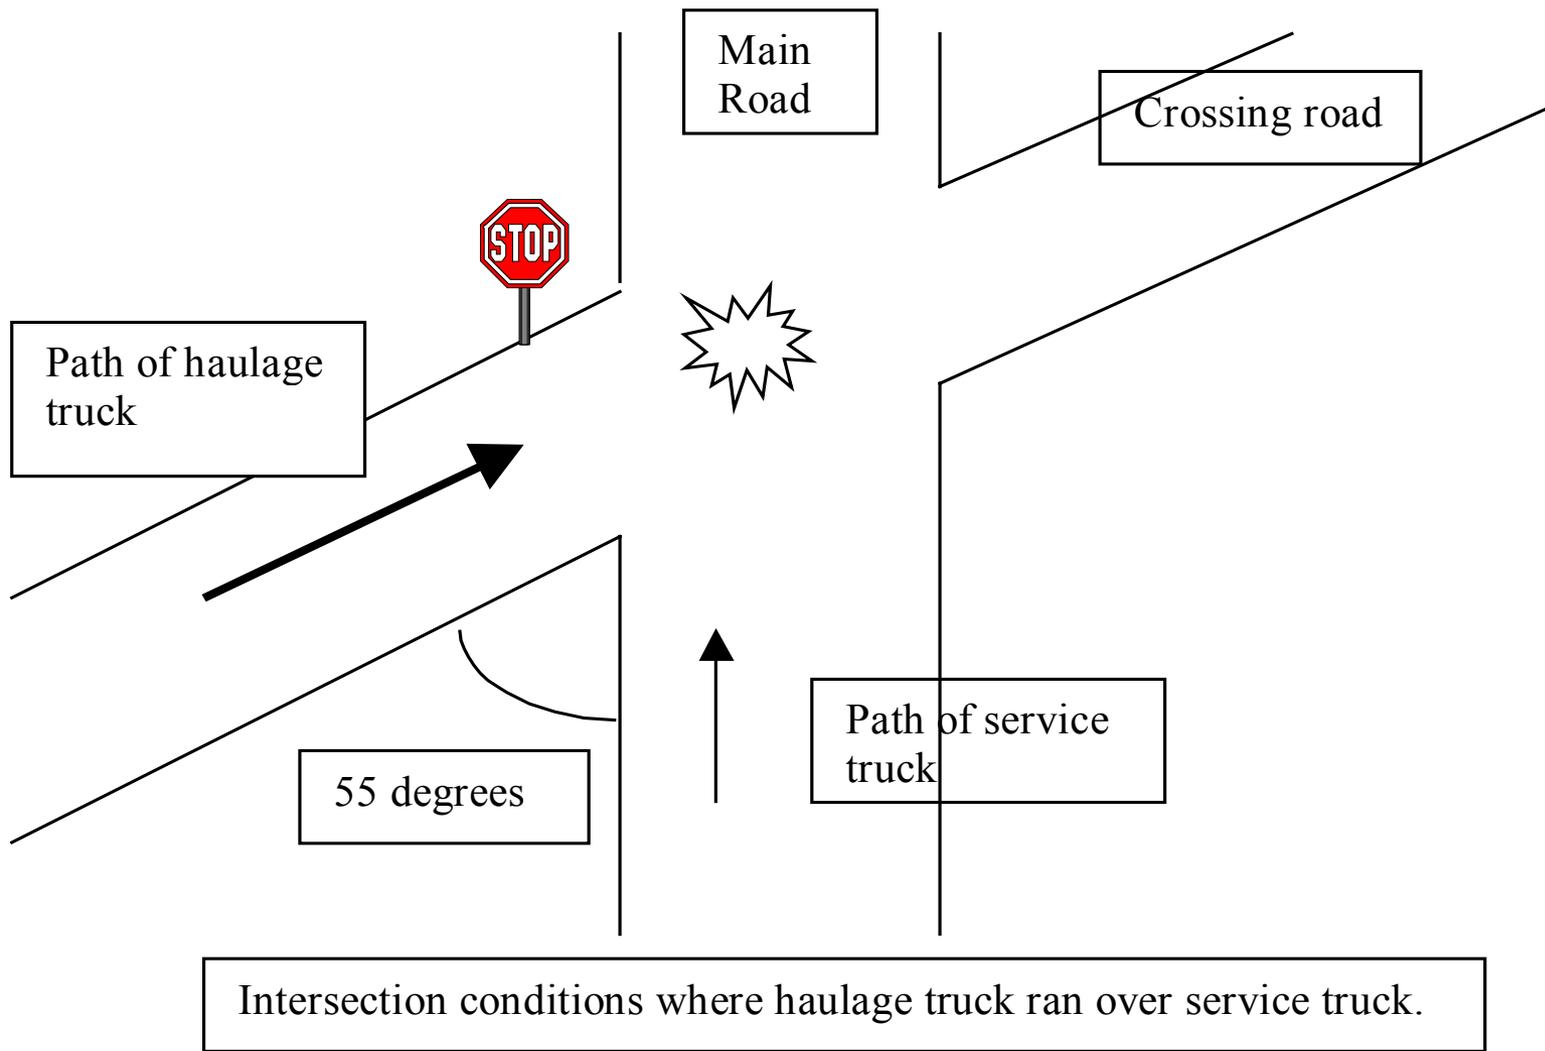
This was the layout of the intersection. A “drive left” traffic pattern was used. Note that this intersection layout - with the crossing road intersecting at an angle of about 55 degrees - would have made it more difficult for the haulage truck driver to see traffic approach the intersection from his right side.

Intersections should be laid out keeping this right side blind spot in mind. Avoid intersections at angles of less than 90 degrees to the truck's right side. Layout intersections to provide the drivers with as much sight distance as possible.

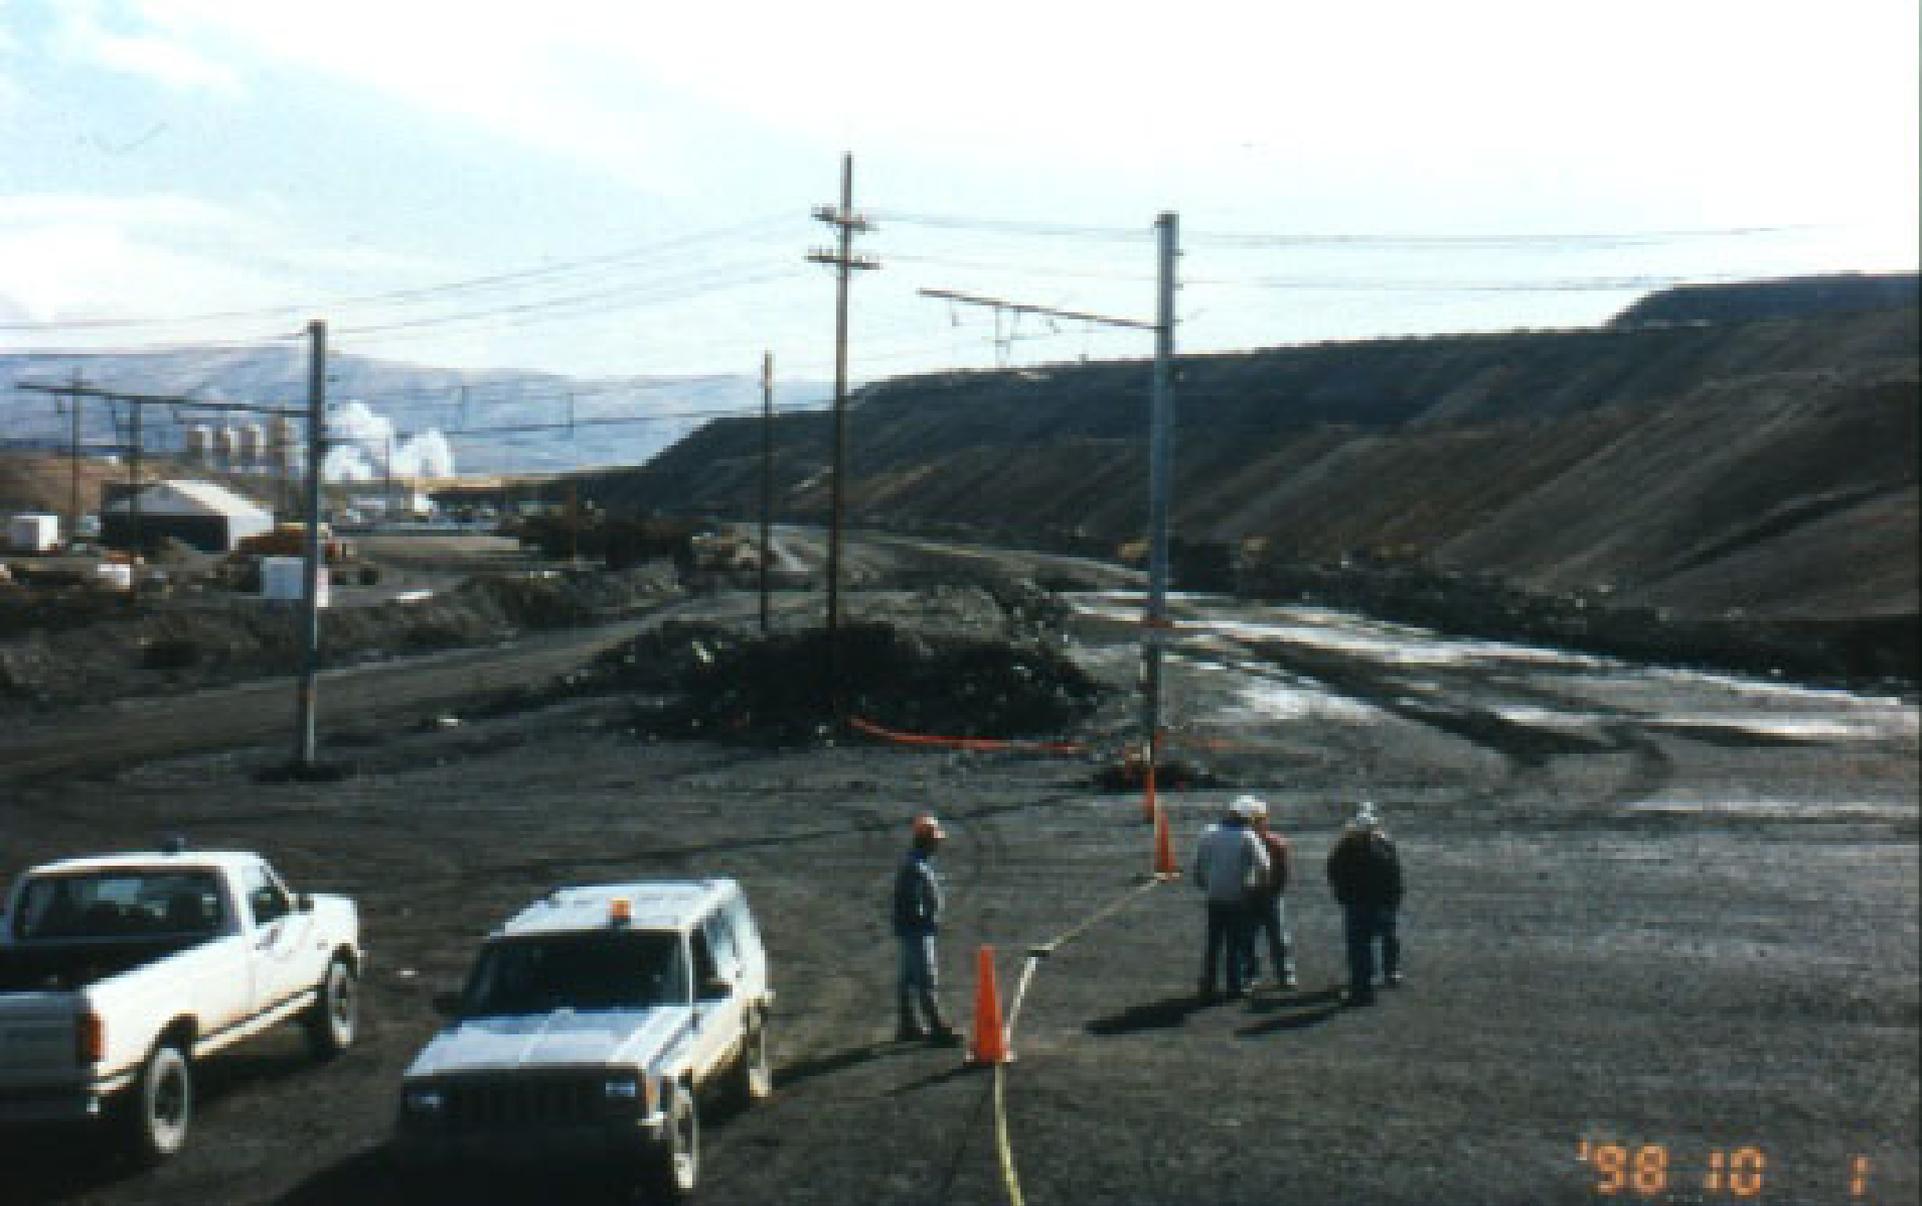
Here's the actual intersection. The main road runs from left to right across the front of the picture. The haul truck would have approached and stopped near the right side of the picture.

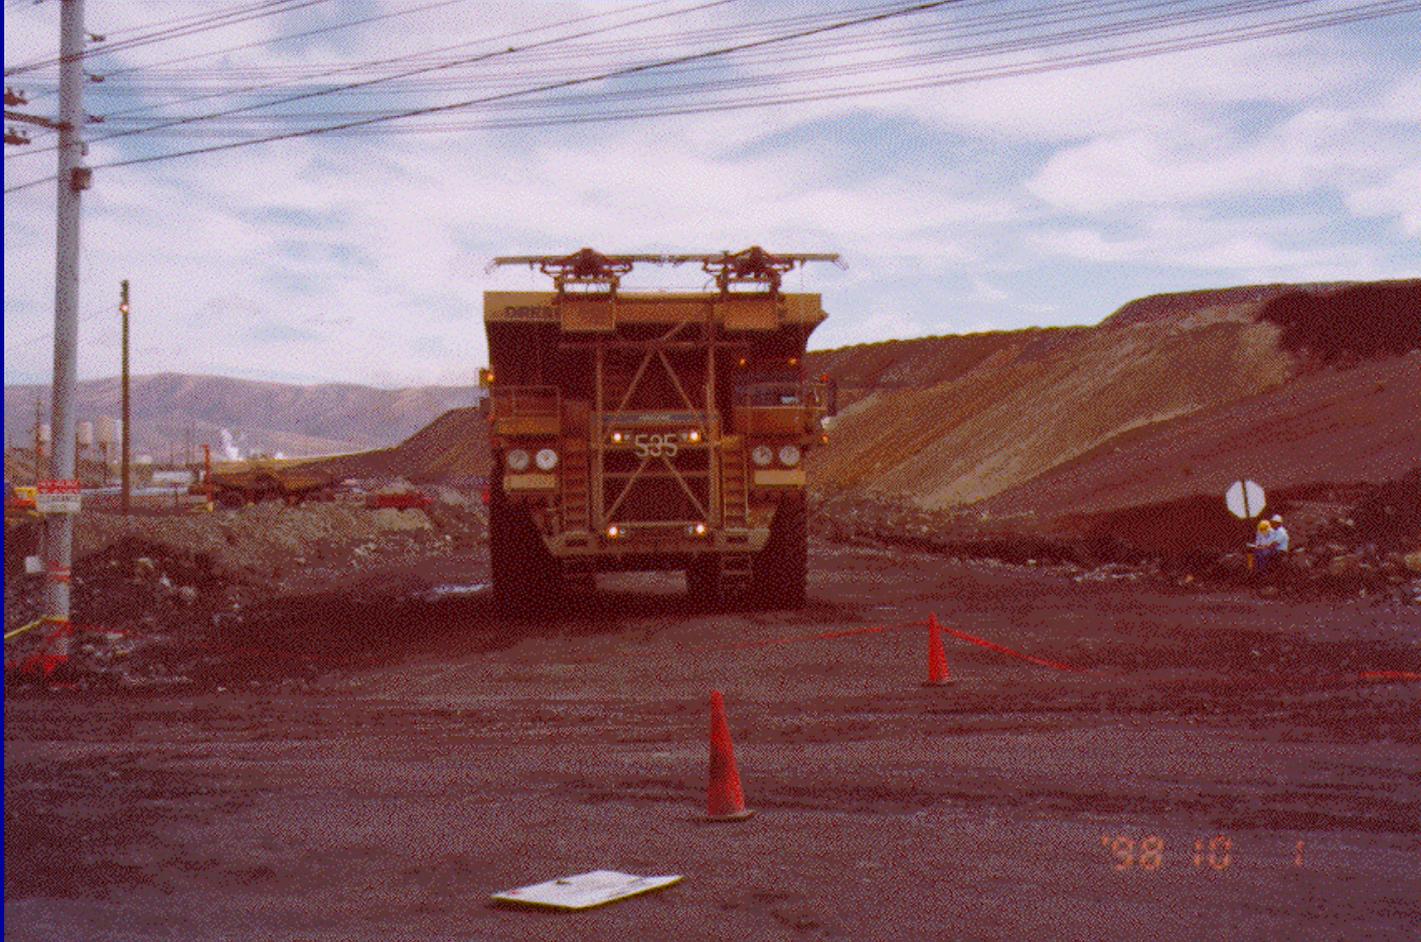
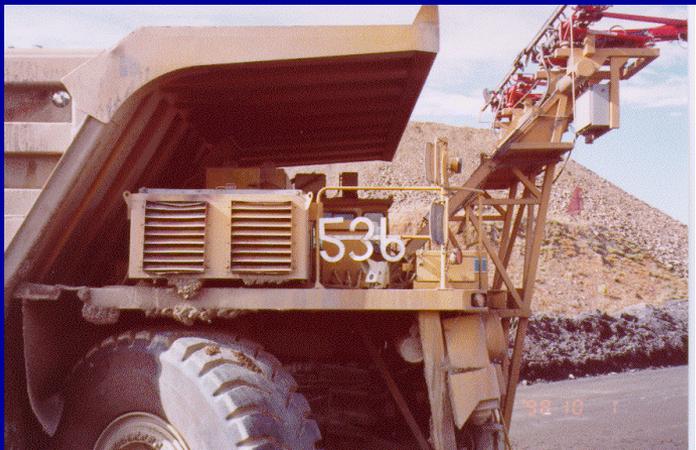
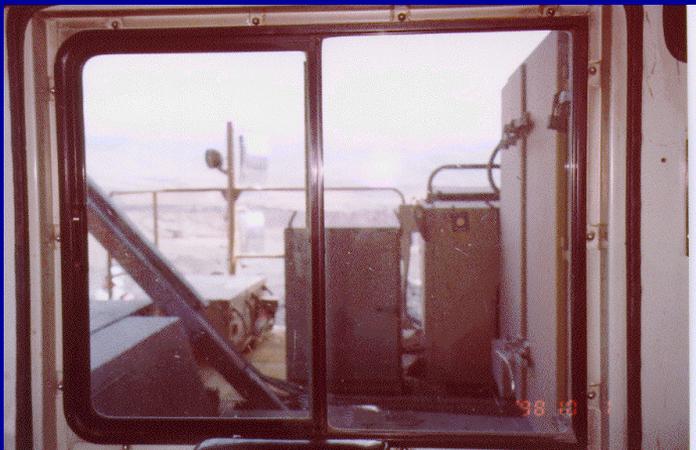
This shows a haul truck stopped at the intersection.

Notice in the insets below how the driver has a difficult time seeing to the right side.
