Surface Haulage Accidents...

...Ways to
Prevent Them

MSHA's investigations of surface haulage accidents reveals two key points:

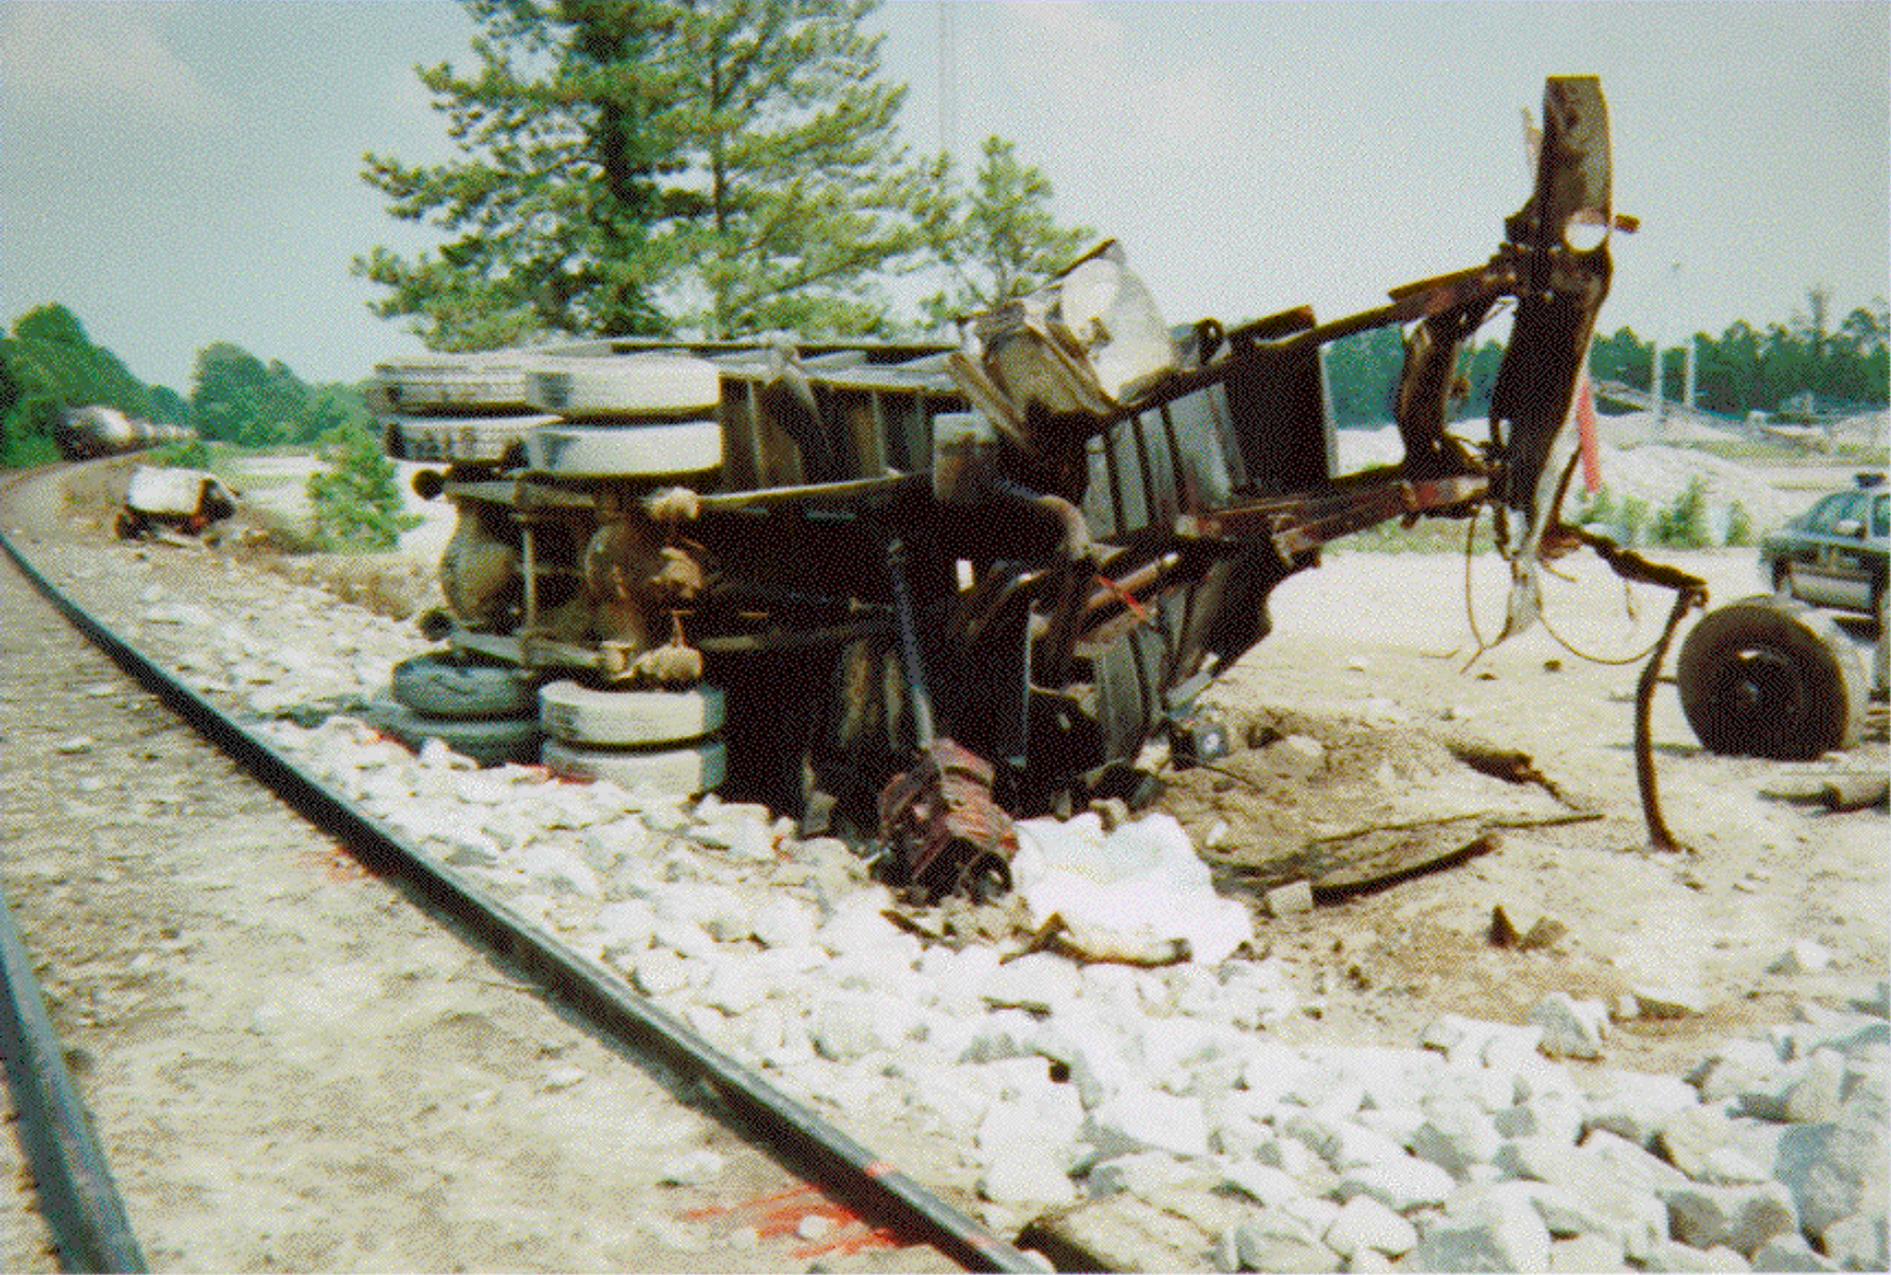
At this crossing, a 44 year old driver was killed when her truck was struck by a train. She had 15 weeks of experience.

The accident occurred at 1:40 p.m. Other workers heard the train whistle, but the victim did not stop her truck at the crossing.

Drivers should keep these points in mind concerning railroad crossings:

- **It can take a train a half mile to come to a stop from 30 mph;**
- **Trains can come at any time.**
- **Never attempt to beat a train to the crossing - it's easy to underestimate the train's speed.**
- **Always stop, look and listen at railroad crossings.**

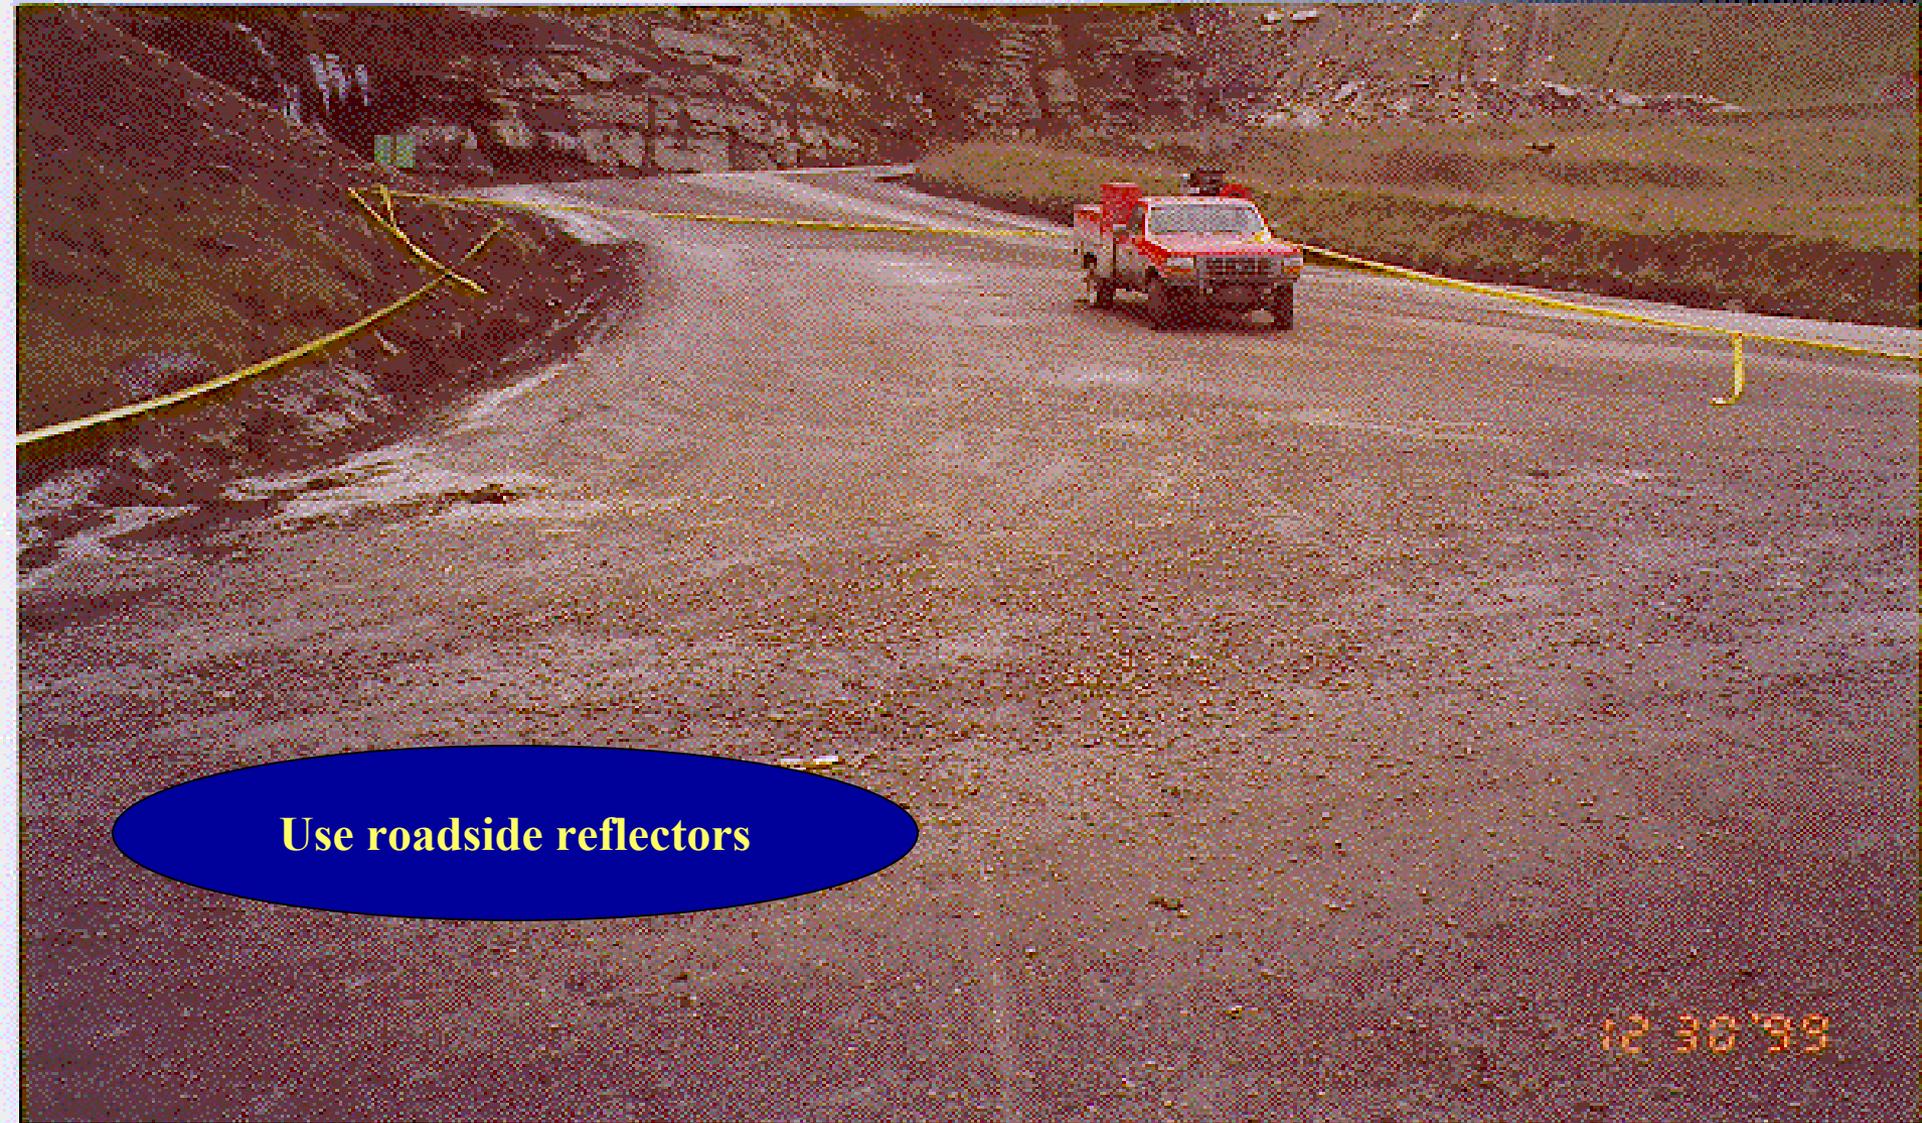
A fatal accident occurred in at this site involving a 10-ton welding truck. The welding contractor was leaving mine property around midnight. He came down this 10 percent grade to a “T” intersection. Note the skid marks coming across the intersection.

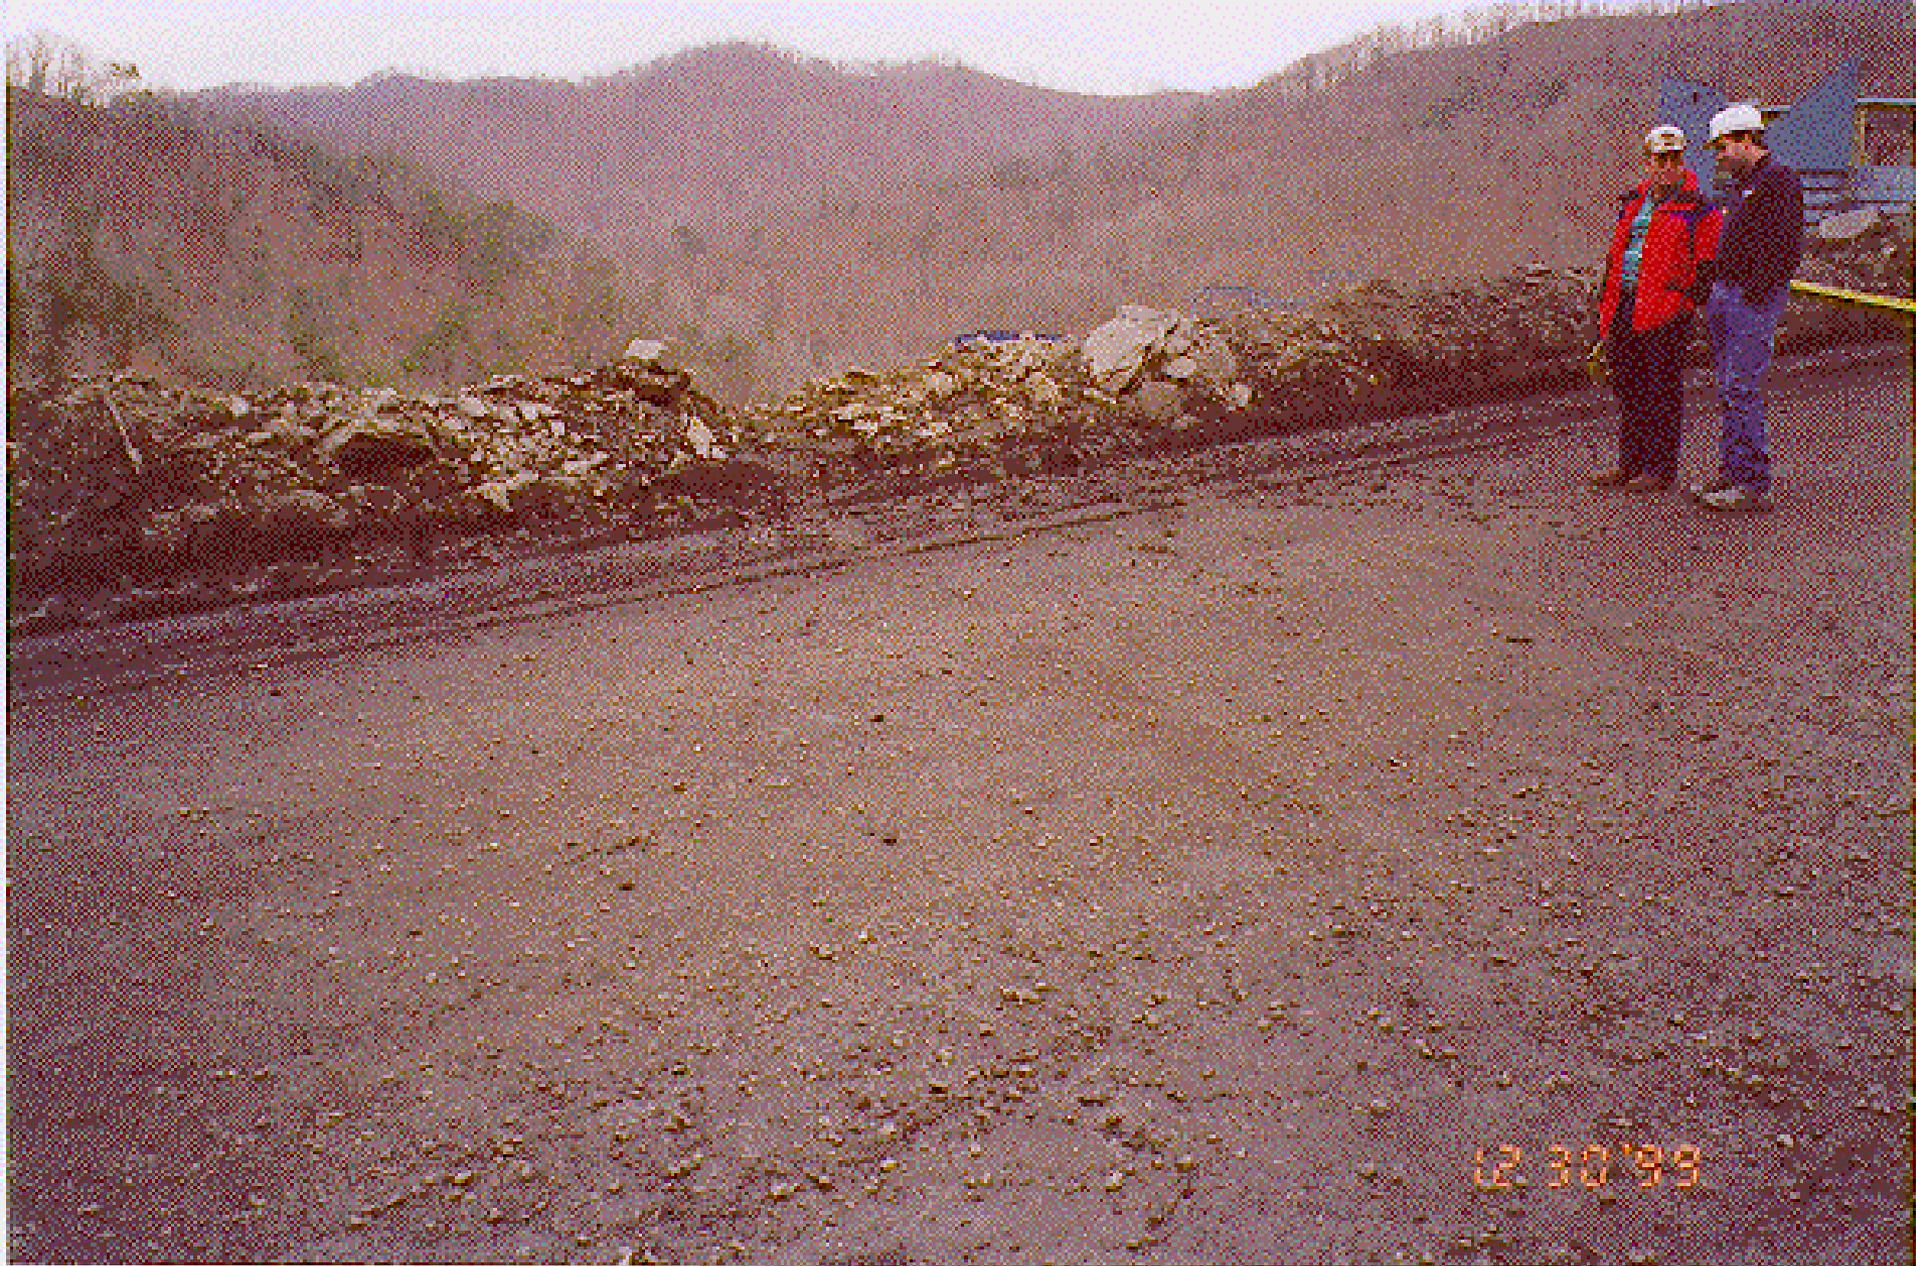
The skid marks were 125 feet long and led through this berm and over a highwall.

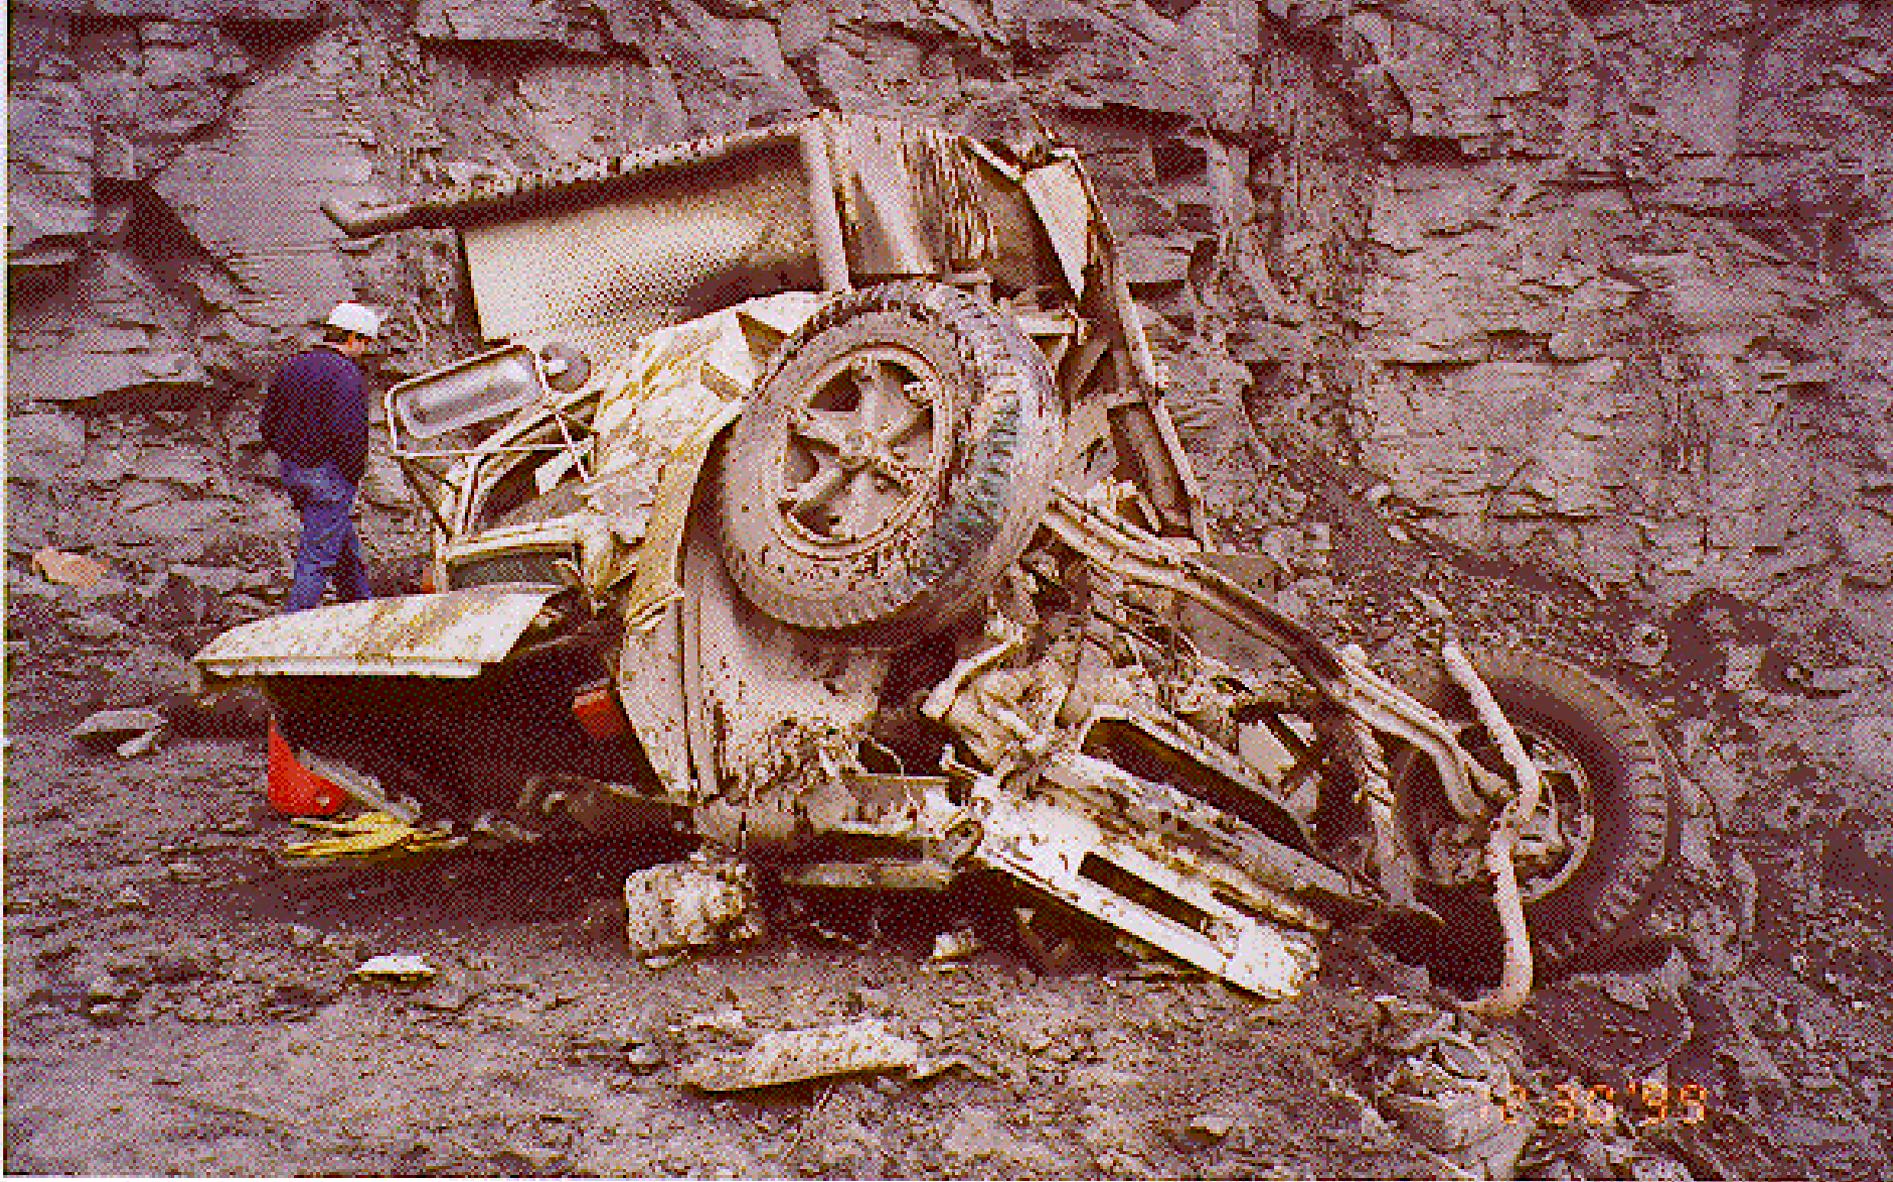
The truck fell 160 feet to a bench. Although the rear brakes were found to be defective, a factor in this accident may have been the victims unfamiliarity with the mine roads while driving after dark. The use of road side reflectors may help in this type of situation.

- Road side reflectors can provide similar safety benefits on mine roads. They would be helpful for new employees and visitors on the property. And they would benefit older drivers since our ability to see at night diminishes as we age.

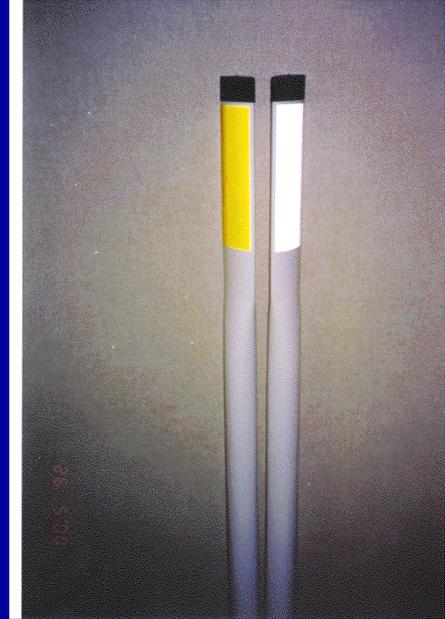
As shown to the left, road side reflectors are a common safety feature on public highways.

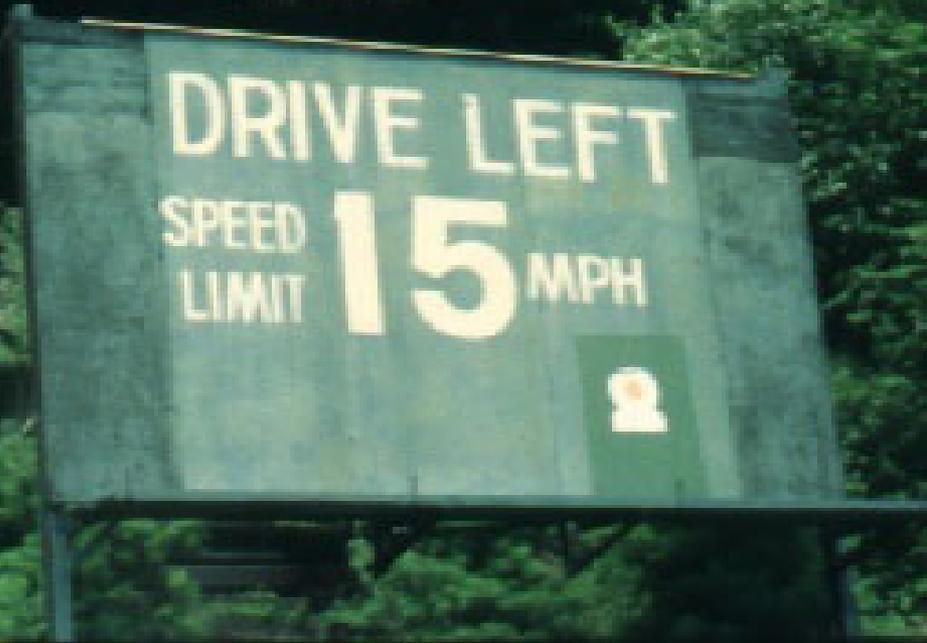
DRIVE LEFT
SPEED LIMIT 15 MPH

Suppose a tire salesman sees this sign as he enters mine property and drives on the left side as he makes his way to the maintenance shop. As he gets back in his truck after spending a couple of hours at the shop will that salesman remember to drive left as he leaves the property? Make sure there are sufficient signs for this type of circumstance - especially when unusual right-of-way rules are used on the property.

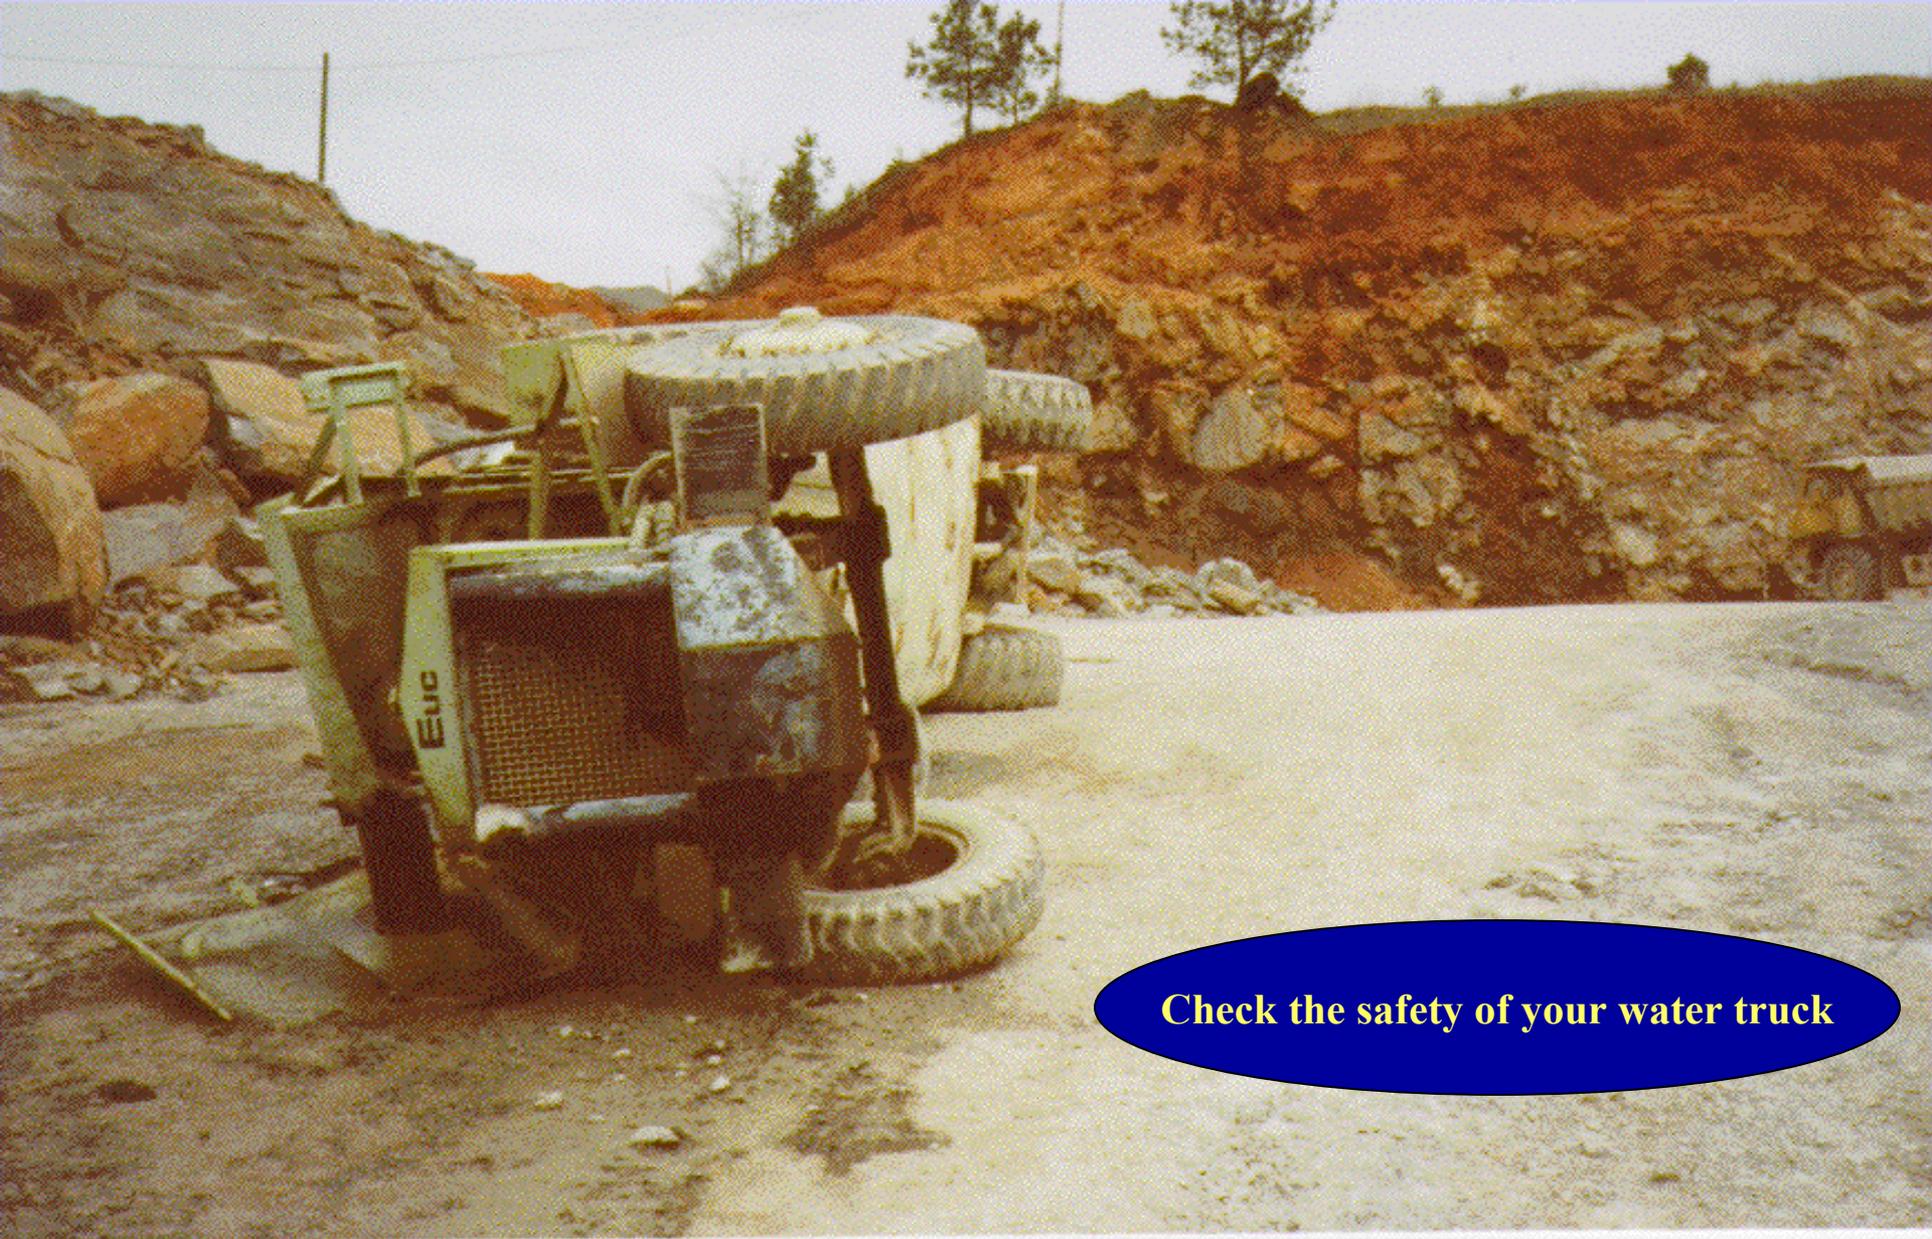
Several fatal accidents have occurred in recent years involving water trucks. This one occurred as the water truck rounded a curve while descending a 7 to 9 % grade. The victim's regular job was in quality control and he only occasionally drove the water truck.

The water truck was about half full at the time of the accident and the tank was baffled from front to back.

A witness reported that the truck appeared to be “going too fast” as it rounded the curve.

The victim was not wearing the seatbelt and the rear brakes were found to be defective.

Avoid water-truck accidents by ensuring that: water trucks receive preventive maintenance just like production equipment; water tanks are baffled to control the effects of the water movement in the tank; and water-truck drivers are properly trained on operating the truck.

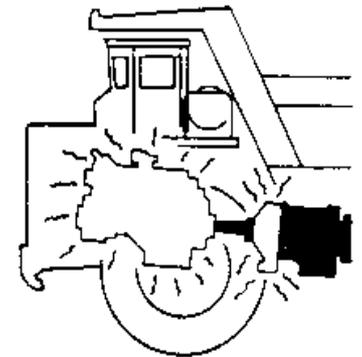
In order to use the retarder effectively and efficiently, before the grade is descended, the transmission must be in the proper gear range and the converter in direct drive (lockup). The retarder pedal should be depressed 10-14 seconds before the grade is descended to allow enough time for the retarder to become fully activated. The retarder is most effective when fully activated just before the grade is descended. Also, it might be necessary to accelerate

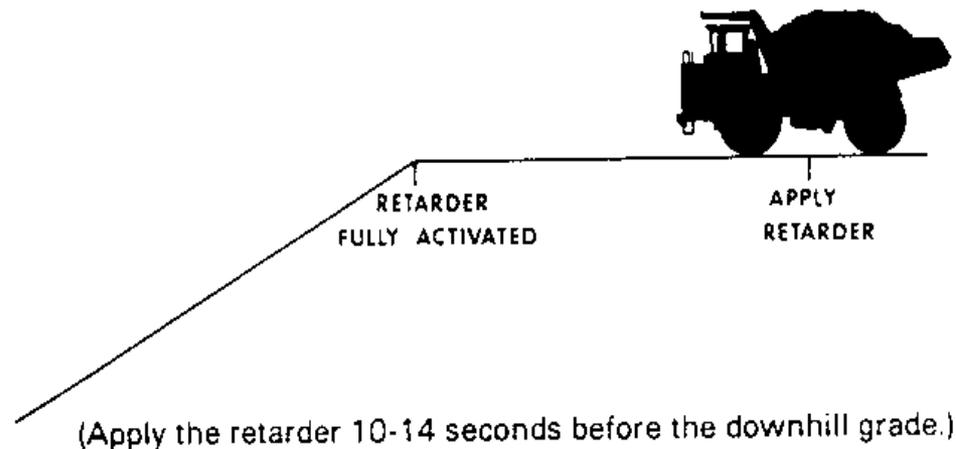
Disengage Retarder
When Going Upgrade or
When Stopped for Long
Intervals
